**Geomorphic Assessment of Bloody
and Sugarloaf Brooks**
South Deerfield - Deerfield, MA

Prepared for
Town of Deerfield

Prepared by
Nicolas Miller
Field Geology Services
Charlemont, MA

June 2025

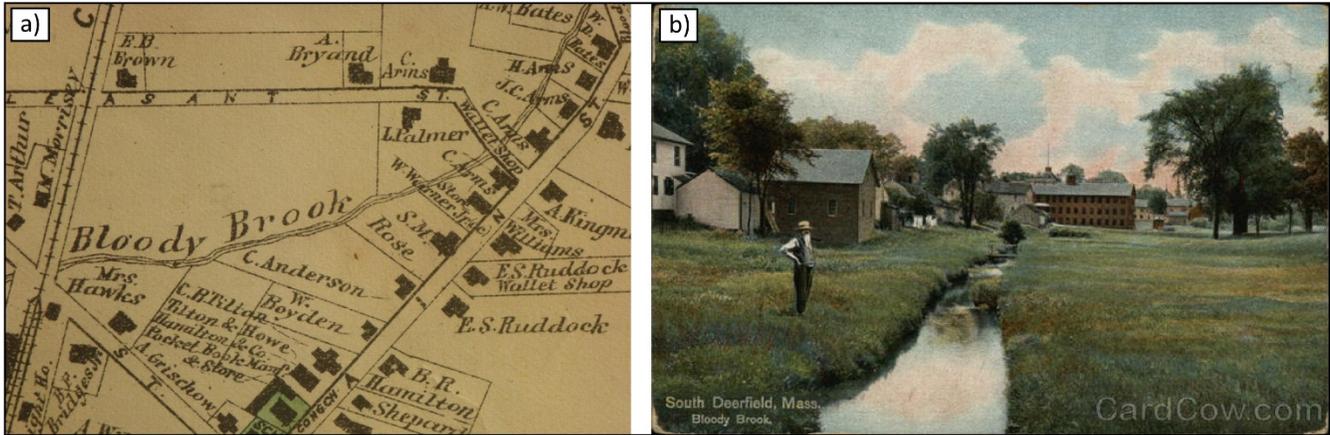
Figure 2. Evidence of channel straightening from archival sources includes a) straight channel planform on 1871 Beers Atlas map, and b) 1910 postcard view of straight Bloody Brook channel near the center of South Deerfield.

Based on the 1895 topographic map (surveyed 1884-85), Bloody Brook was straightened prior to 1885 (Web citation 1 and Appendix 2). Historic aerial photographs (since 1962) showed few changes in channel location in the section of Bloody Brook that runs through South Deerfield. This is due at least in part to past channel manipulations of the river channel to facilitate residential, commercial and civic development (FRCOG, 2024a).

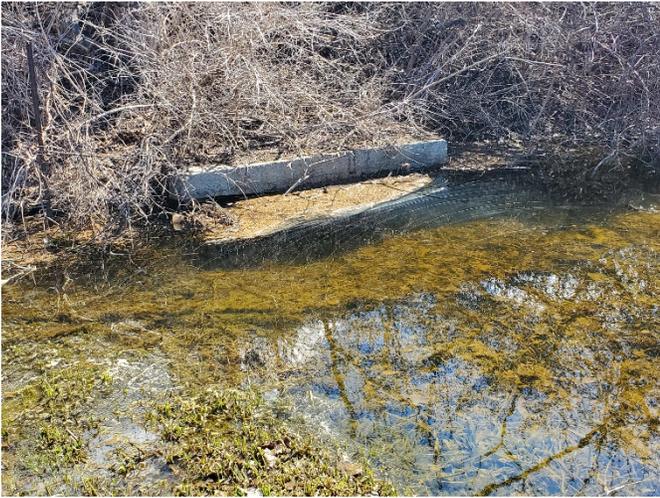
Reach BLD11 is the upstream-most reach in the Bloody Brook study area, starting at Route 5&10 and extending to the upper railroad culvert, a distance of 1470 feet (the stream crosses under the railroad grade again in the upstream section of Reach BLD05). This reach of Bloody Brook is ephemeral and was mostly dry during November 2024 field mapping; homeowners adjacent to the brook report that this is normal, but that the stream often floods during periods of extended rain, backwatering upstream of the undersized railroad culvert and transforming residential yards into short-lived ponds. The artificially straightened channel is still relatively straight, although there is evidence of meander reformation. The channel substrate is sand and fine gravel.

Backwatering upstream of undersized railroad culvert

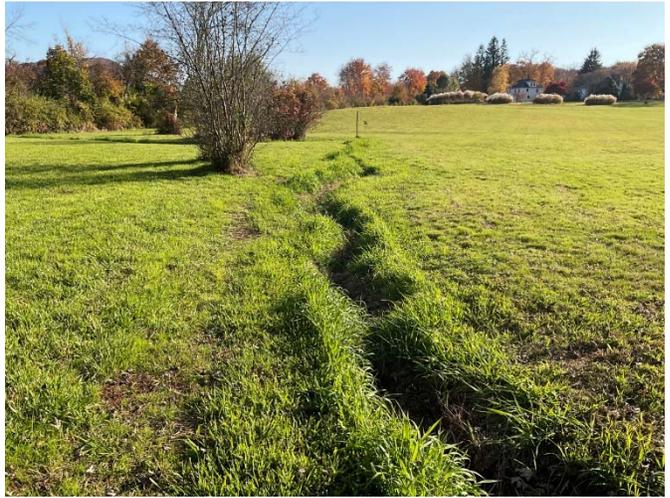
Channelized stream lacks riparian buffer

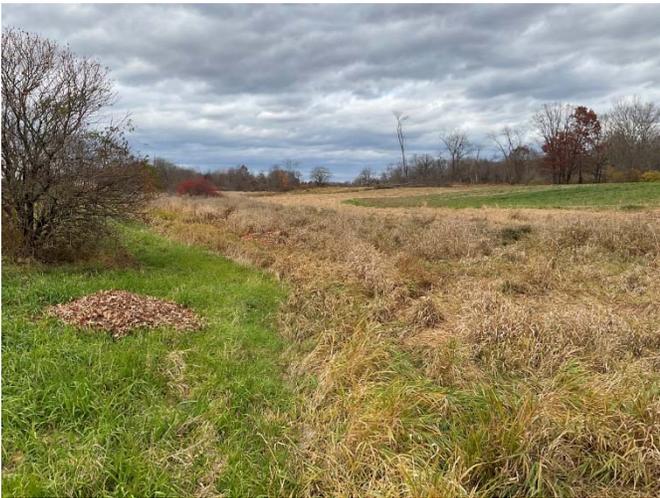
Upstream view of grassy wetland channel in BLD10

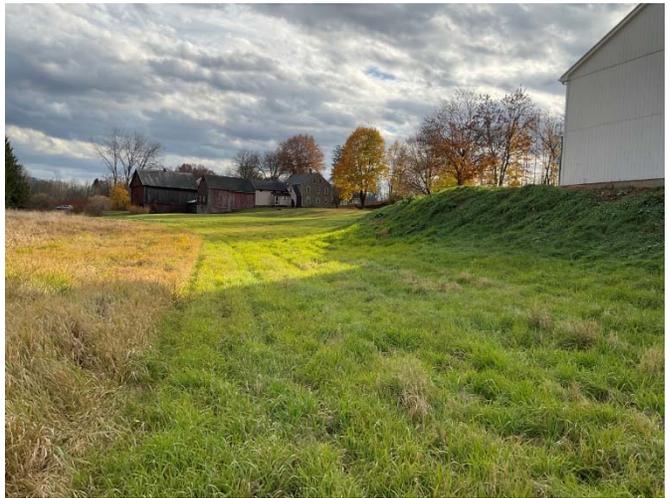
Downstream of the railroad grade there is a deep scour pool, evidence of the increased flow velocities exiting the undersized railroad culvert (Table 2). Like Reach BLD11, this reach is also ephemeral but often becomes backwatered during wet periods. Upstream of Jackson Road the stream resembles a wet meadow, supporting a suite of wetland plants; the substrate is silt, consistent with the wetland vegetation. Land use in the stream corridor is mostly agricultural. Areas of artificial fill, including the railroad grade itself, encroach upon the stream corridor confining flood flows (see photo below).

Barn built on artificial fill along edge of stream corridor

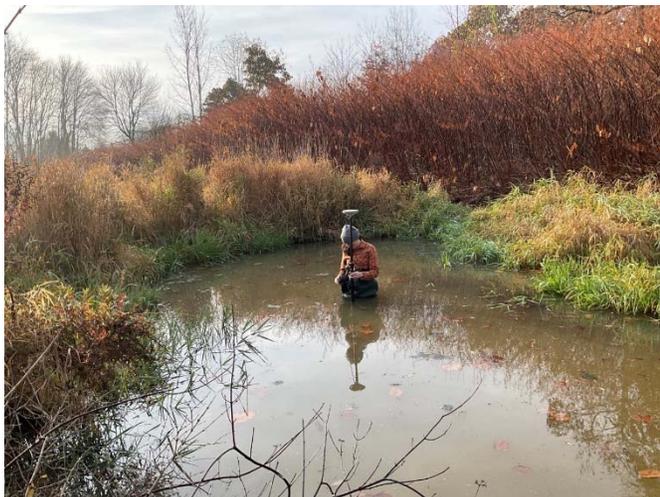
Scour pool downstream of Jackson Rd

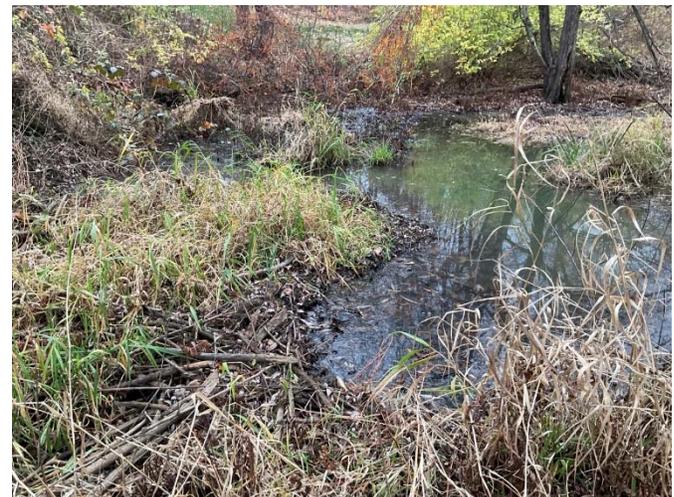
Beaver dam impounding water in Reach BLD09

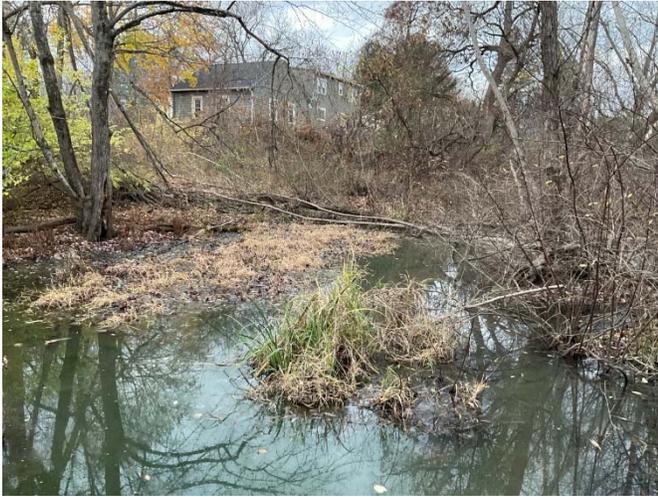
Backwatering in side channel

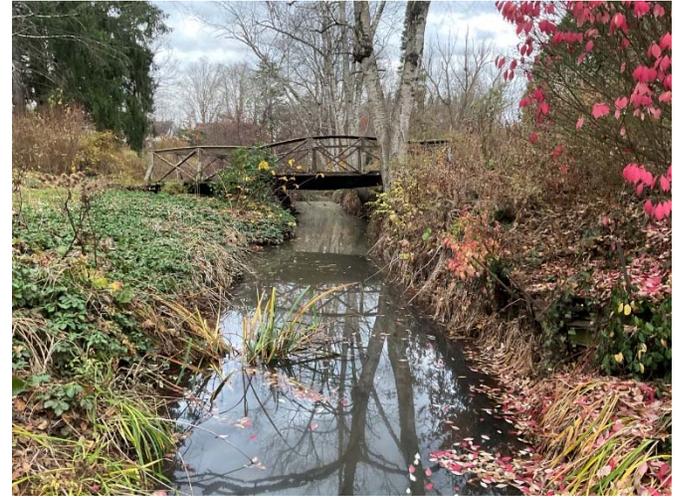
or retaining walls; armoring was mapped along 11.2 percent of the streambanks in the reach (Table 4). The stream is impounded in several locations, by private driveways, pedestrian bridges, undersized culverts, and one beaver dam.

Retaining walls along straightened channel

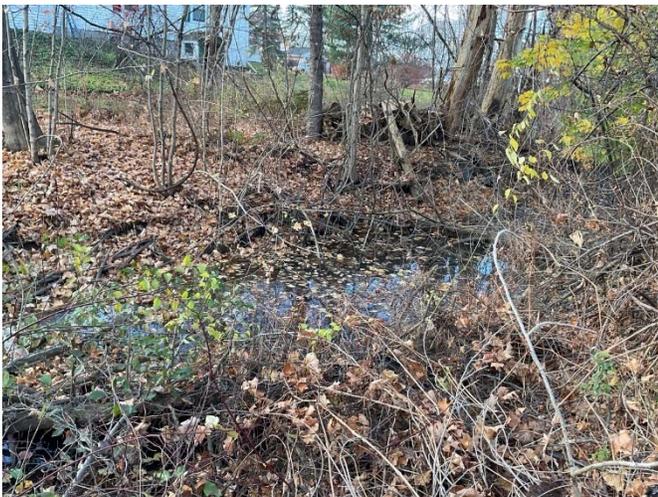
Low gradient channel filled with debris

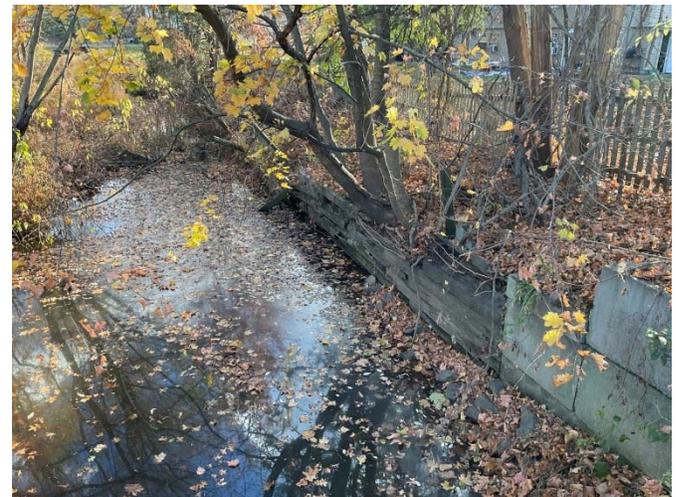
Failing timber retaining wall along right bank fill

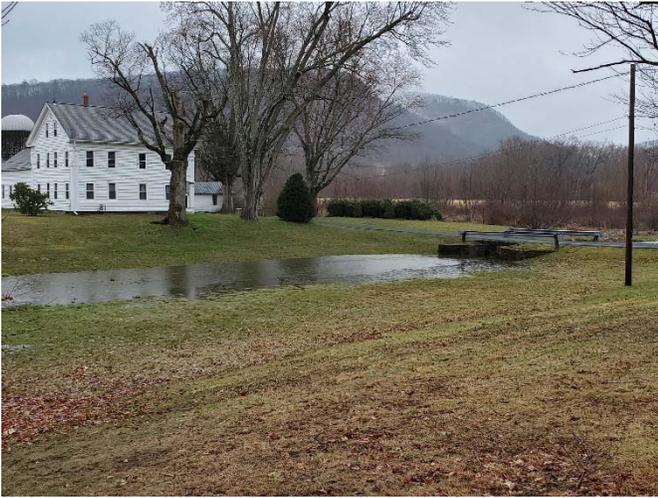
Ponding upstream of undersized culvert at private drive

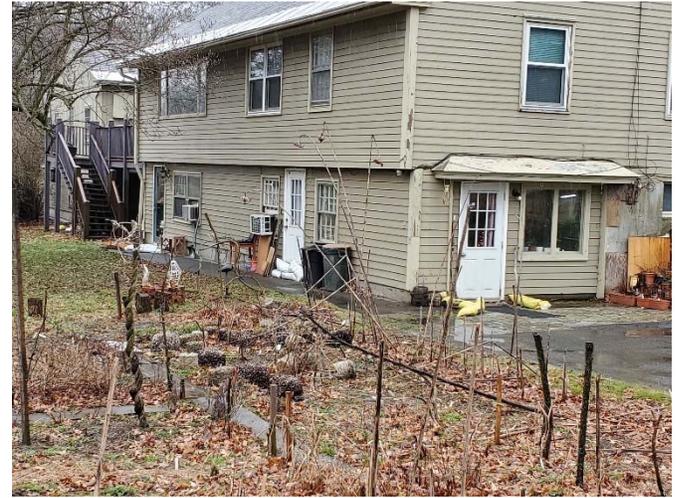
The straight channel continues downstream of Hillside Road and crosses through several undersized crossings that constrict the channel: a private residential right-of-way, Captain Lathrop Drive, and then a private driveway at Bloody Brook Farm. The stream is re-meandering through this reach with deposited point bars paired with erosion on the opposite bank. Erosion and bar deposition are both more prevalent in this reach than in upstream reaches (Table 4). One eroding bank of note is just downstream of Captain Lathrop Dr, where the artificial fill surface along the right bank was protected by a timber retaining wall that is now failing (see photo). The low gradient channel is filled with vegetation, sticks, and organic debris. The substrate is a mix of silt and sand. Evidence of repeated flood inundation includes a house at the corner of North Main St and Captain Lathrop Dr with placed sandbags at first floor doors to hold back floodwaters (see photo).

Sandbags at first floor doors = evidence of flooding

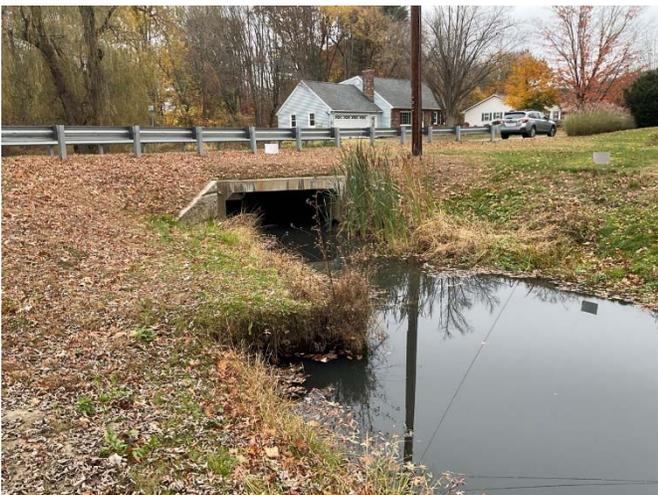
Recently replaced culvert at Kelleher Drive

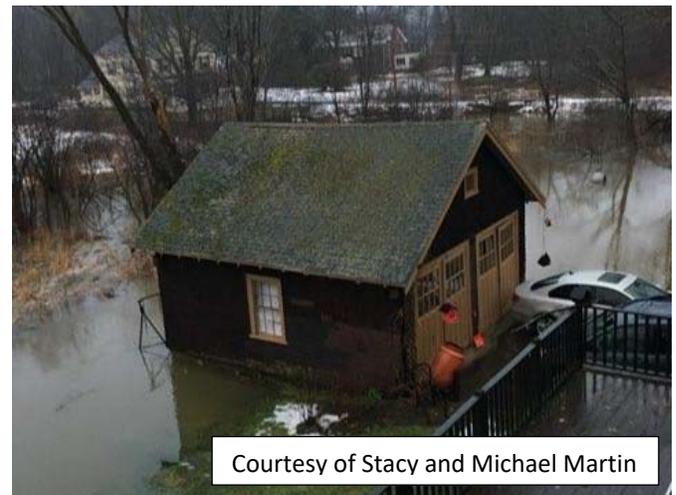
Flooding upstream of 130 North Main St.

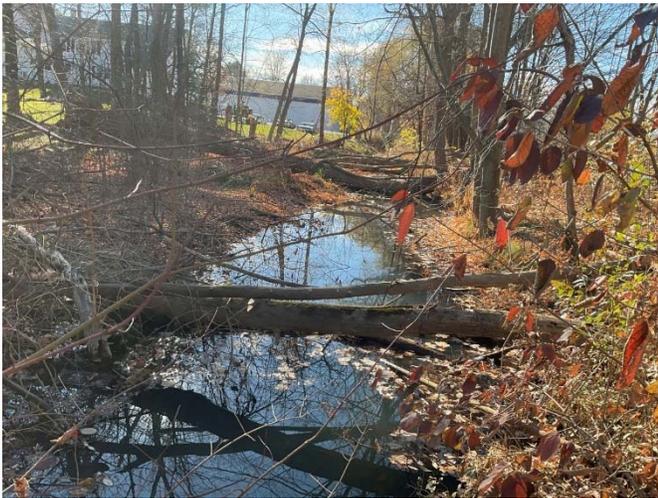
Channel-spanning debris jams upstream of Pleasant St

roughness may need to be reduced to maintain flow velocities and sediment transport capacity. Therefore, it may be appropriate to remove channel-spanning wood and naturally recruited woody material in this setting to maintain the movement of water and sediment through the stream system.

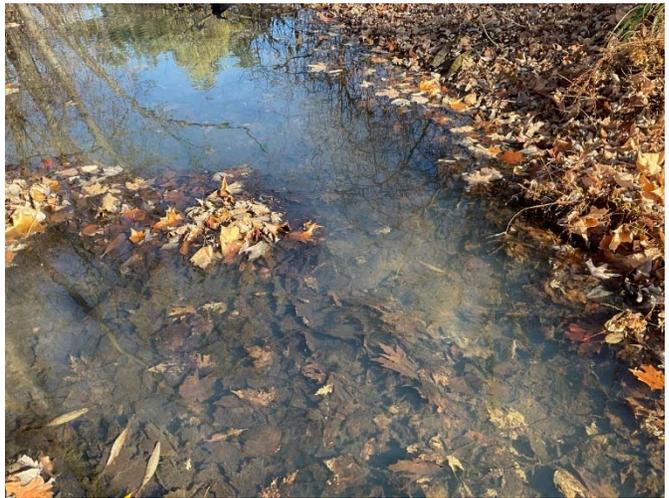
Thick layers of leaves and organic debris in stream

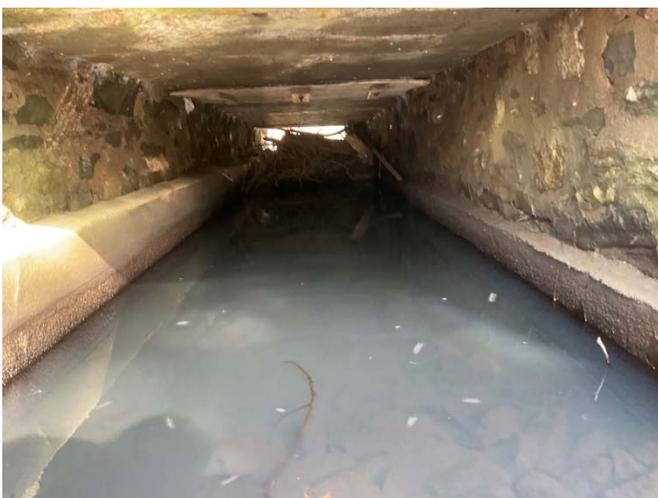
The Pleasant St culvert is significantly undersized, and this condition is worsened by the dumped riprap at the culvert outlet, which is at a higher elevation than the inlet. This geometry forces backwatering, with its accompanying sediment and debris deposition, at even low flows. The Pleasant St crossing was selected by Field Geology Services as one of the areas for more detailed topographic survey efforts (Figure 6). During surveying a significant quantity of trash and debris was noted partially blocking the culvert and limiting its hydraulic capacity. This debris has since been removed.

Upstream view of debris blocking Pleasant St culvert

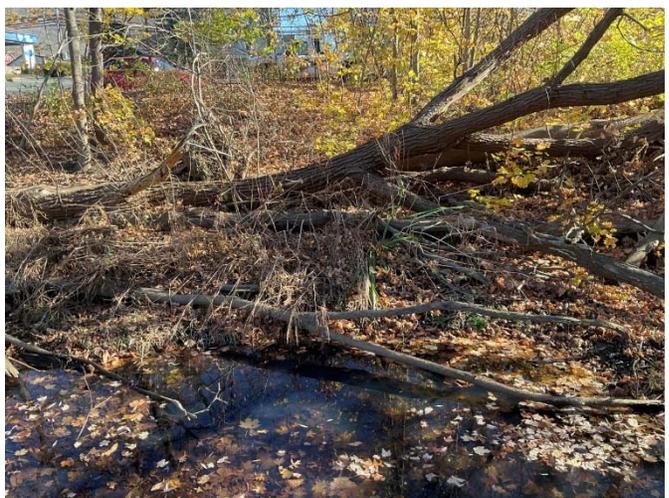
Fallen tree trapping debris downstream of Pleasant St

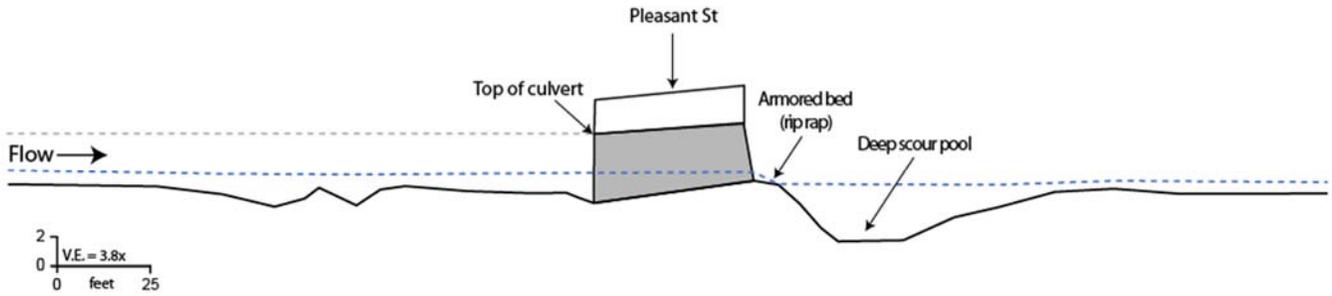
Figure 6. Longitudinal profile surveyed through Pleasant St crossing showing higher bed elevation at the culvert outlet than inlet upstream and a deep scour pool that has developed downstream of the undersized crossing

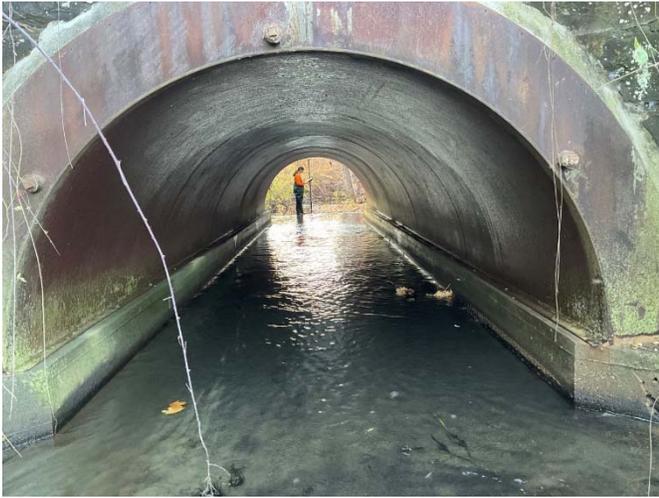
Downstream of the elementary school, the railroad crossing is a retro-fitted arch with a poured concrete bed and marks the downstream end of the reach. With a maximum width of 9.2 feet and a height of 5.8 feet (Table 2), this culvert has a much greater capacity than the Pleasant St culvert upstream; however, this culvert is still well smaller than those required by the Massachusetts State Stream Crossing Standards. A more in-depth discussion of optimal culvert dimensions will be possible once the proposed conditions hydraulic modeling has been completed in FY2026 and will be discussed in a subsequent memo produced by GZA.

Retro-fitted railroad culvert (downstream view)

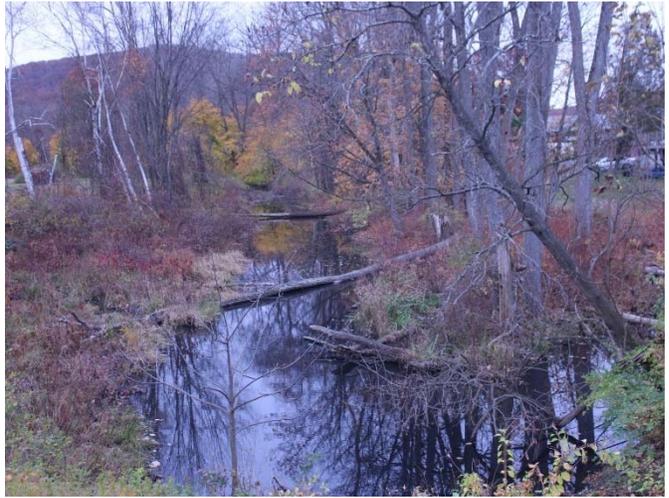
Backwatering upstream of railroad culvert in BLD06

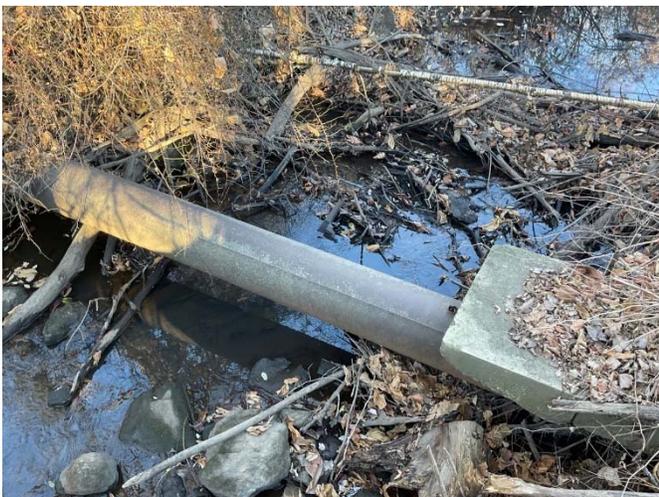
Invasive vegetation downstream of the lower railroad crossing makes the stream difficult to access. Industrial mill buildings are situated along the left bank corridor, while residential parcels are located along the right bank upstream of Route 5 and 10. Near the former North St crossing, a sewer pipe and a natural gas line cross the stream (see photo). These structures have accumulated a significant quantity of wood and debris. This is one of seven debris jams mapped in the reach. A deep scour pool has formed next to the sewer and gas lines, indicating increased fluvial erosion risks. The natural gas utility was contacted by a Town representative following this discovery and was told the line had been decommissioned. The utility will work to remove the gas line.

Sewer and gas lines crossing Bloody Brook

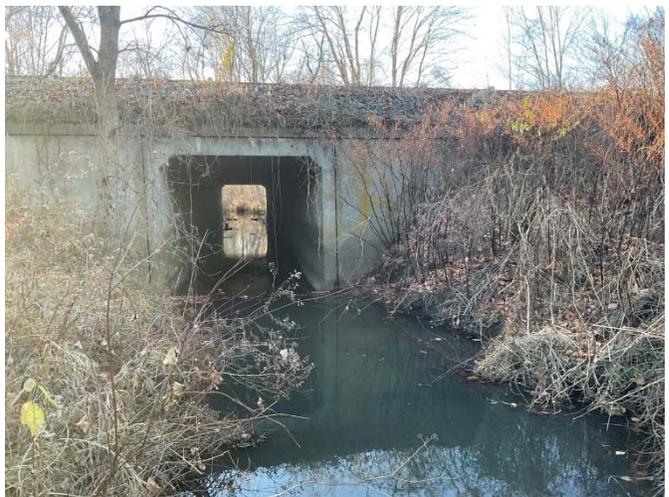
Box culvert under Route 5 and 10 (downstream view)

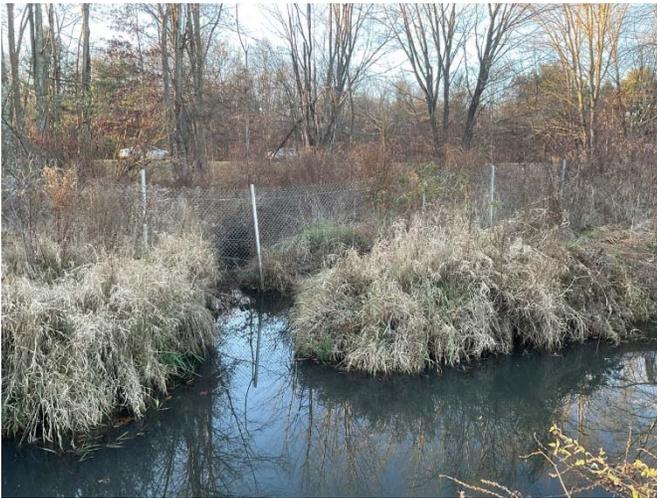
Confluence with unnamed tributary at reach break

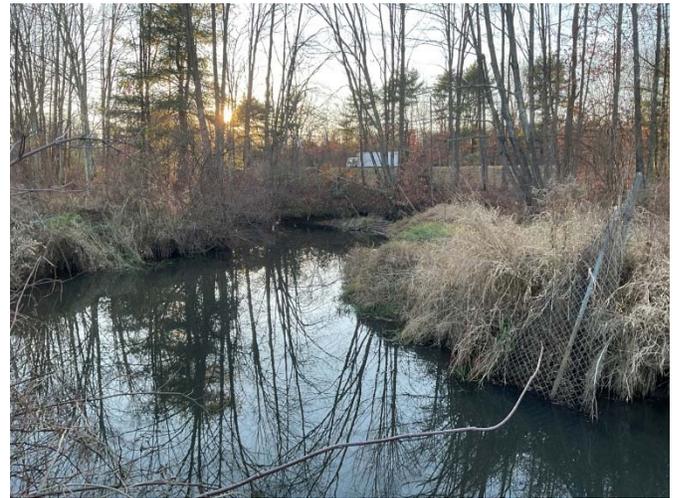
Downstream view with I-91 in background

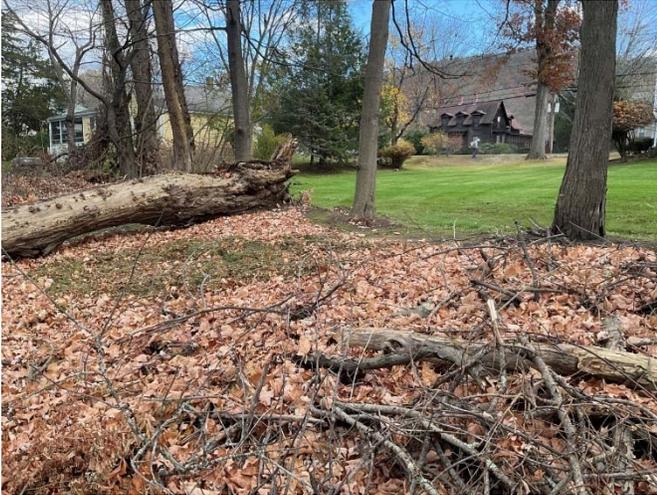
Mapping of Bloody and Sugarloaf brooks revealed that many homeowners are dumping leaves, yard waste, organic debris, demolition materials and other trash along the riparian area and directly in the channel itself. This was noted most significantly in BLD09, BLD06, SUG08, and SUG07 where the streams run through the backyards of heavily residential parcels. Many homeowners hire landscaping companies, some of whom were seen blowing leaves directly into the stream channels.

Leaves blown from lawn into Bloody Brook

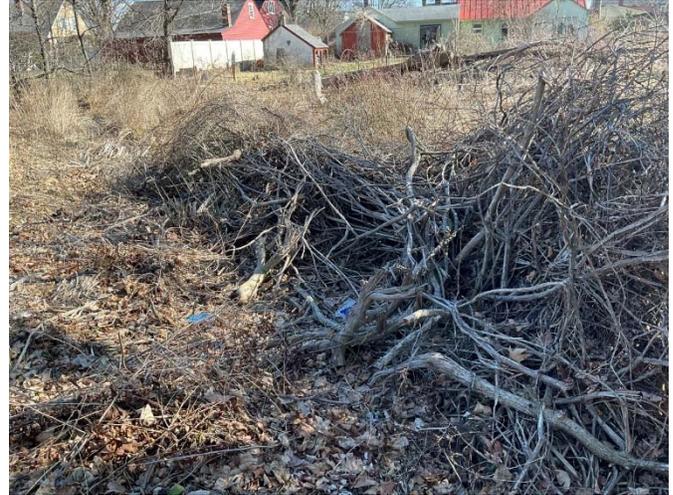
Branches and debris dumped along Sugarloaf Brook

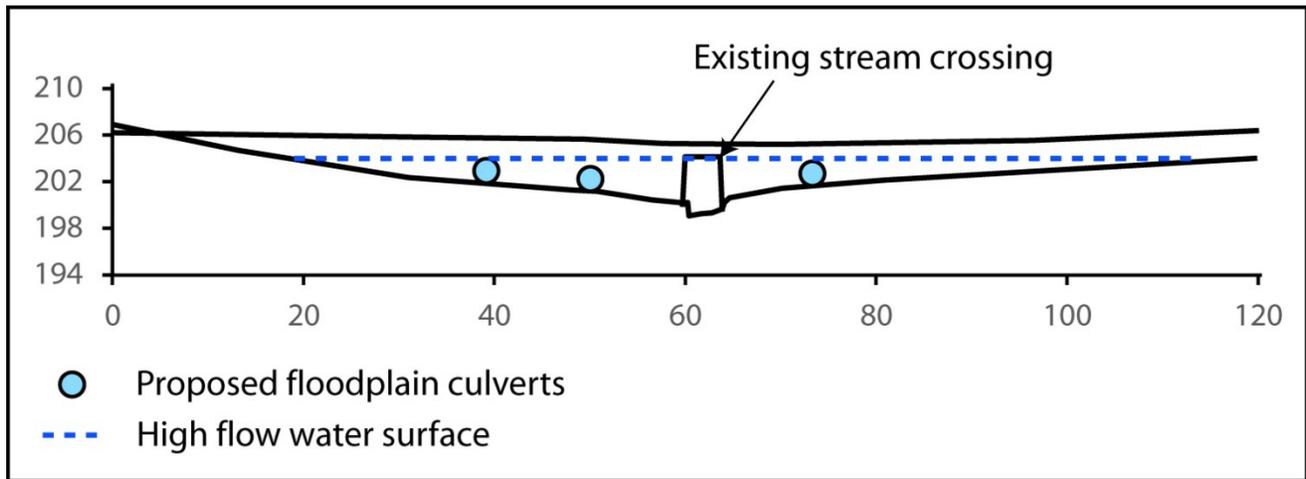
Figure 7. Surveyed cross section of private crossing at Bloody Brook Farm showing undersized culvert and floodplain blocked by roadway approaches that disrupt sediment transport and increase flood inundation upstream. Floodplain relief culverts could be considered to reduce flooding and erosion hazards.

As noted earlier in this memo, a discussion and prioritization of culvert upgrades will be included in future memos once the hydraulic modeling and analysis has been completed in FY2026. However, there are several practices that can be applied throughout the watersheds. First, there is the need for culverts to be inspected and maintained. Several culverts were observed to be crushed, partially blocked, or otherwise compromised. Routine maintenance is required, and could be delegated to landowners or other residents, with the understanding that properly sized crossings will require less routine maintenance. Second, there are many crossings where the roadway approaches on either side of the culvert block the floodplain. In these cases, the roadway can act as a dam during high flows increasing flood inundation upstream and fluvial erosion hazards at the crossing. One good example of this is the private driveway at Bloody Brook Farm, which appears to dam Bloody Brook during frequent high flow events (Figure 7). Floodplain relief culverts can be installed to mitigate the flooding and erosion hazards in these situations. This is often a relatively inexpensive alternative to full culvert replacement and is expected to require less permitting effort.

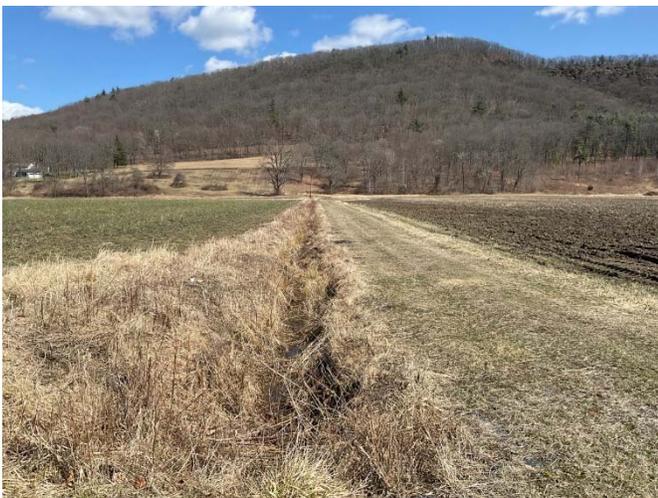
Sugarloaf Brook agricultural fields lacking a buffer

Limiting runoff and sediment and nutrient inputs to Bloody and Sugarloaf brooks can be improved by establishing and enhancing riparian buffers. Grass and herbaceous filter strips have been shown to reduce sediment loading from agricultural fields by 60 to 90 percent (Daniels and Gilliam, 1996). Forested buffers effectively reduce sediment and nutrient loading (Klapproth and Johnson, 2009), while also providing a myriad of habitat and ecosystem services such as forage and cover for a wide range of birds, amphibians, reptiles, and mammals. FRCOG found that riparian buffers in the Bloody Brook watershed were limited and absent in many stream reaches (FRCOG, 2024a). Buffer enhancement can include planting native trees and shrubs, wetland, and pollinator plants, and mitigating invasive species such as Japanese knotweed.
