**TOWN OF DEERFIELD**  
FACILITIES CONDITION ASSESSMENT  
OF  
TOWN BUILDINGS

**Congregational  
Church**

Gorman Richardson Lewis Architects

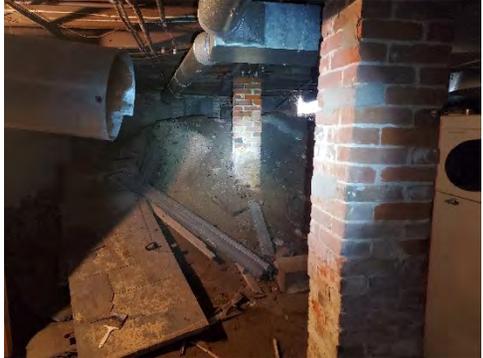
<p>S1</p>

Component	Deficiency	Description	Photograph
Foundation/Floor Slab	<input checked="" type="checkbox"/> Deterioration <input type="checkbox"/> Weakness <input checked="" type="checkbox"/> Settlement Other	<ul style="list-style-type: none"> <li>• Accessible portions of basement appear relatively dry considering there is not poured concrete slab or vapor retarder throughout.</li> <li>• Dirt is mounded on either side of the center aisle of the main hall and is within 1'-6" of the underside of timber framing. Timbers appeared sound with no signs of rot observed.</li> <li>• Several brick piers supporting the main hall floor are deteriorated with disintegrating mortar and spalling brick.</li> <li>• Front exterior stairs supporting pediment columns appears to be settling leaving a gap of about 1" below the northern column.</li> </ul>

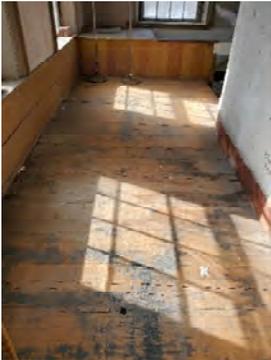
Upper Floors	<input type="checkbox"/> Deterioration <input type="checkbox"/> Weakness <input checked="" type="checkbox"/> Settlement <input type="checkbox"/> Other	<ul style="list-style-type: none"> <li>• There is a noticeable settlement of 2"-4" towards the center aisle of the main hall.</li> <li>• The balcony floor is very uneven with many boards heavily worn.</li> </ul>

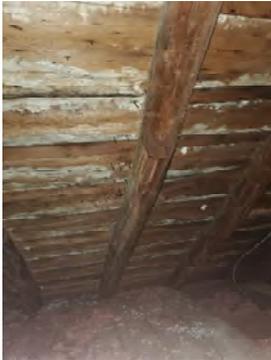
<p style="text-align: center;">S4</p>

<p style="text-align: center;">S3</p>
Roof	<input type="checkbox"/> Deterioration <input type="checkbox"/> Weakness <input type="checkbox"/> Settlement <input checked="" type="checkbox"/> Other	<ul style="list-style-type: none"> <li>• Due to the limited access and lighting within the main hall roof structure, it was difficult to observe the majority of the framing. In areas that could be accessed, there are signs of slight moisture staining on framing, minor settlement, checking of timbers, etc. typical of wood framed structures of this era.</li> <li>• The attic of the rear addition was not accessed during this visit.</li> </ul>
