TOWN OF DEERFIELD
FACILITIES CONDITION ASSESSMENT
OF
TOWN BUILDINGS

**Police
Department**

Executive Summary

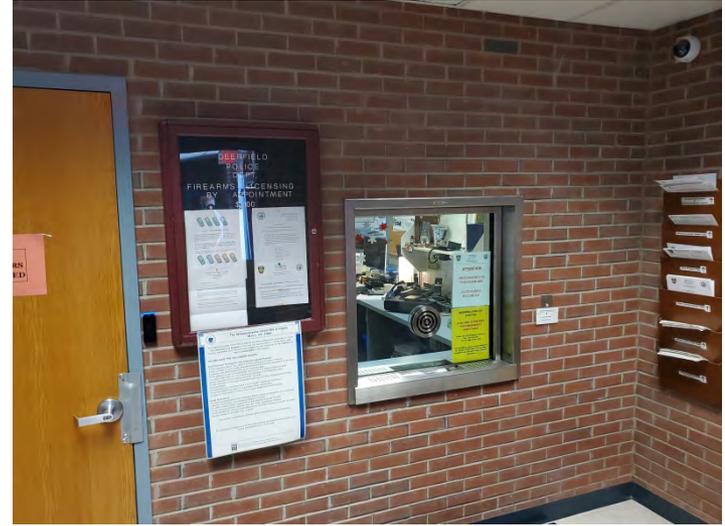
A2 Lobby 103

- **Lobby [103]** is the main vestibule into the Police Station. Those who come to visit the station are to arrive here and speak with the receptionist through the 2'-6" x 2'-6" window. Flooring is 12 x 12 Vinyl Composite Tile (VCT) which is in good condition with typical scuffs. The walls consist of brick masonry which is in good condition though in need of cleaning. The door entering into the lobby from the Town Hall's Entry 101 is a hollow steel door with a vision panel and locking mechanism in good condition. The reception window is a 30-inch square bullet proof glass with metal trim all around, in good condition. The ceiling is a 24 x 24 tegular ceiling tile grid in good condition.

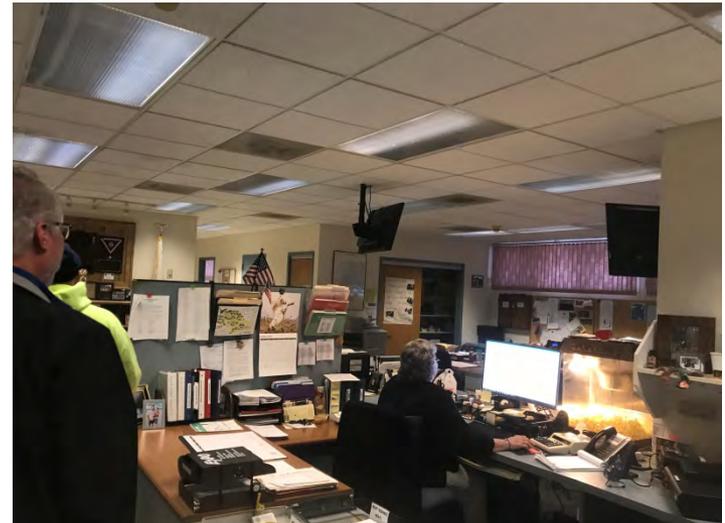
A4 Work Area 105

- **Clerical / Officers Work Area [105]** is the main function space of the police department. Currently there is a large clerical desk as well as 4 desks for officers who are at the station. The flooring consists of broadloom carpet which transitions to 12 x 12 VCT all in good condition with occasional scuffs from chairs and boots. Walls are painted plaster / gypsum wallboard with vinyl base. At the time of this visit the Clerical and Work Area had not been repainted and on the meeting room wall there is currently a wall-mounted bracket for a TV/ Monitor which was moved to the opposite side of the meeting room door. The door entering into the Clerical space from Lobby 103 is a wood door with door handle hardware and a locking mechanism that is operable from the clerical desk. There is a total of six (6) windows, four (4) of which are operable awning windows and two (2) which are fixed. The ceiling consists of 24 x 24 tegular ceiling tiles, some with water staining from previous HVAC leak which has been repaired. The water stained ceiling tiles are expected to be repaired soon, as of 05/22/2020. The Clerical / Officers Work Area is able to be used effectively for its purpose as office space, providing space for desks, storage, and meetings when necessary.

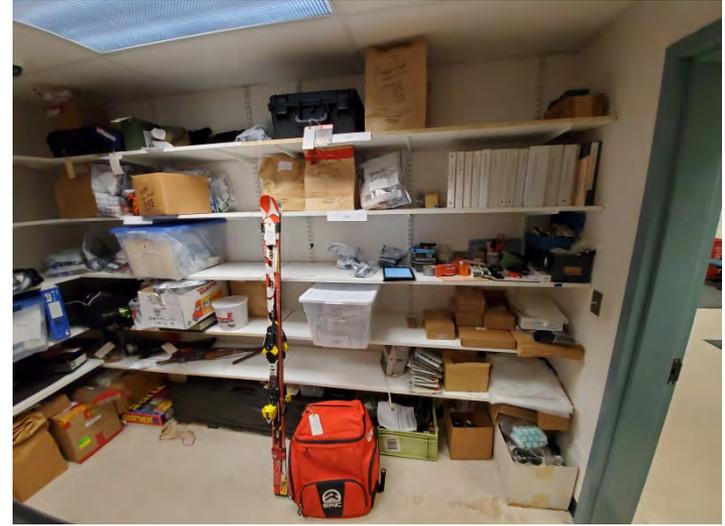
A6 Evidence Archives 108

- **Evidence Archives [108]** have shelving all around the walls to provide storage for all active evidence. This shelving upon our visit was almost completely filled with evidence and the department may need to expand their storage in the future. The flooring is 12 x 12 VCT which is clean throughout except for the transition from the corridor of the evidence archive; this location is soiled and heavily stained. The interior walls are painted plaster / gypsum wallboard which have some scuffs from the storing items but are overall in good condition. The exterior wall is painted CMU blocking which is in good condition. The ceiling consists of 24 x 24 tegular ceiling tiles in which a few have water staining but are in good condition.

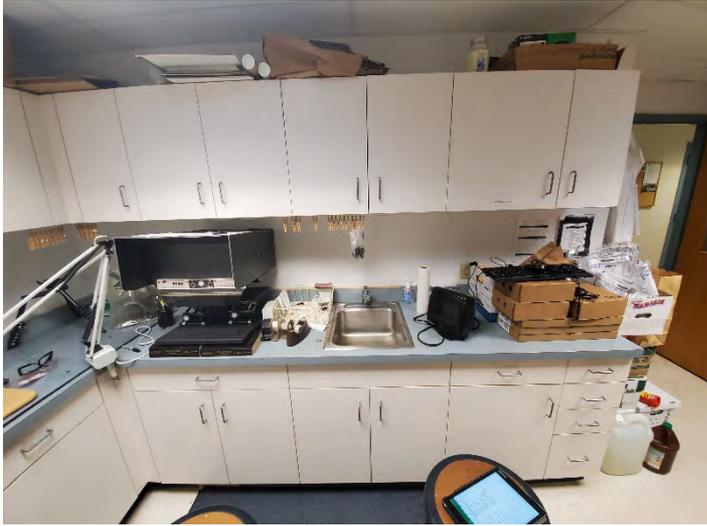
A9 Laboratory 111

- **Laboratory [111]** serves as a crime lab in which evidence is inspected for various traces relating to the criminality of a case. The flooring consists of 12 x 12 VCT and with the exception of scratches from desks and chairs, is in good condition. The walls are painted plaster / gypsum wallboard which has not been repainted yet and show signs of scuffs and scratches in expected areas. The entry door into the lab is a wood door with a vision panel as well as door handle hardware and a locking mechanism. There is an L shaped laminate countertop with base wood cabinets (8' x 5'-9") and matching upper cabinets which are all in good condition but should be cleaned. On the countertop is a single bowl sink which is in operable and good condition. The ceiling is 24 x 48 tegular ceiling tiles in which a few are water stained but in good condition. Overall, the condition of the Laboratory is good with the lab being able to function fully, there does seem to be the need of more storage for items that are being examined or equipment that is to be used during examination. Other than the apparent lack of storage, the lab is in good condition.

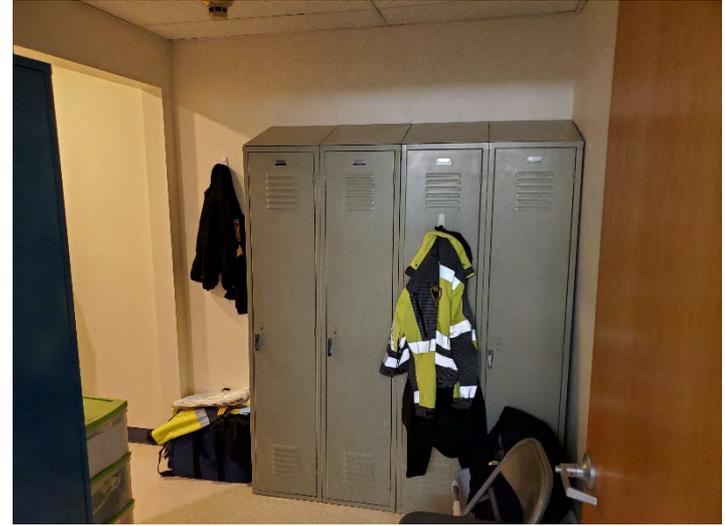
A10 Men's Lockers 115

- **Men's Lockers [115]** features 22 metal lockers of different types. Per conversations with officers at the station, the current layout and size of the locker room is currently sufficient. The flooring is 12 x 12 VCT tile which is in fair condition because of scuffs and some staining underneath the legs of the metal lockers. The walls are a mix of painted plaster / gypsum wallboard and painted CMU, both of which are in good condition. The entry door into the locker room is a wood door with push plate /pull arm hardware in good condition. The ceiling is flush 24 x 48 ceiling tiles; a few tiles have water staining.

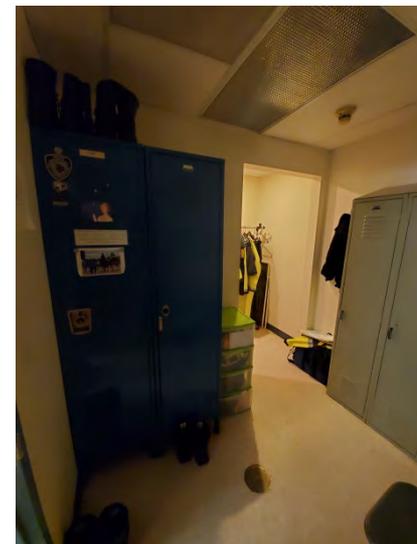
A20 Women's Lockers 112

- **Women's Lockers [113]** features 6 metal lockers of different types. The flooring is 12 x 12 VCT tile which is in fair condition because of scuffs and some staining underneath the legs of the metal lockers. The walls are a mix of painted plaster / gypsum wallboard and painted CMU, both of which are in good condition. The entry door into the locker room is a wood door with push plate /pull arm hardware in good condition. The ceiling is flush 24 x 48 ceiling tiles, few tiles have water staining.

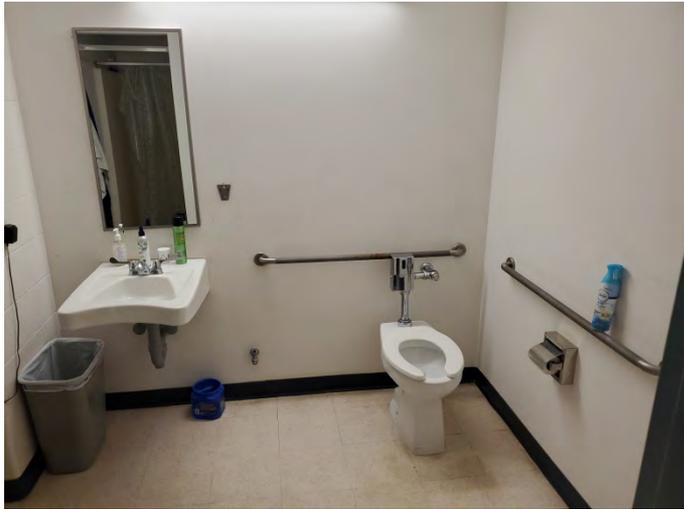
A21 Women's 114

- **Women's [114]** is a continuation of the women's locker room. The flooring is 12 x 12 VCT tile which is in fair condition because of scuffs and some staining underneath the legs of the metal lockers. The walls consist of painted CMU blocking in good condition. The plumbing fixtures throughout include wall mounted sinks, a water closet with appropriate grab bars and space inside stall, a wall mounted urinal, and a stand up shower stall; all of which are in good condition. The ceiling consists of 24 x 48 flush ceiling tiles.

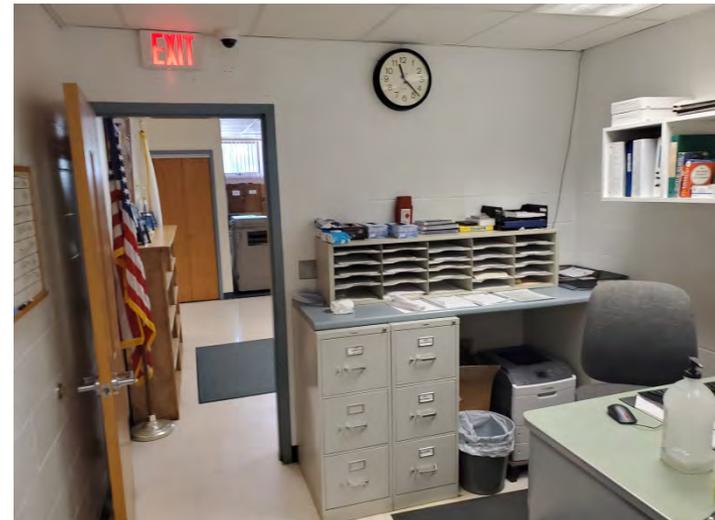
A24 Booking 2

- **Booking 1 and 2 / Breathalyzer [120A – 120C]** is a space utilized for questioning of detainees. The flooring is 12 x 12 VCT which has some staining from the desk legs but is in good condition. The walls throughout the booking area are painted CMU which had recently been repainted. Between Booking 1 and Booking 2 and between Booking 2 and Breathalyzer is a painted CMU knee wall which was also repainted recently. The door into the booking area from the clerical and work area is a wood door with a small vision panel, door handle hardware, and a locking mechanism, in good condition. Various furnishings include; a 6'-6" plastic laminate wall mounted shelf, an L shaped (4'-6" x 2'-3") laminate countertop with wood base cabinets below and above, and a wooden bench with metal railing for those who are being detained.

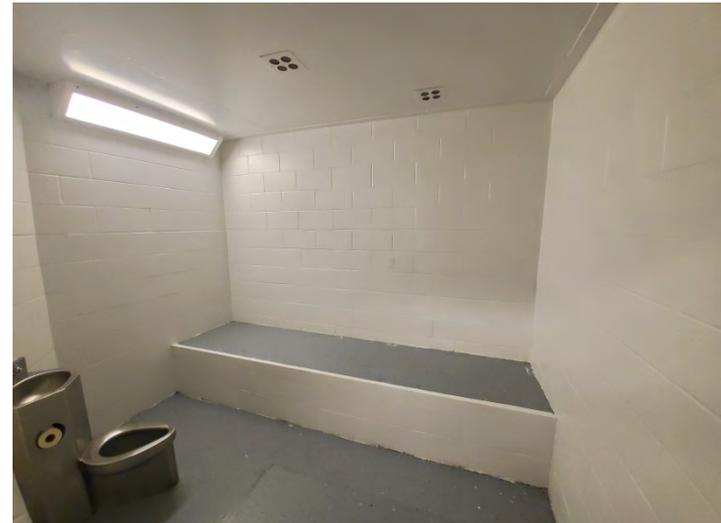
A32 Cell 2

- **Cell 2 [123A]** is the first cell on the right side of Corridor B. The flooring is a continuation of the epoxy from Vestibule 123 which also has some cracking as well as no proper transition up the CMU wall. The walls in Cell 2 is painted CMU which has some cracking at the base where the epoxy flooring meets. There is a water closet and sink combo plumbing fixture which has some cracking inside the toilet bowl as well at the base of the fixture. Chief Paciorek mentioned that some of these fixtures are starting to rust and will need replacing soon to keep those who use these fixtures safe. The ceiling is also a painted conventional ceiling which is in good condition.

- Interior Architecture:
 - Apply new flooring to entry vestibules and cells which are beginning to crack and do not have proper floor to wall transitions.

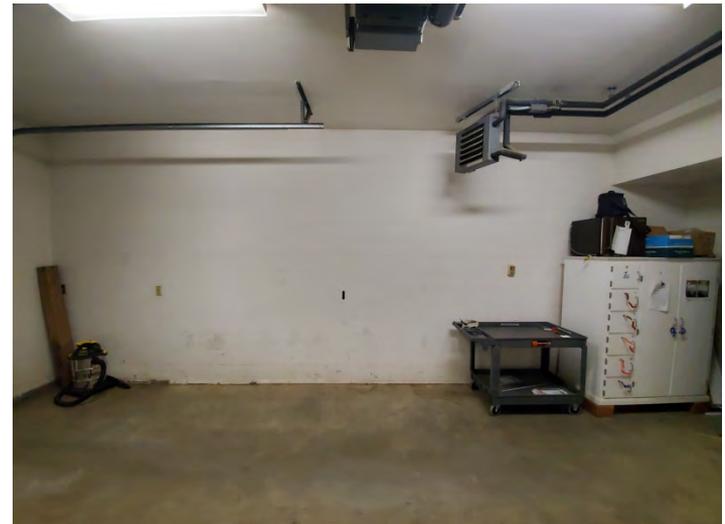
A36 Sallyport 117

- **Sally Port [117]** is used for those who have been detained and is being brought to the booking area of the station. The Sally Port's flooring is a concrete slab which has typical stains and marks from its usage but no major cracks. The walls are painted CMU blocks which should be repainted but are in good condition. There is an overhead exterior door (9'-4" x 8'-10") which is in good / fair condition. The door into the Sally Port from the booking area is a steel door with door handle and closer hardware in good condition. Next to the doorway is a fire extinguisher cabinet which at the time of our visit did not have a fire extinguisher currently located inside. There is a utility sink which is used regularly located to the right side of the doorway, the sink is dirty but in serviceable condition. The ceiling is a painted conventional ceiling which is in good condition.

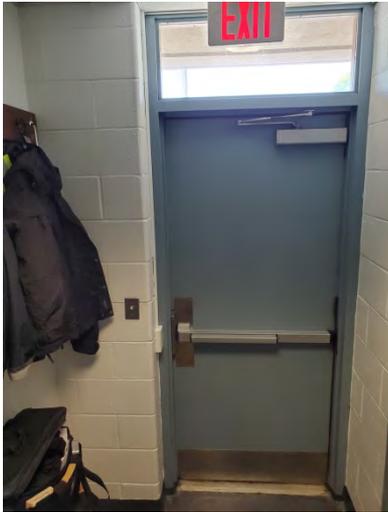
A41 Vestibule 119 (door to exterior)

- **Vestibule [119]** is the main entryway for officers and employees of the police department. Its location not adequate for those who as users must walk through the booking area to get the officer's work area. The flooring for the vestibule is epoxy which had recently been redone and features the stations crest / badge embedded in the epoxy. The walls are painted CMU which are in good condition. The exterior door into the vestibule is a steel door with push bar and door arm hardware in good condition. The exterior of the frame is rusted at the base from exterior elements and occasional salt from conditioning the parking lot during the winter, consider replacing soon. The door entering into the booking area from the vestibule is a steel door with door handles and locking mechanism, in good condition. The ceiling is made up of flush 24 x 48 ceiling tiles which are in good condition.

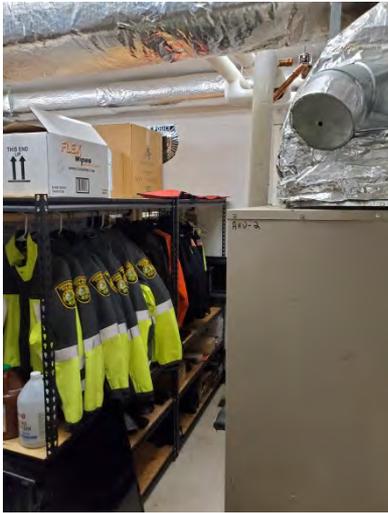
A45 Mechanical Room & Storage at 2nd Floor

- **Mechanical / Storage [202]** is used primarily as a mechanical room which houses two HVAC units (*see MEP/FP section of this report for more detailed information*). The flooring throughout the mechanical room is 12 x 12 VCT tiles which most are in fair condition and are stained and cracked. The walls are painted plaster / gypsum wallboard which have some scuffing and staining but are in good condition. The door entering into the space is a steel door with door handle hardware and locking mechanism in good condition. The ceiling of the mechanical room is a painted conventional which has exposed HVAC ducts below running throughout the room. This room's main purpose is as a mechanical room and it is also being used as a storage room for files, equipment, and uniforms in which the police department has run out of room to store on the first level. As more cases pass through the department, more storage space is going to be necessary for those files and having a proper room for storage is going to become necessary.
