**TOWN OF DEERFIELD**  
**FACILITIES CONDITION ASSESSMENT**  
**OF**  
**TOWN BUILDINGS**

**Senior**  
**Center**

**Gorman Richardson Lewis Architects**

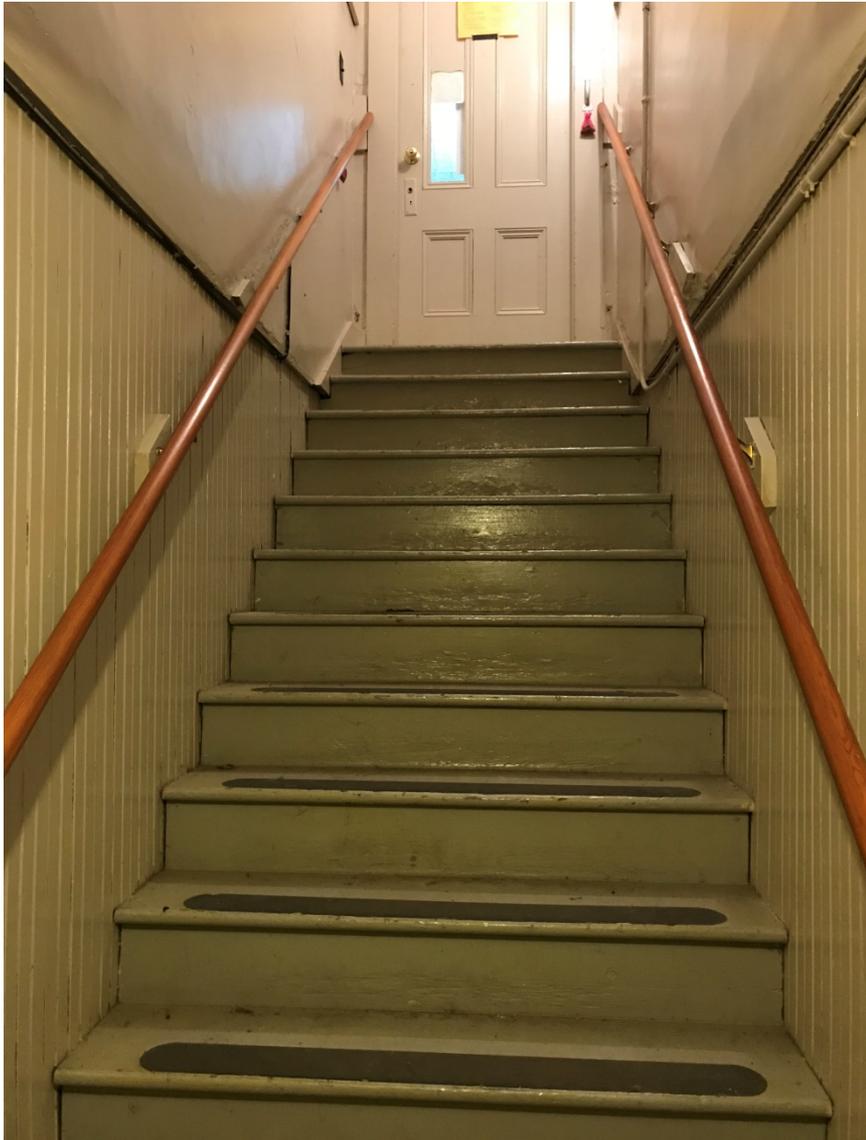
0-1 Stair 01

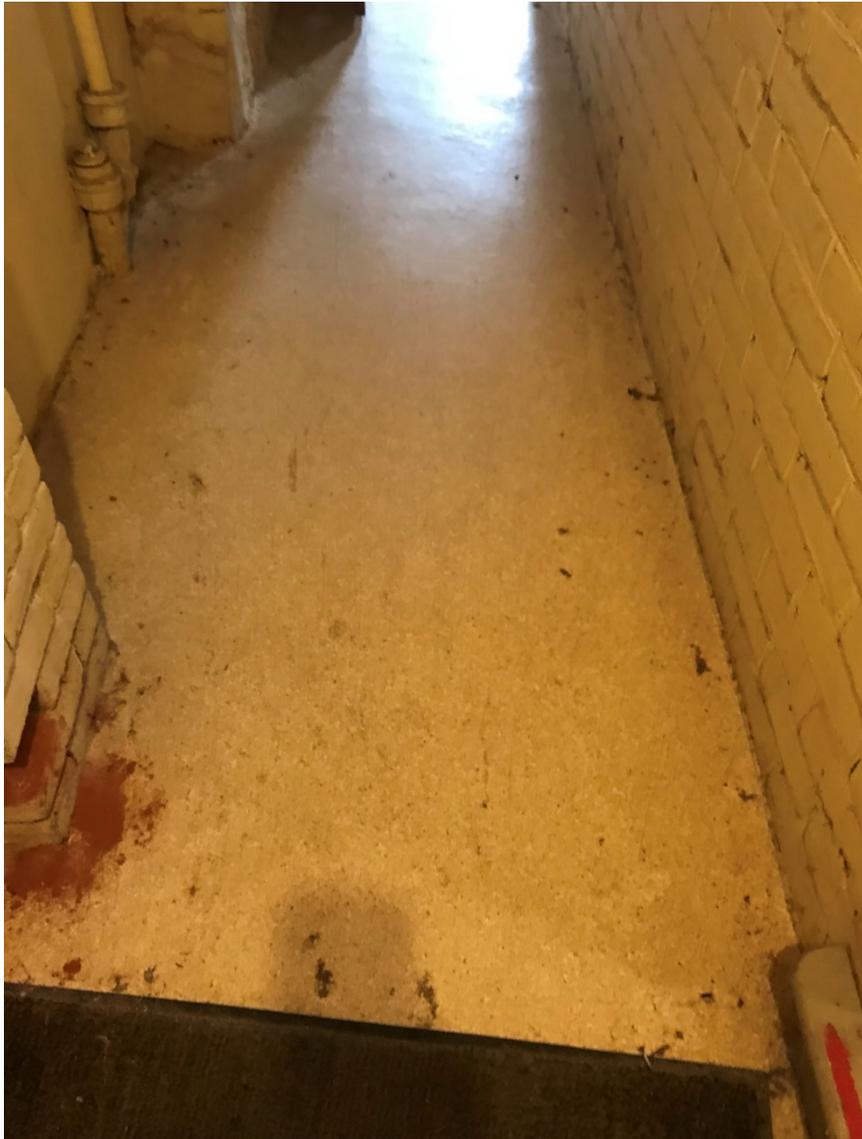
0-4 Corridor 001 floor

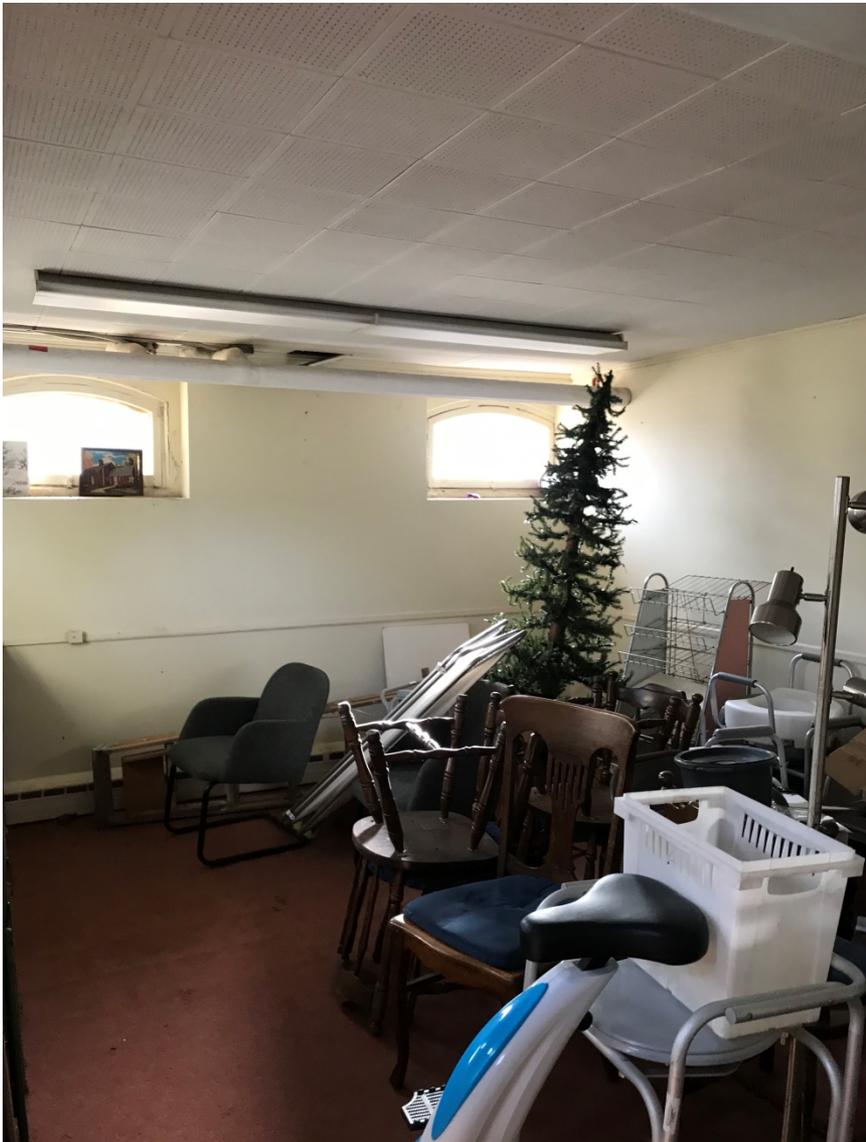
0-7 Activity Room 002

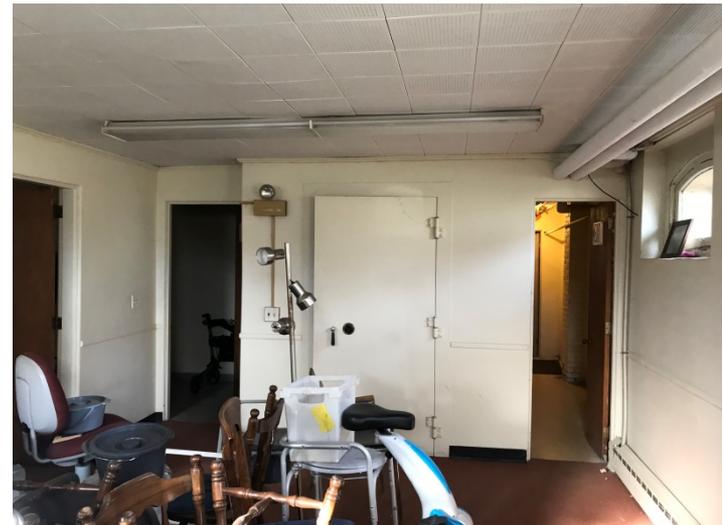
0-9 Activity Room 002 with Vault Door

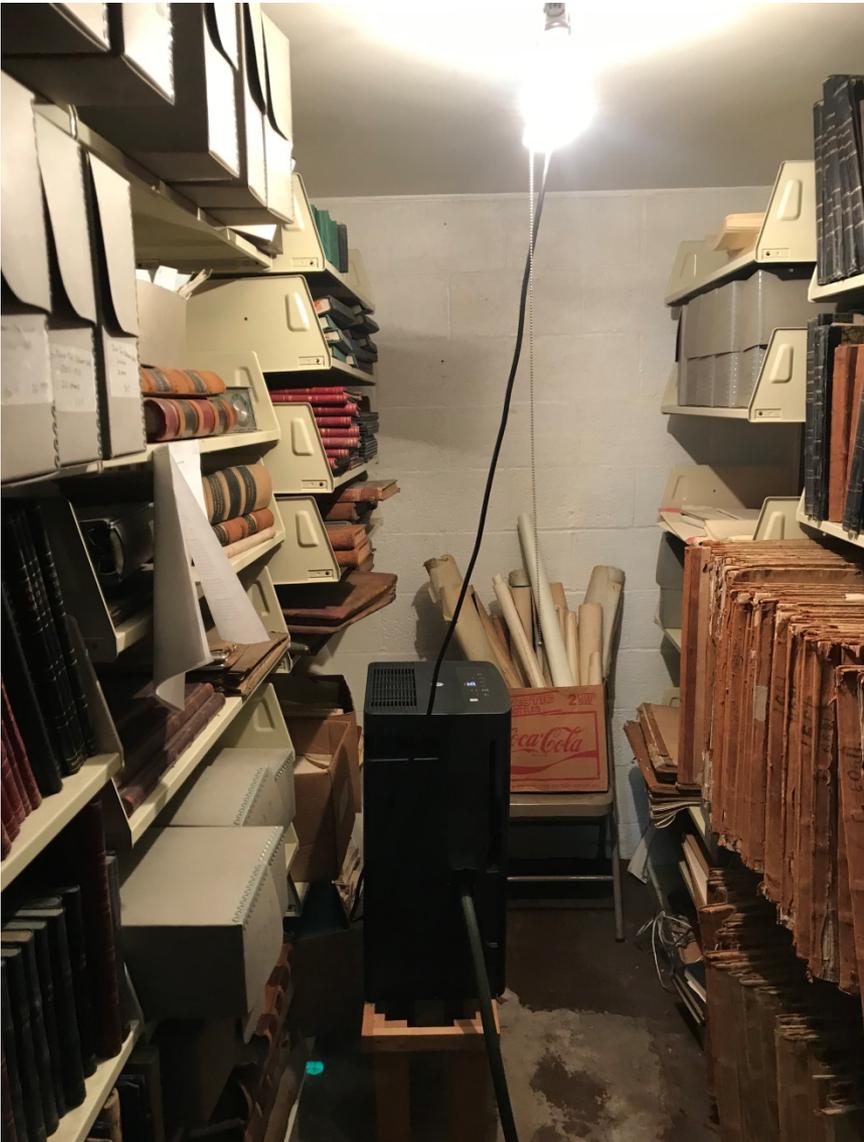
0-10 Vault (with dehumidifier)

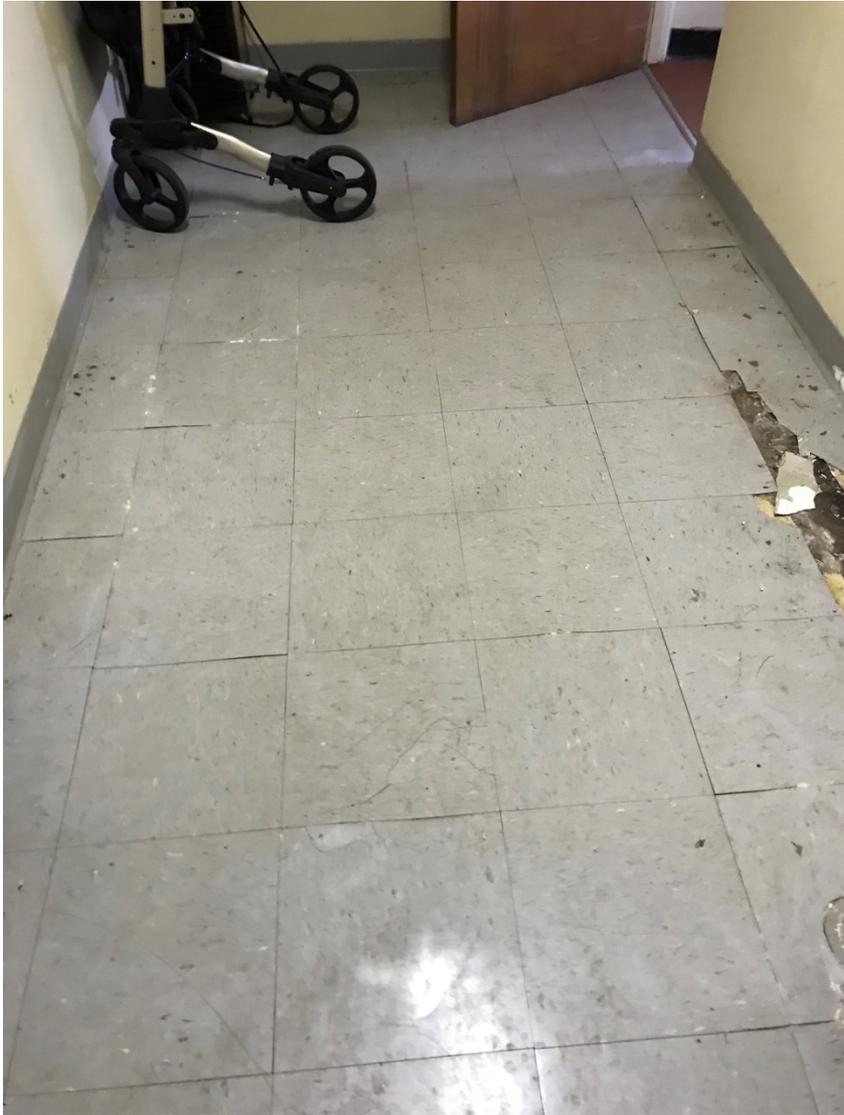
0-13 Corridor 005 floor

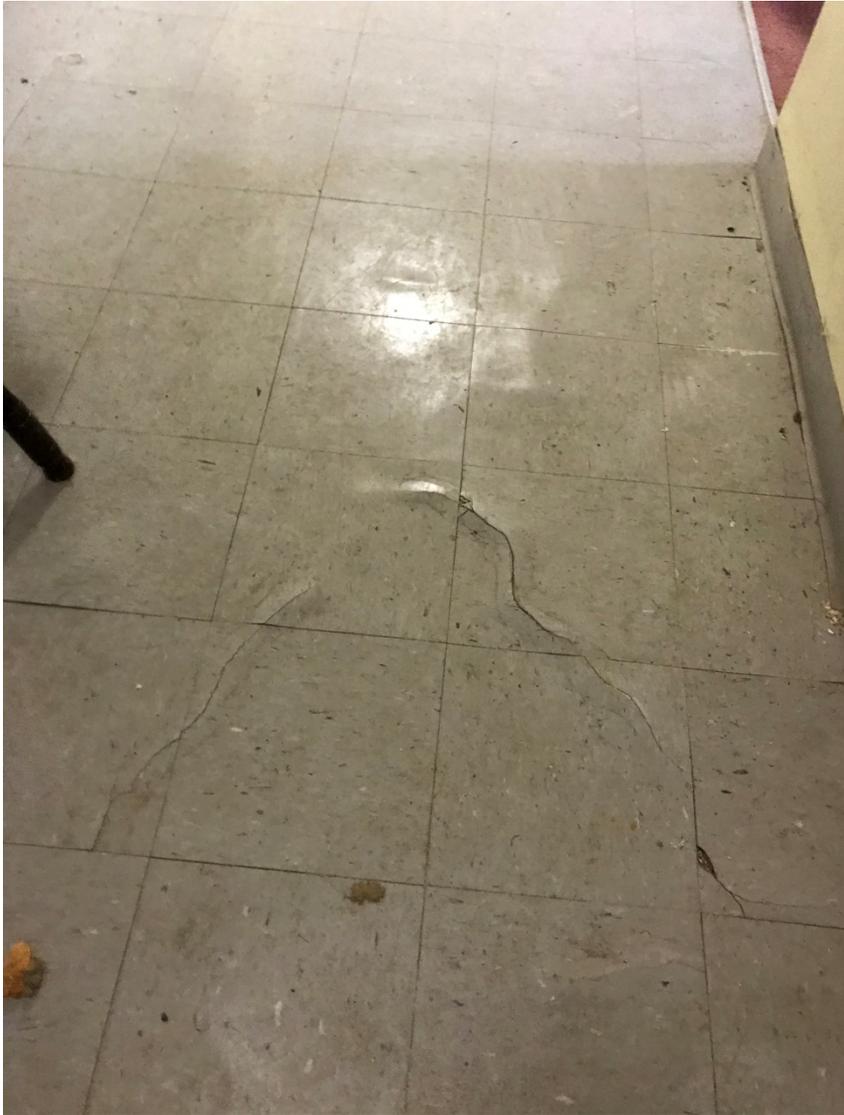
0-16 Corridor 005 floor

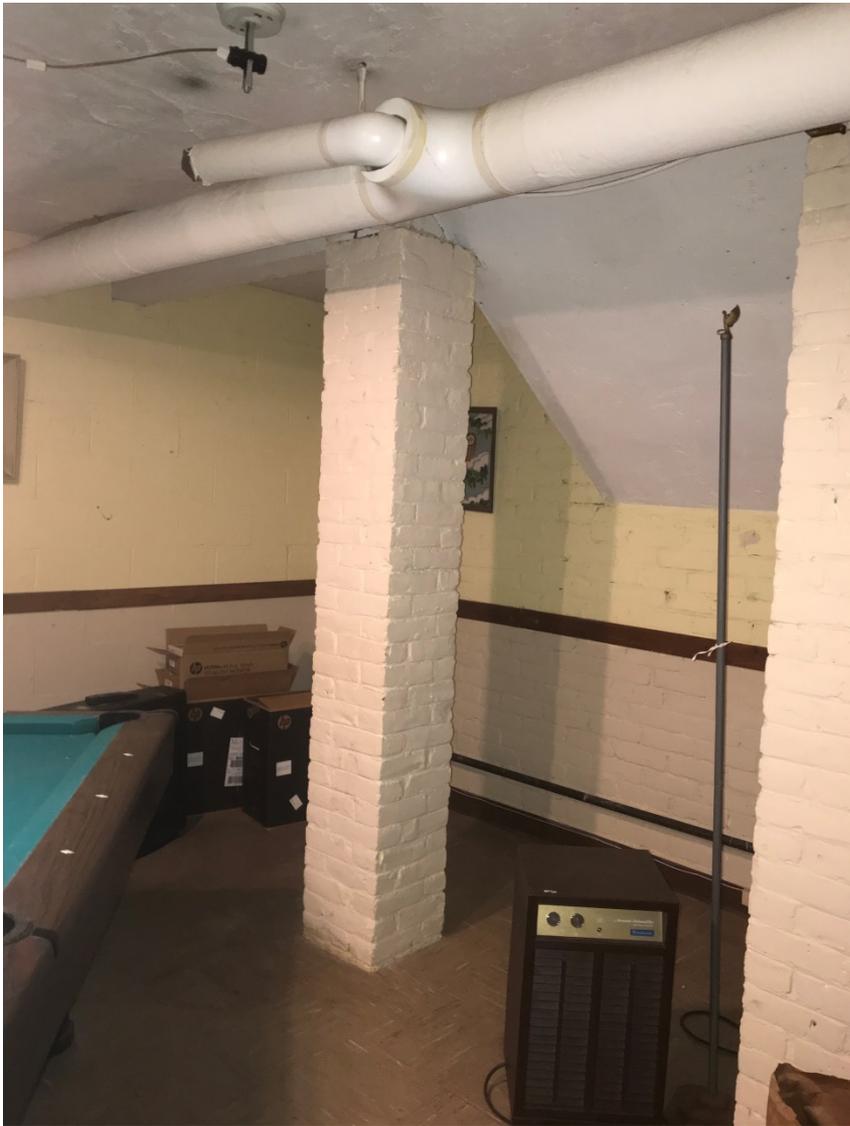
0-19 Billiards Room brick columns

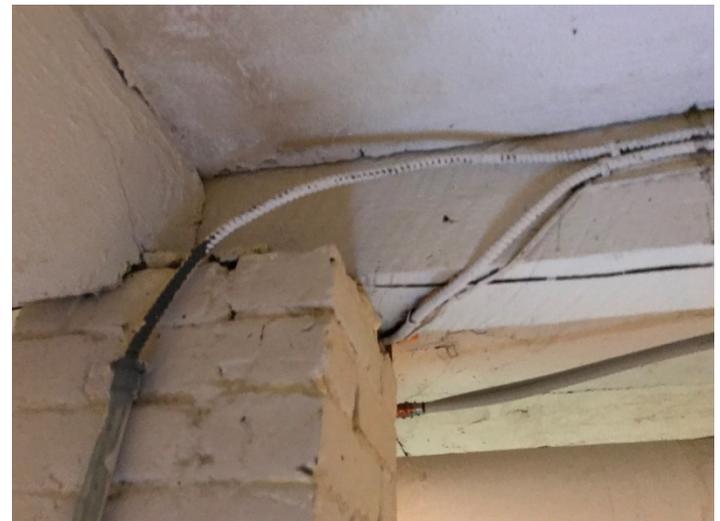
0-21 Checked beam at column in Billiards Room

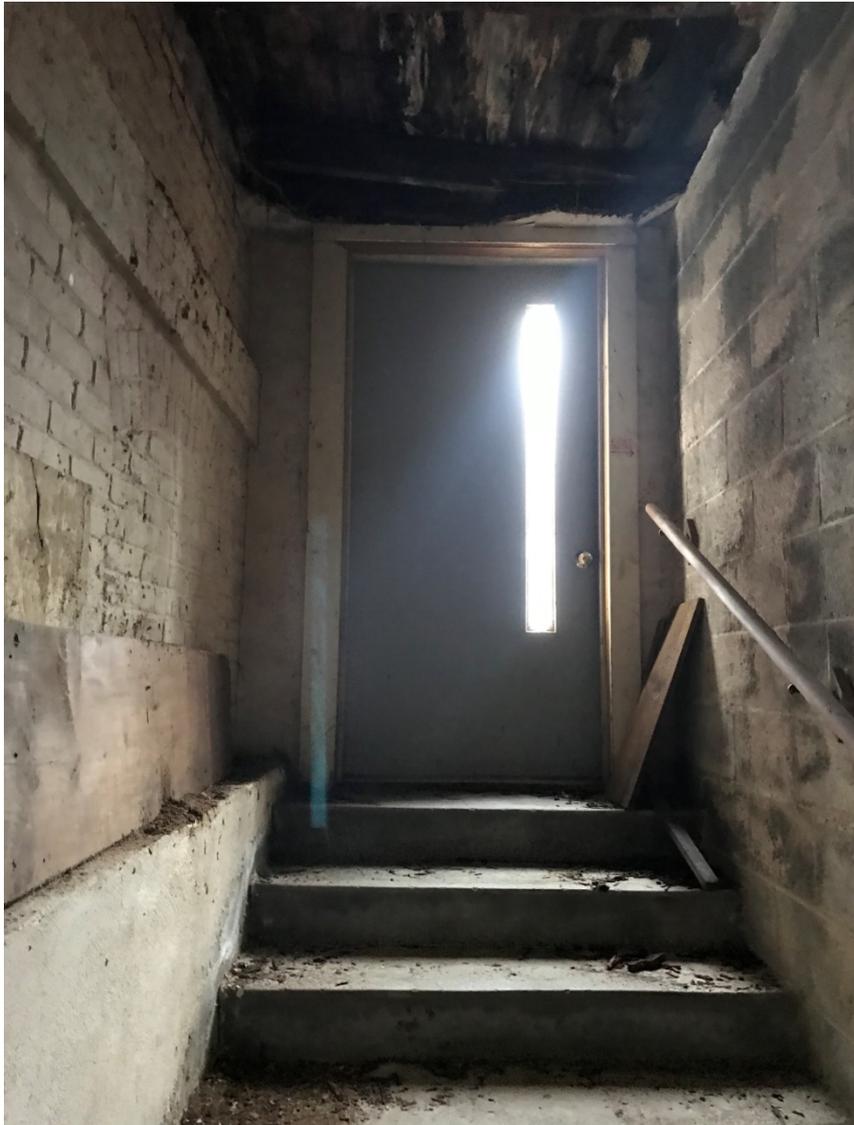
0-26 Rear Exit

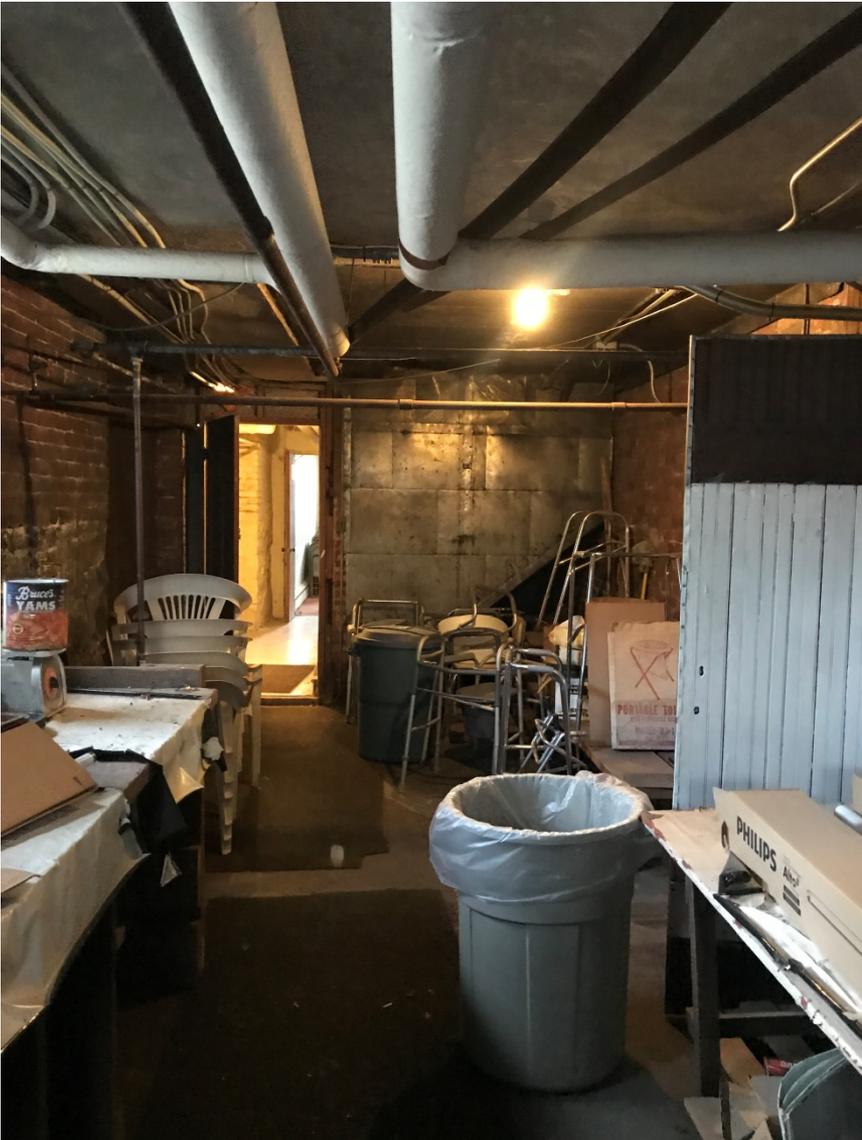
- Storage Room [008] is unfinished and in very rough condition, with the concrete floor slab cracked and uneven, the exposed foundation wall at the exterior perimeter of the room revealing significant efflorescence at the joints of the stone foundation indicating water infiltration. The wall adjacent to the interior stair and a portion of the ceiling adjacent to this wall are clad in metal presumably for fire-resistance. The windows are as noted above.

0-29 Storage Room 008

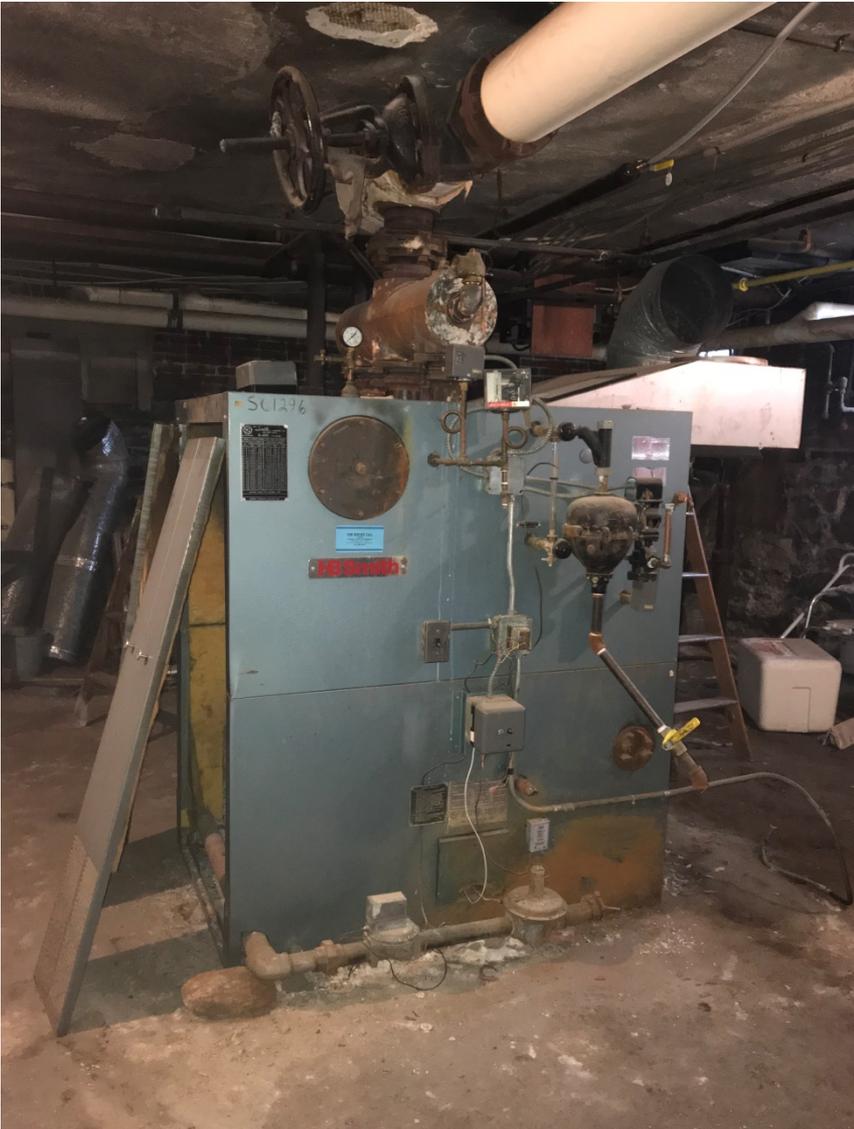
0-32 Boiler Room 009--old (abandoned) boiler

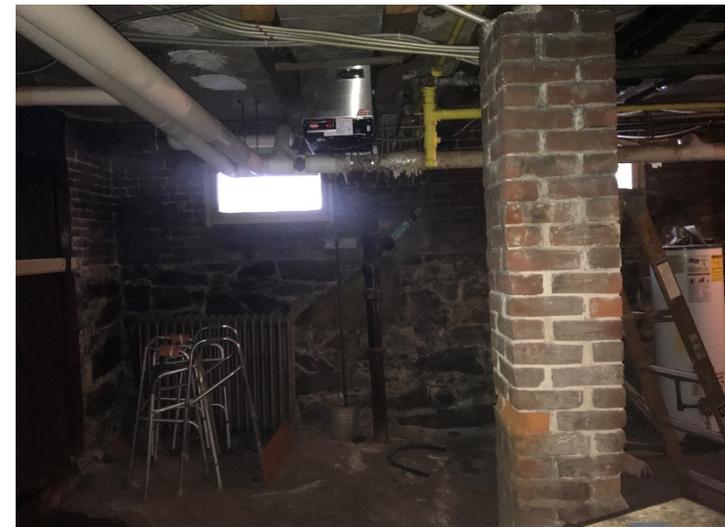
0-33 Boiler Room

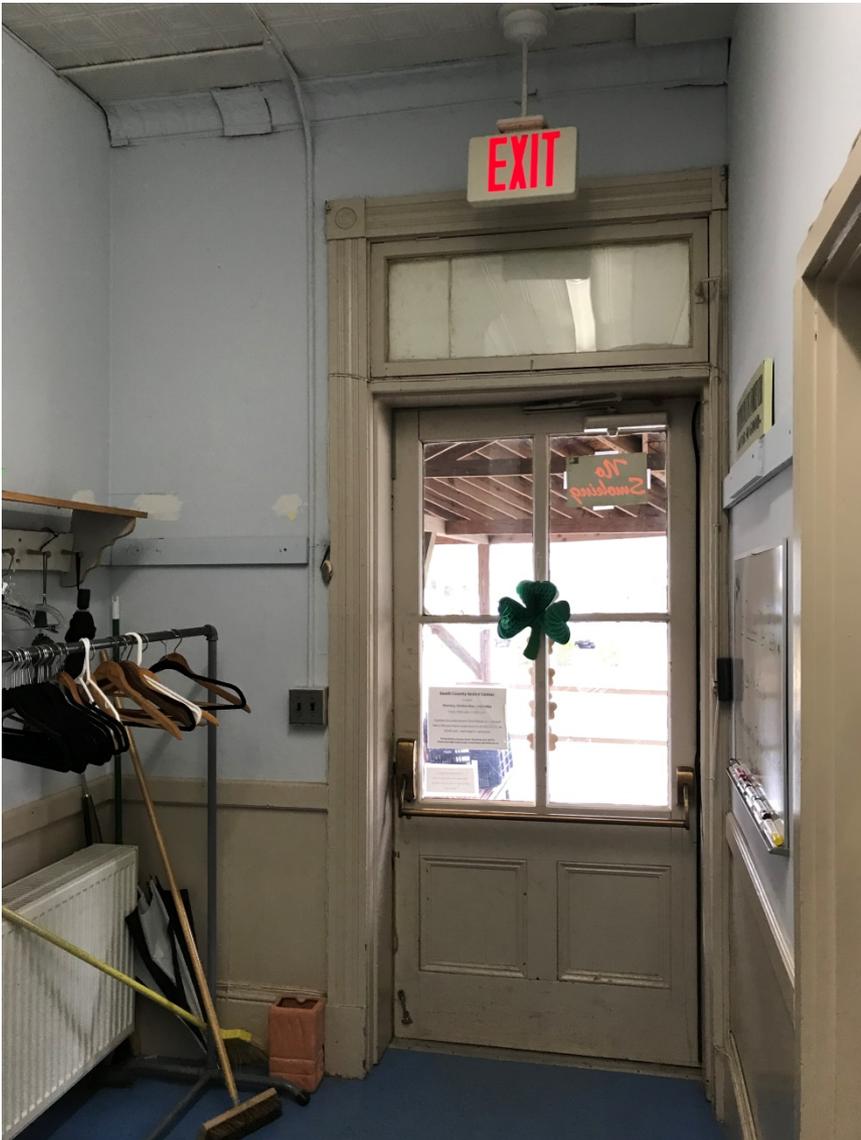
1-1 Rear (main) Entry

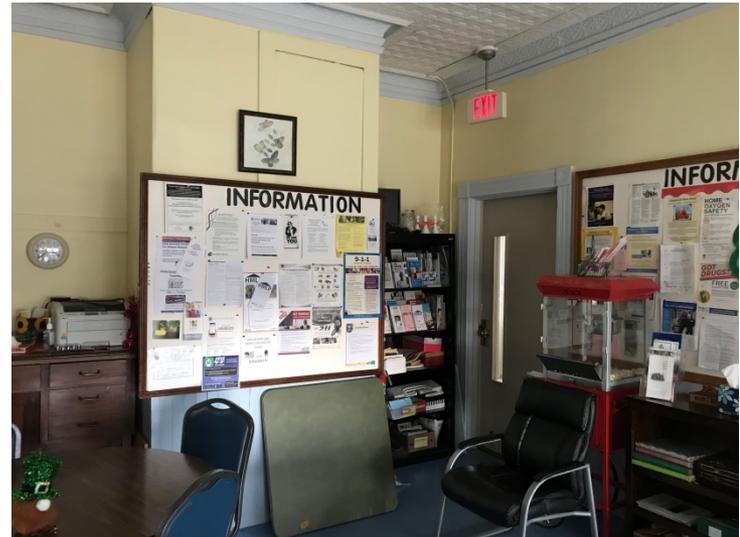
1-7 Activity Room 101

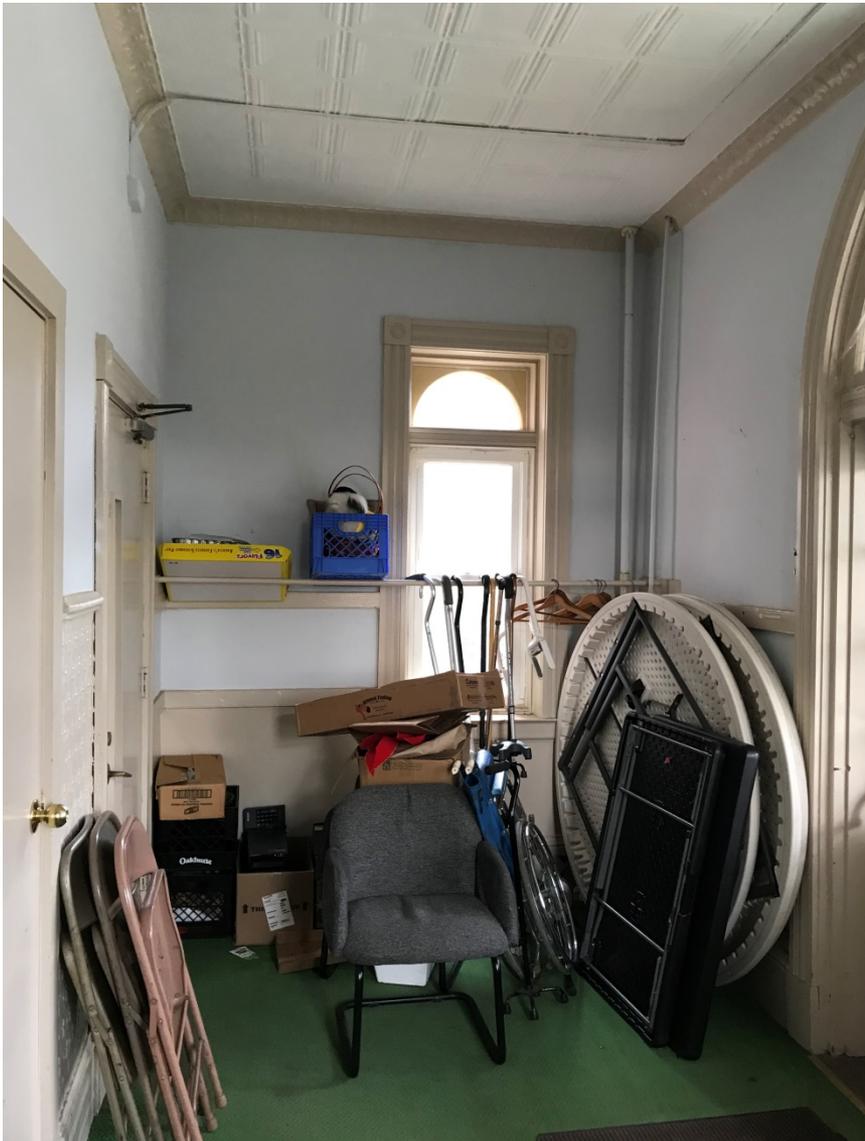
1-8 Entry Vestibule 108

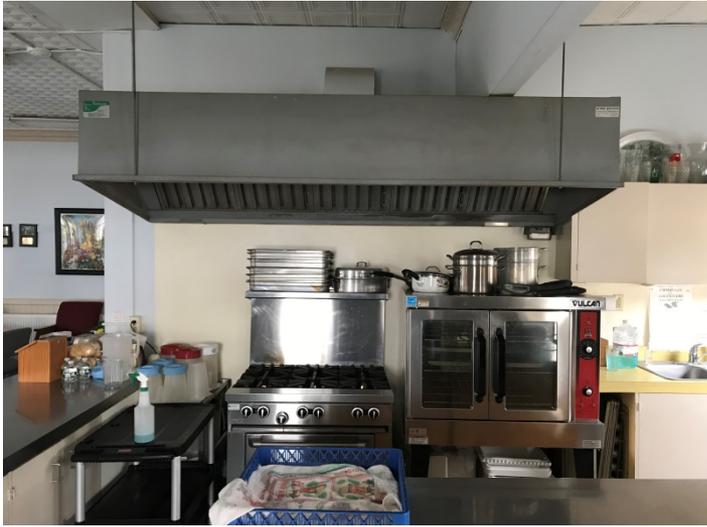
1-19 Kitchen 107 toward cooking area

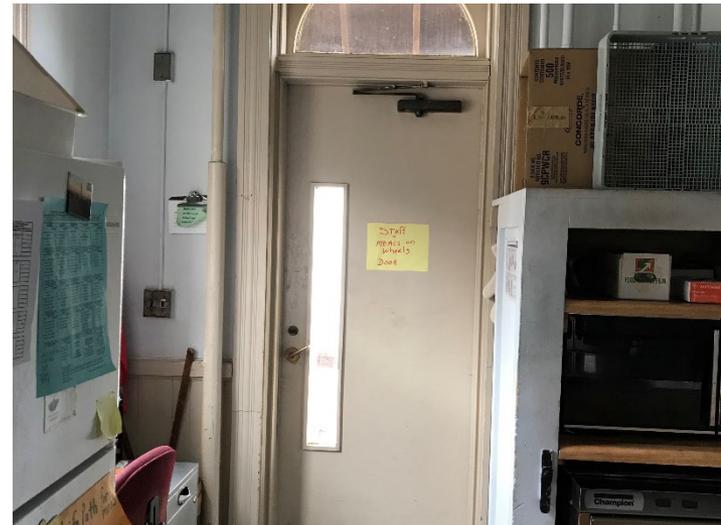
1-22 Kitchen egress door

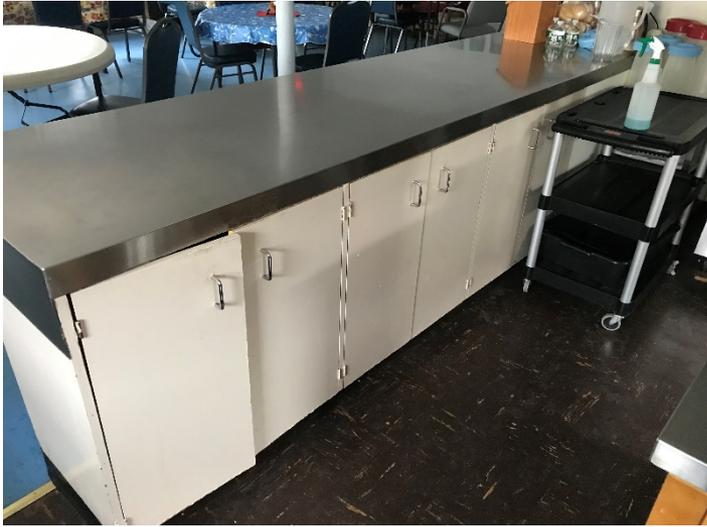
1-23 Kitchen side of serving counter

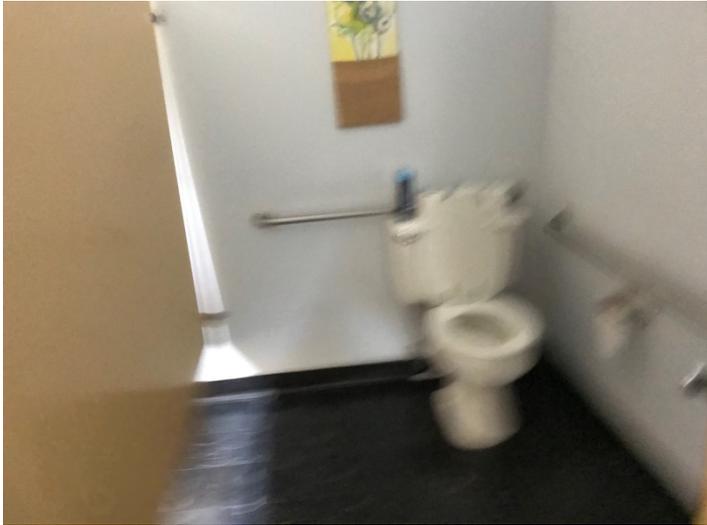
1-31 Women's Room 104 water closet (HC)

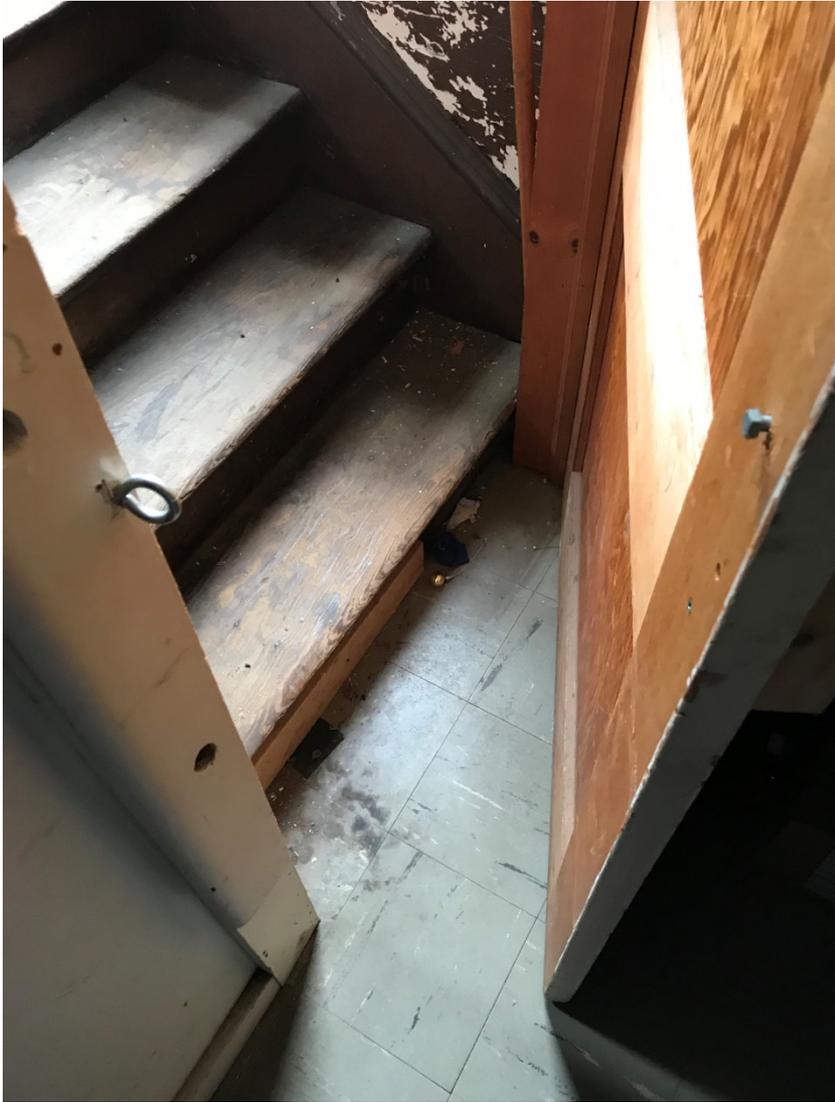
1-39 Egress Hallway 102 stair to 2<sup>nd</sup> floor

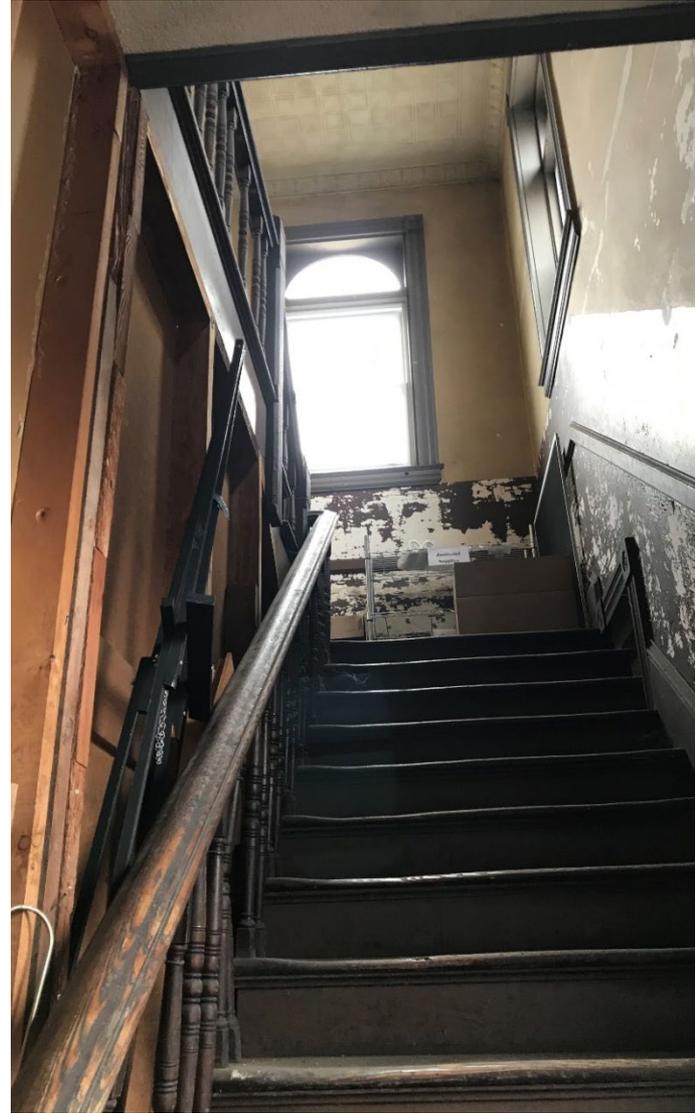
1-40 Egress Hallway 102 stairs to 2<sup>nd</sup> floor

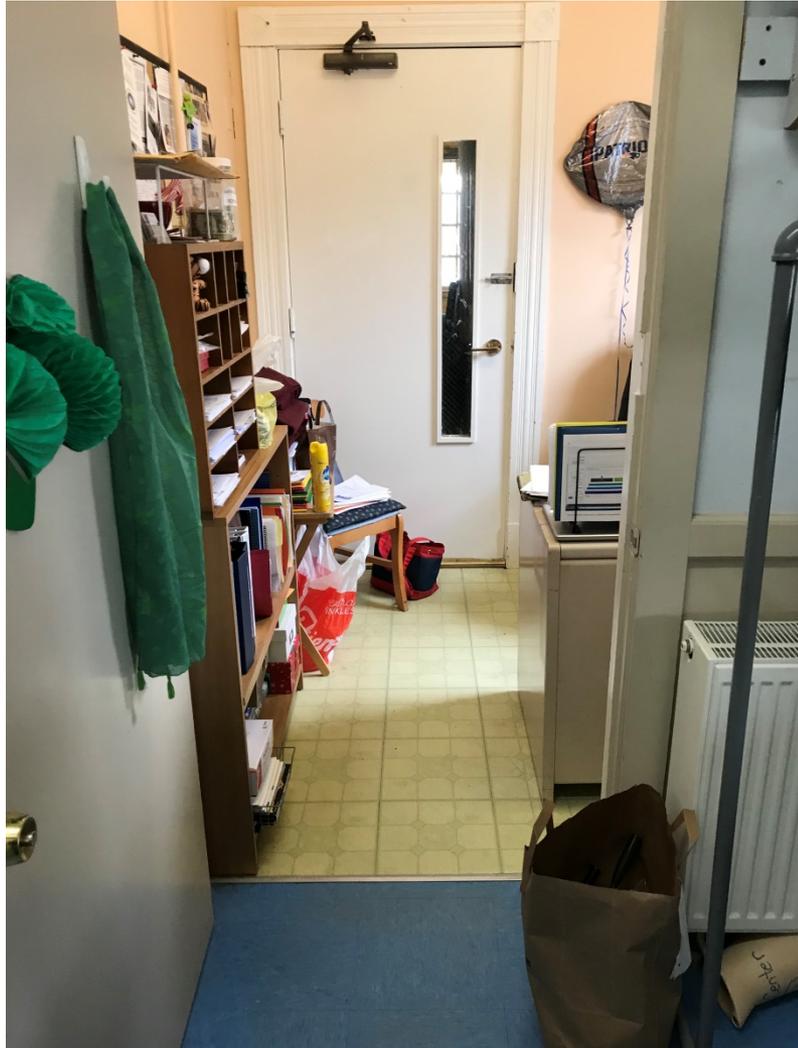
1-41 Office 103 from Corridor 100

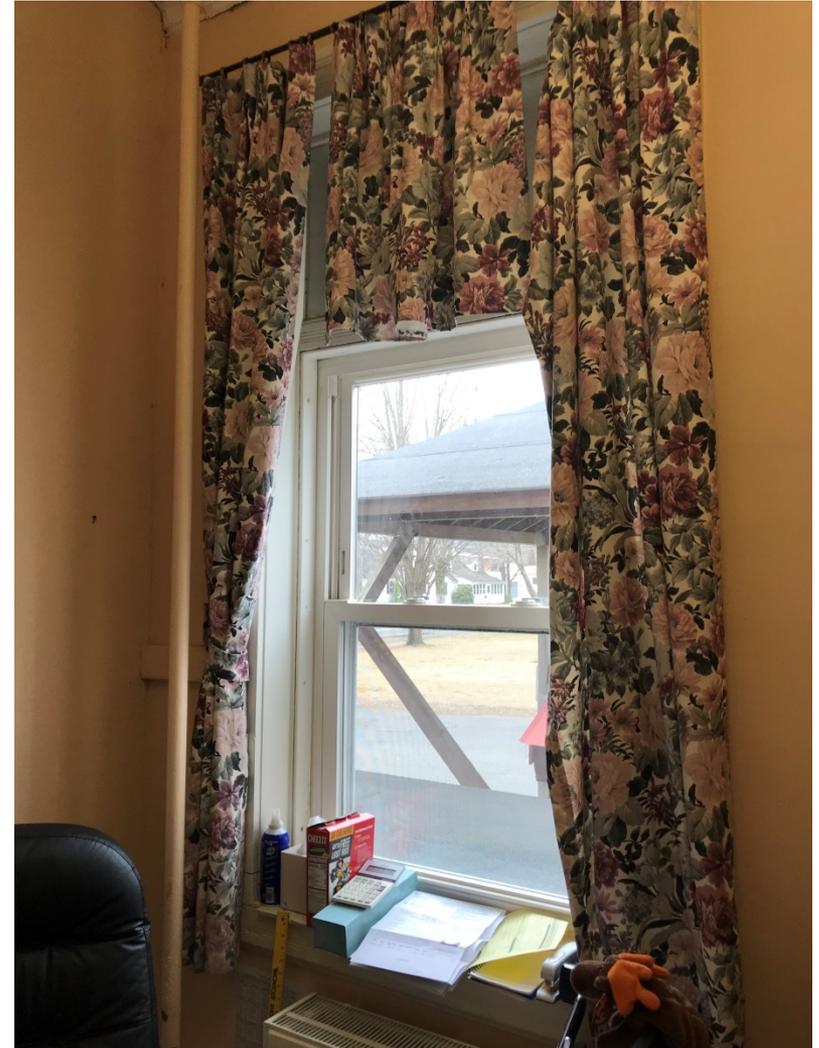
1-42 Office 103 window

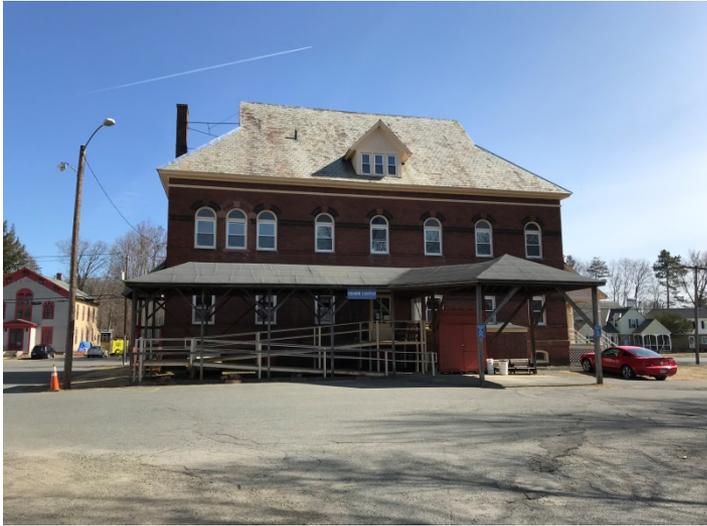
1-43 Rear (west) façade with rear entry ramp

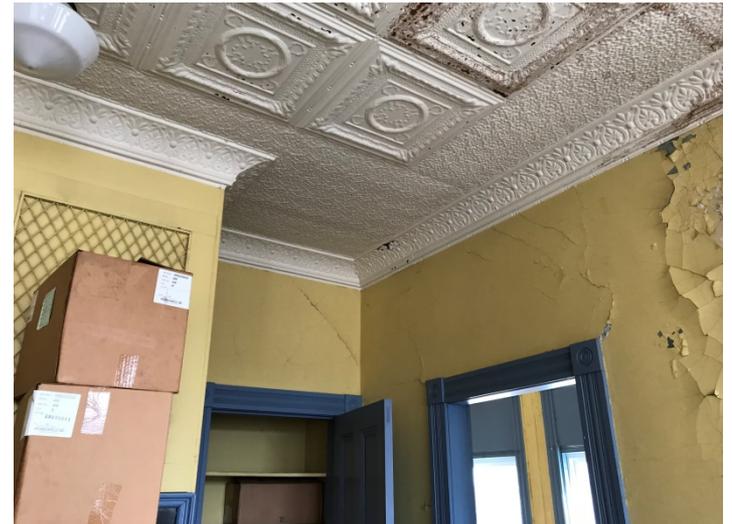
2-8 Room 201 ceiling at door to Room 206

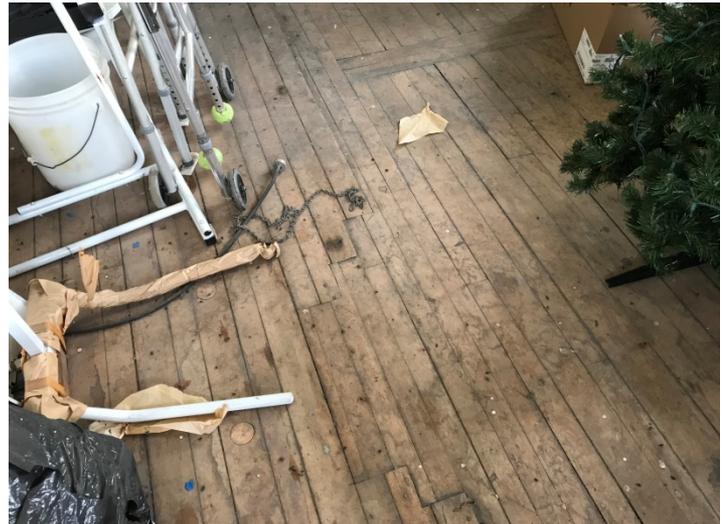
2-16 Room 203 floor

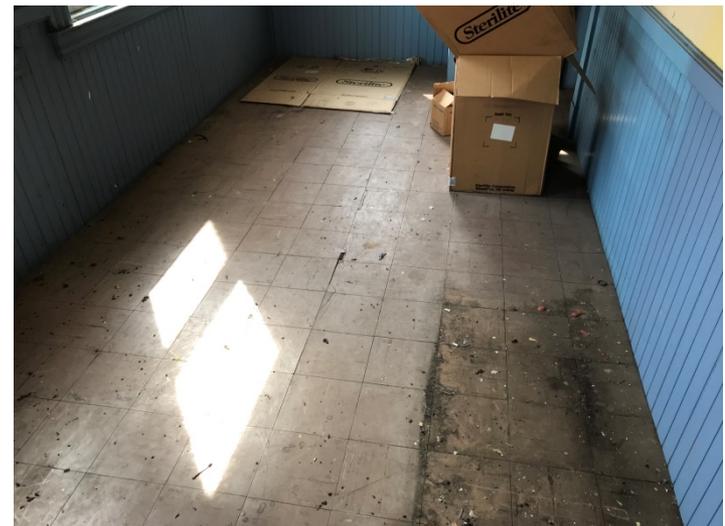
2-20 Room 206 floor

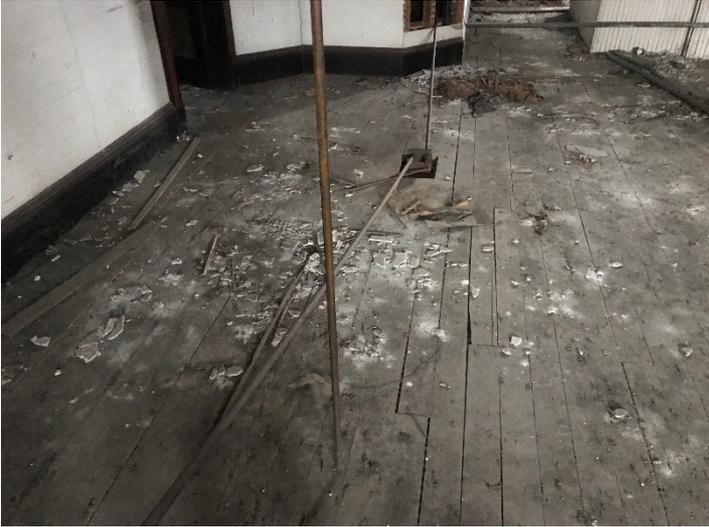
3-1 Floor of finished area

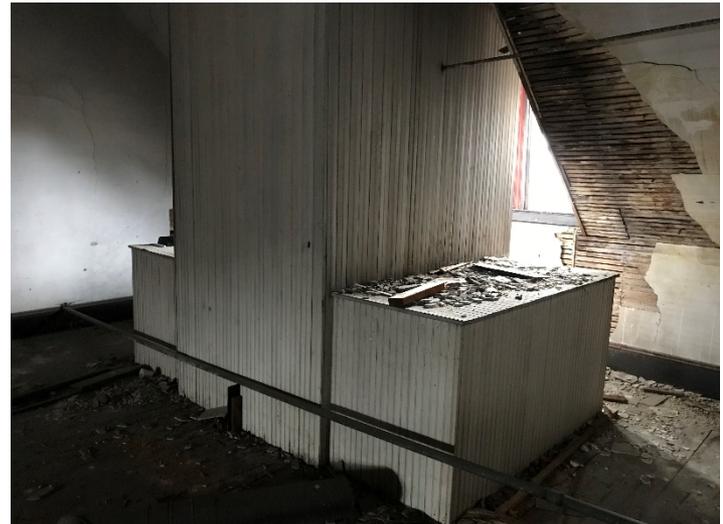
3-8 Vent shaft enclosure at west dormer

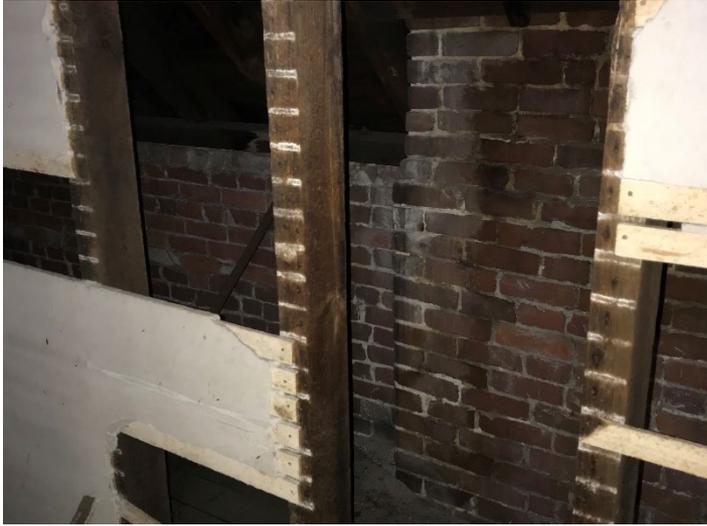
3-13 Exterior brick wall behind finished wall

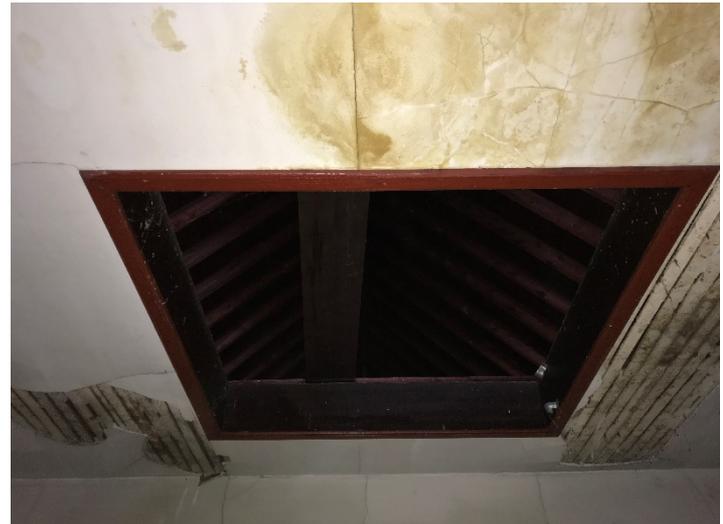
3-16 Open ceiling hatch at Room 303

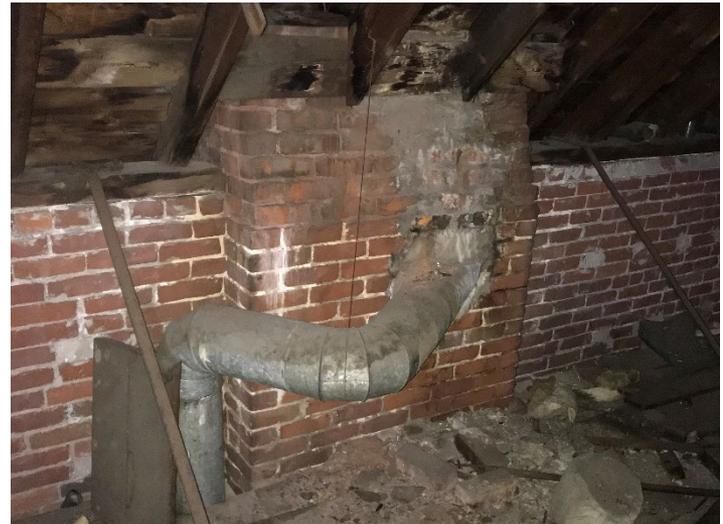
3-24 Flue duct at north chimney

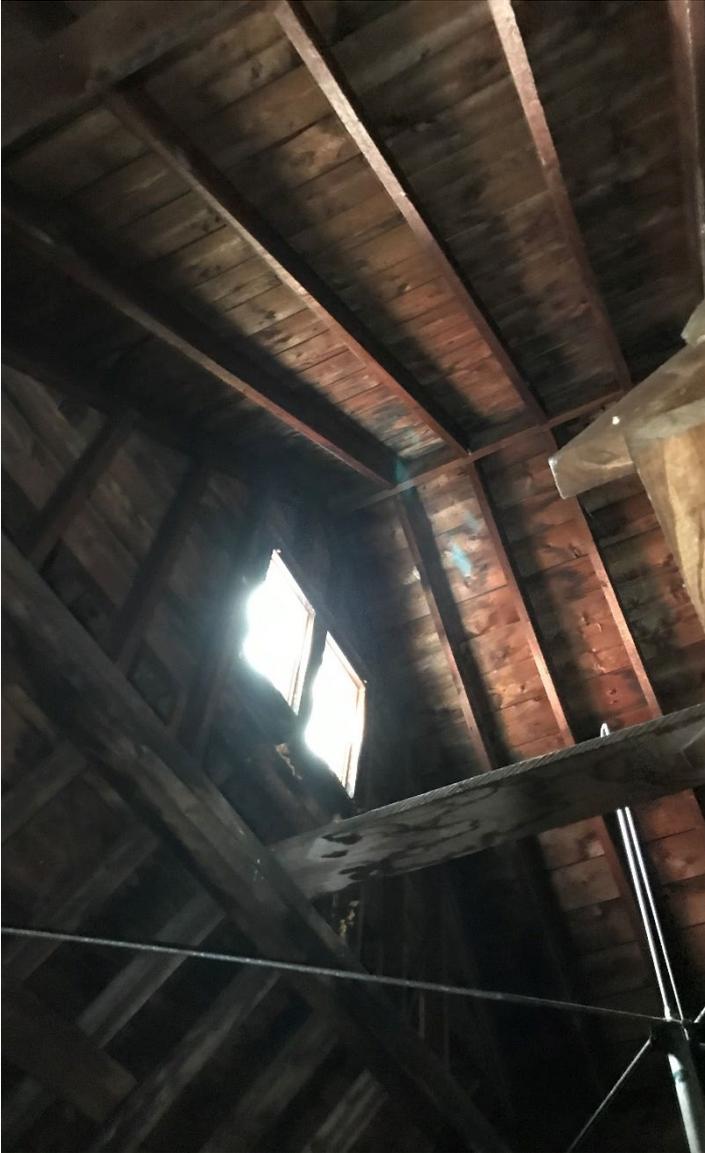
3-25 Windows at south gable end wall
