TOWN OF DEERFIELD
FACILITIES CONDITION ASSESSMENT
OF
TOWN BUILDINGS

Town Hall
Municipal Offices

Executive Summary

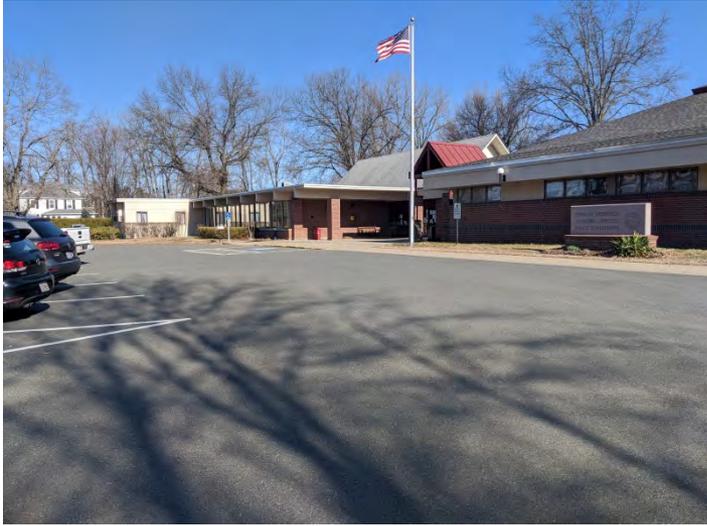
1. Front (south) with Main Entry

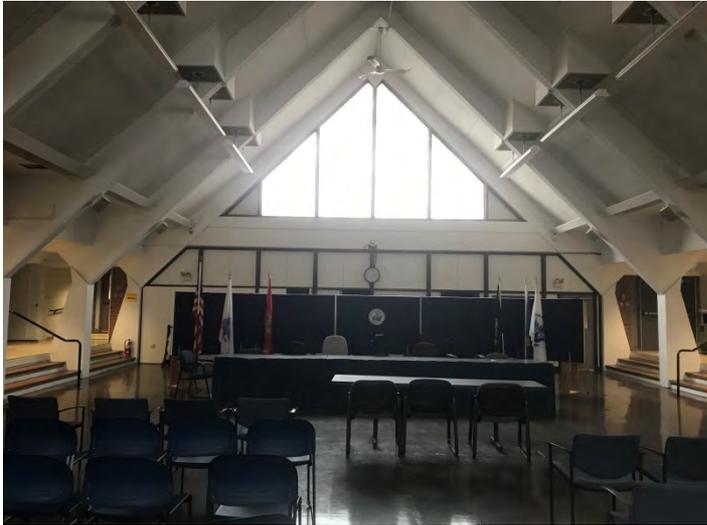
5. Assembly gabled end wall

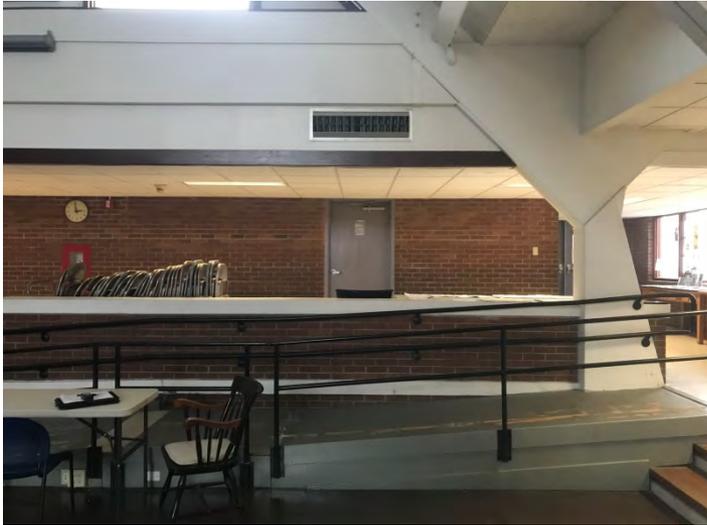
- The existing ramp is a wood framed structure with plywood walking surface finished with a slip-resistant covering that is severely worn. The handrails on one side of the ramp have been cut at the top of the ramp rather than with the required 12-inch extension. Clear dimension between handrails is only 44 inches (48" min. required per 521 CMR)
- There are no handrails installed at the steps between each set of piers.
- Nosings at the steps down to the Assembly floor are protruding rather than sloped back to the face of the riser.

9. Wheelchair Ramp at Assembly

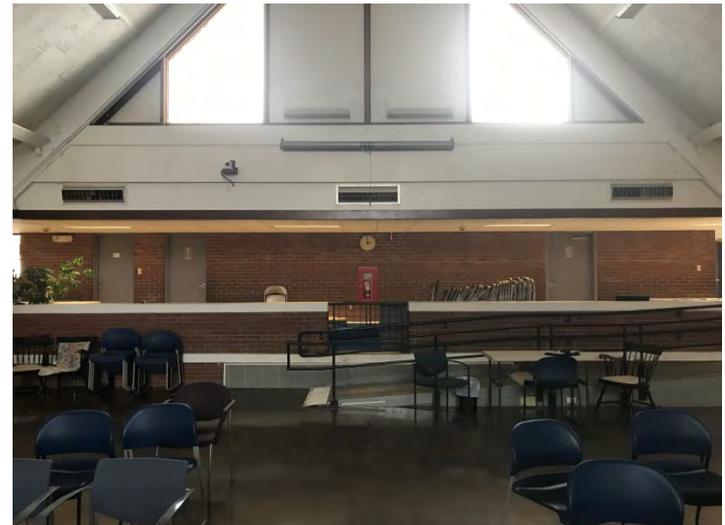
12. Assembly – East gable end wall

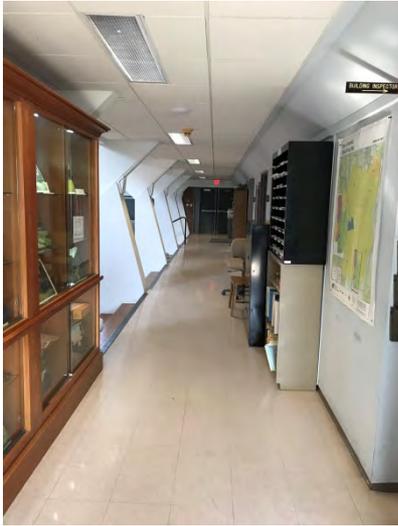
13. North Corridor

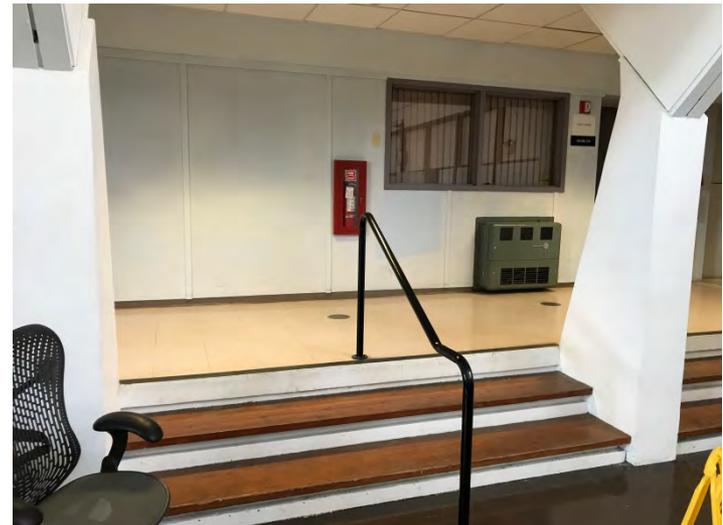
16. South Corridor (Nurse's Office beyond)

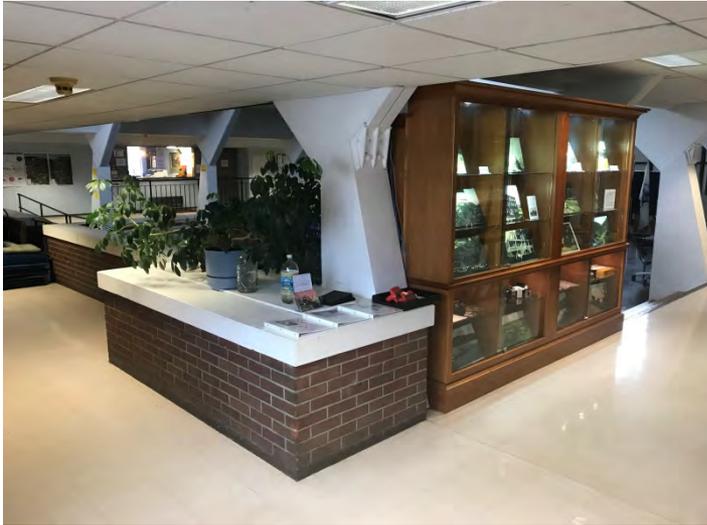
17. Corner at East Corridor (left) and North Corridor (right)

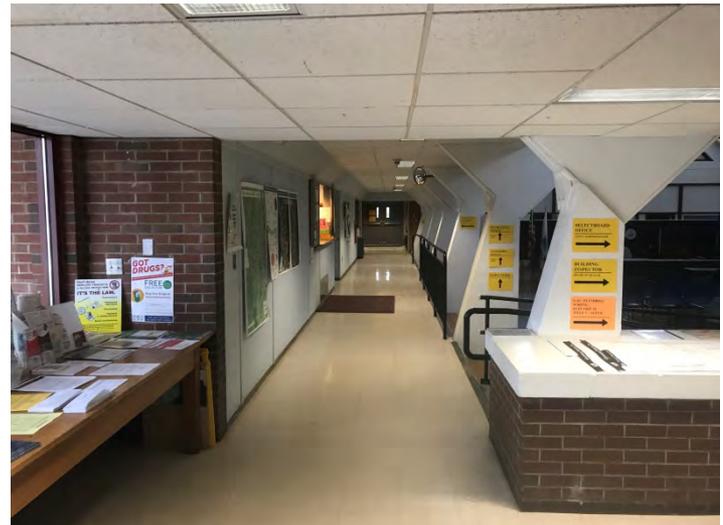
20. Corner at East Corridor (right) and South Corridor (left)

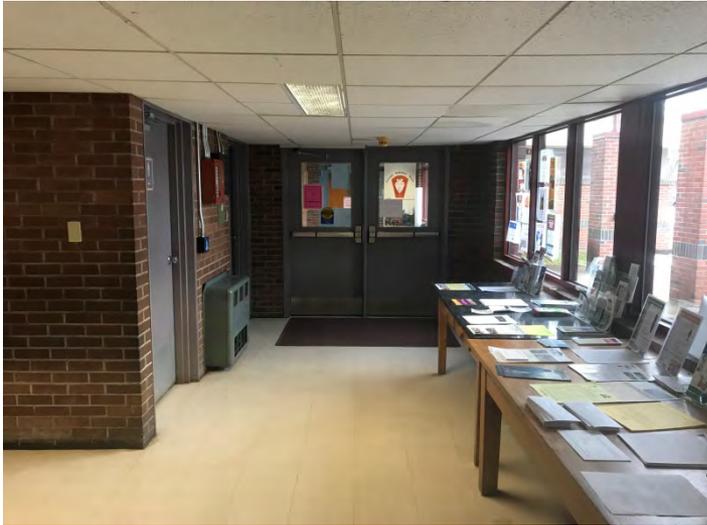
21. Hall 126 (toward main entry)

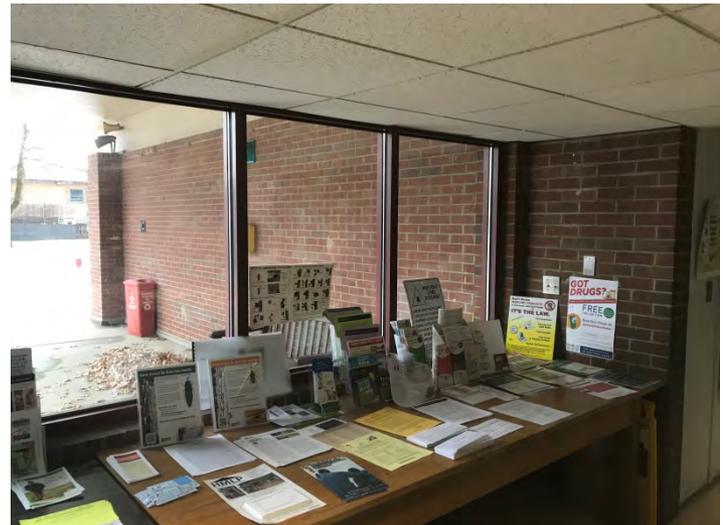
24. Hall 126

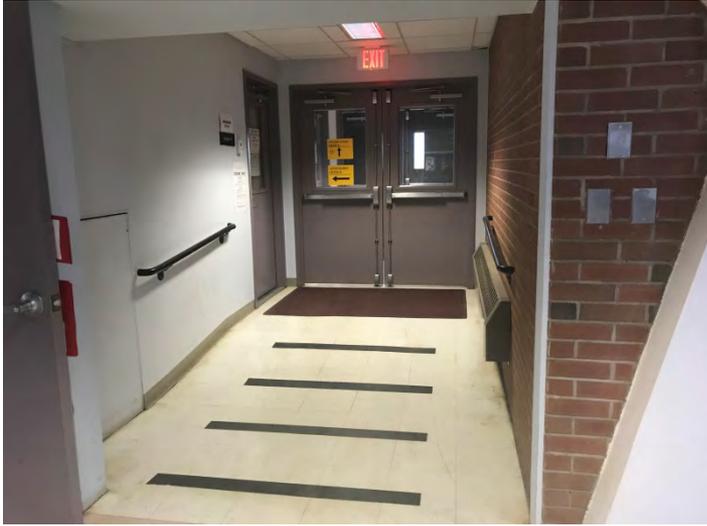
- South Corridor Extension:
 - Flooring includes a short ramp up toward a set of double egress doors with VCT flooring with slip-resistant black strips in fair condition.
 - Painted wall-mounted pipe handrails on each side are in good condition.
 - A pair of double painted solid core wood egress doors with exit (panic) hardware and large vision panels as well as the painted solid core wood door to the Assessor's office are all in good condition.

25. South Corridor Extension

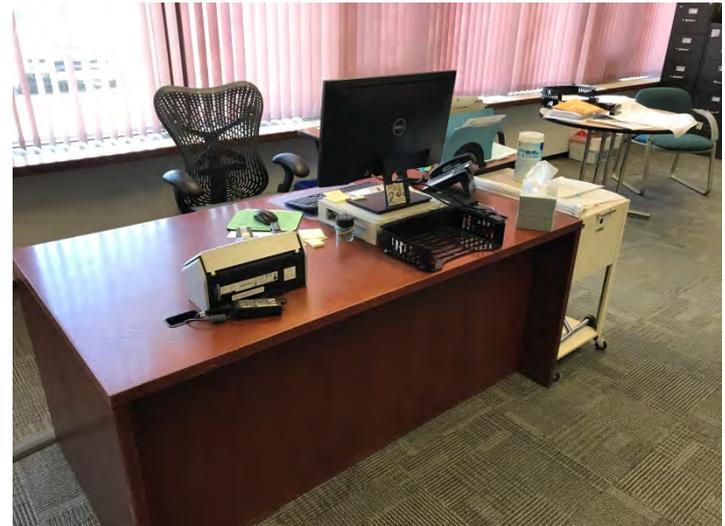
28. Town Administrator's Office

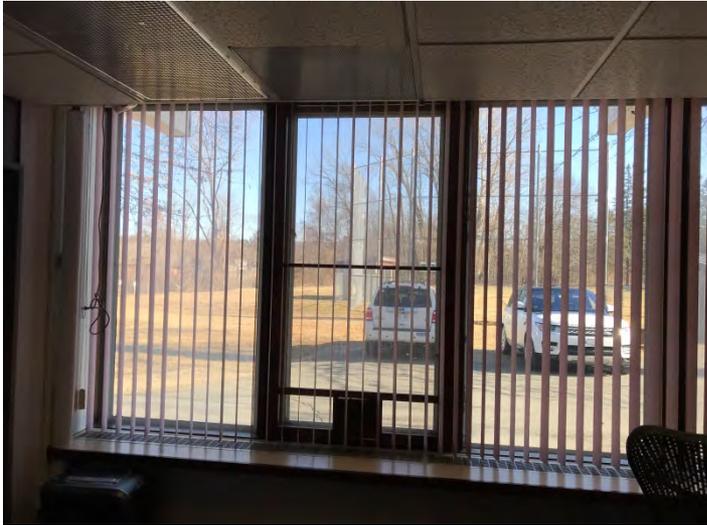
- Windows in exterior wall are (as noted above) the original wood framed fixed glass units (single pane) with intermittent top-hinged awning type units with screens. Although in serviceable condition, the existing windows are thermally inefficient and beyond their service life both in terms of thermal performance and occupant comfort.

29. Town Administrator's Office- typical window system

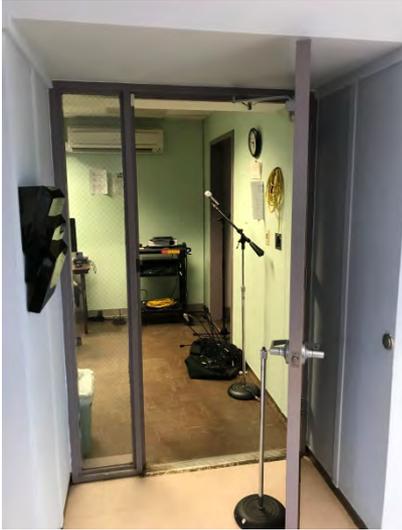
33. FCAT Office entry off North Corridor

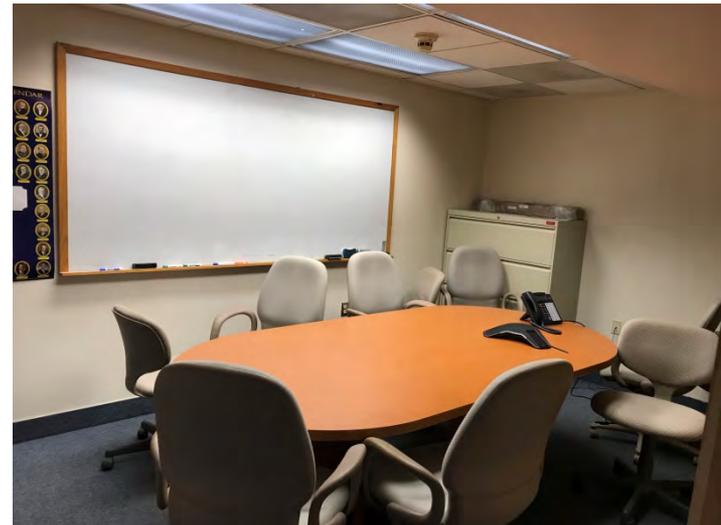
- Conference Room 130:
 - Flooring is broadloom carpet and wall base in fair condition with signs of wear.
 - Walls are painted gypsum wallboard in good condition.
 - Door is painted solid core wood doors in painted hollow metal frames with 10" wide wired glass sidelights and lever hardware. Wood veneer is wavy, a sign of delamination.
 - Conference Room table and chairs in serviceable condition.
 - Ceiling is "Second -Look" 2x2 tegular ACT in a 9/16 suspended grid in good condition;
 - This room is between the North Corridor and Room 131 and therefore has no exterior windows.

36. Conference Room 130

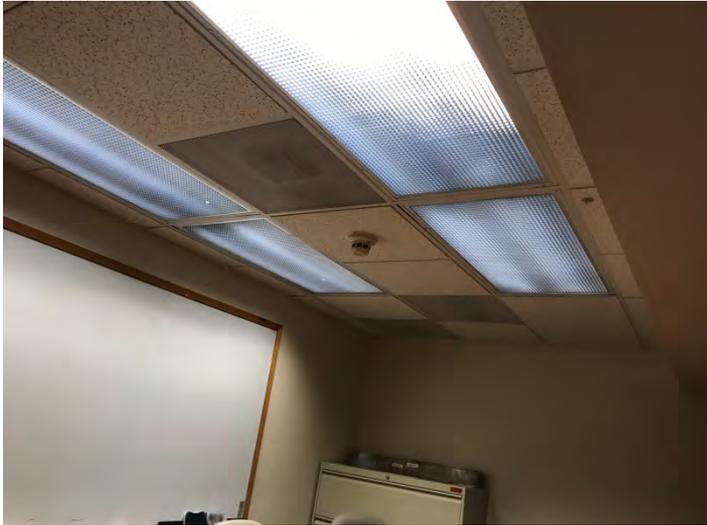
37. Conference Room 130 ceiling

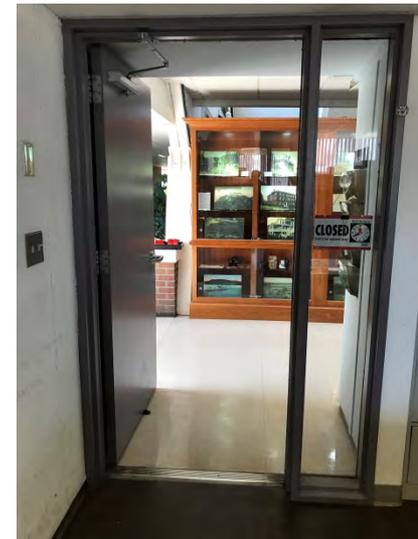
40. Building Inspection Office Entry off North Corridor

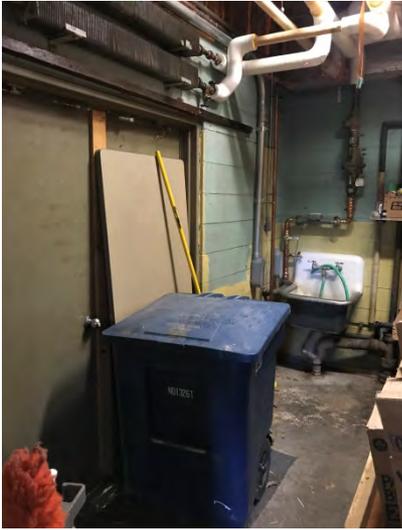
41. Electrical/Utility off East Corridor

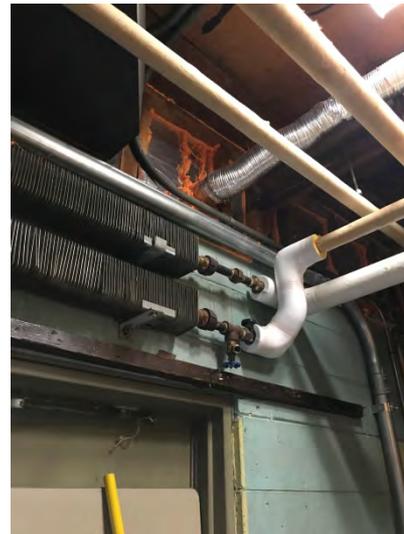
44. Electrical/ Utility exterior wall

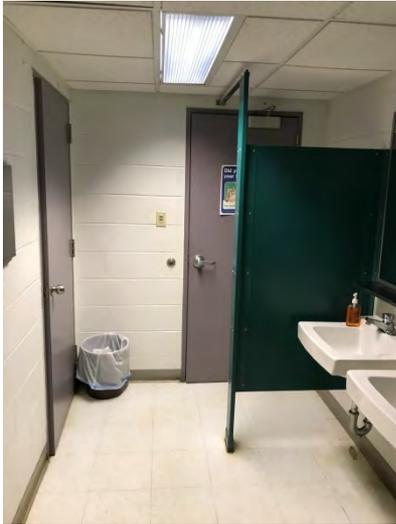
45. Men's Room off East Corridor

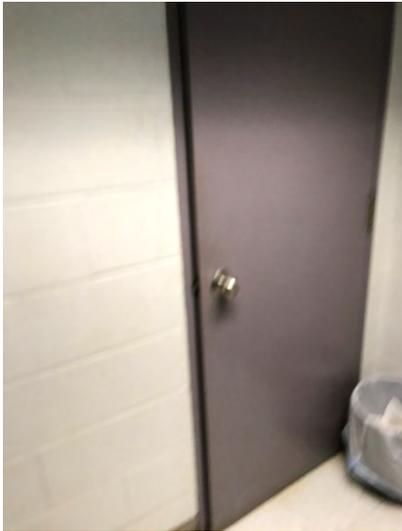
49. Men's Room - door to Mechanical Room

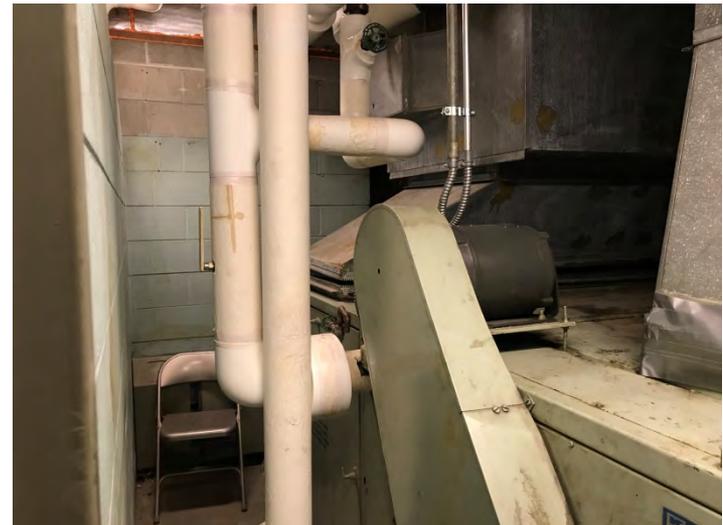
- The existing (original) mechanical room houses a very large indoor air handler with associated ductwork, taking up a significant amount of space, and appears to be beyond its service life. As part of an overall renovation to improve the functionality and efficiency of the Town Hall Building, it is recommended this unit be removed and replaced with a roof-top air handler to provide fresh air to the building along with centralized AC and supplemental heat that would allow repurposing of the existing Mechanical Room to office or support space.

52. Mechanical Room AHU toward Boiler Room wall

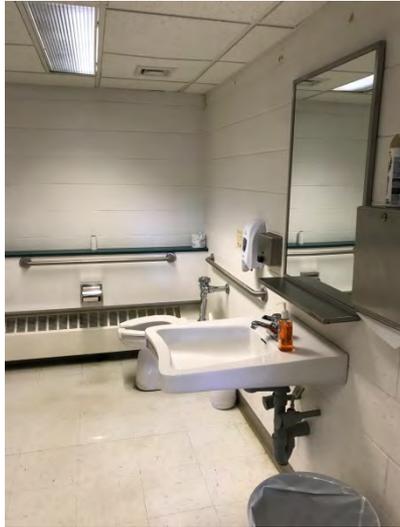
53. Unisex HC Toilet Room

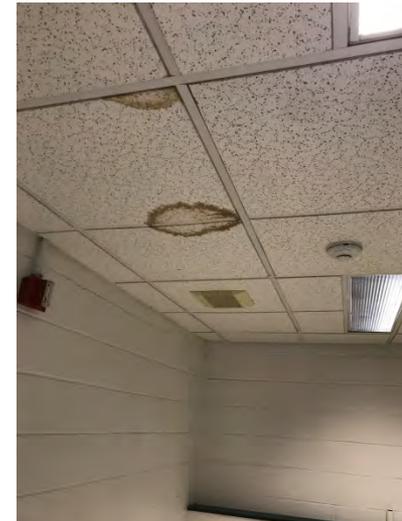
56. Unisex HC Toilet Room- stained ceiling tiles

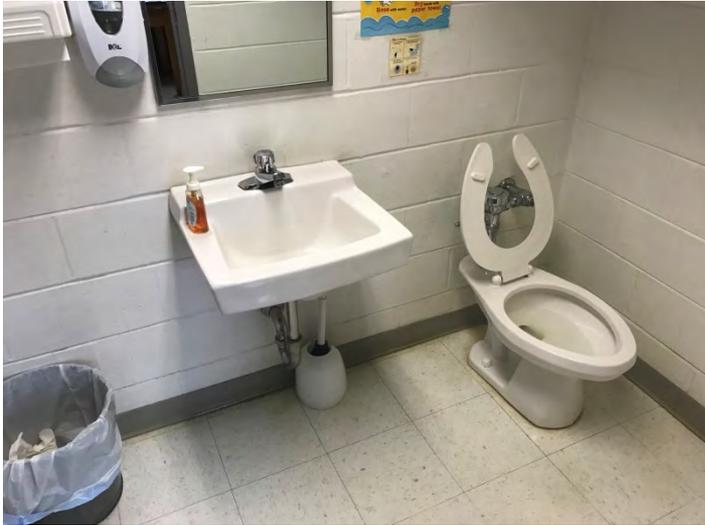
57. Small Men's Room off Hall 126

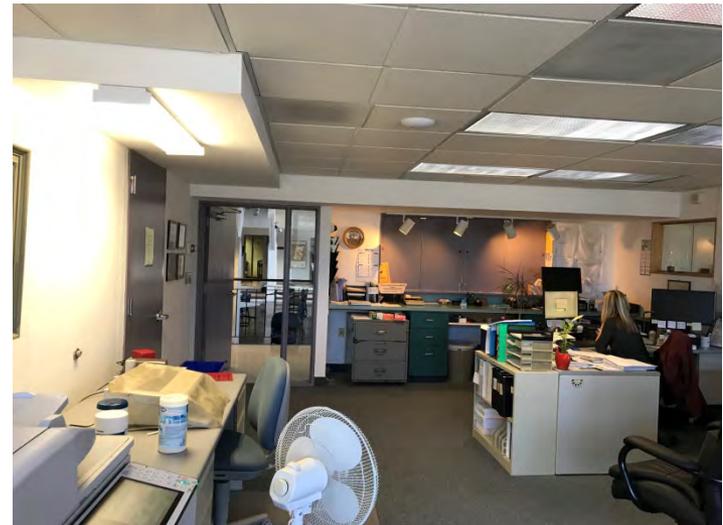
60. Town Clerk's Office

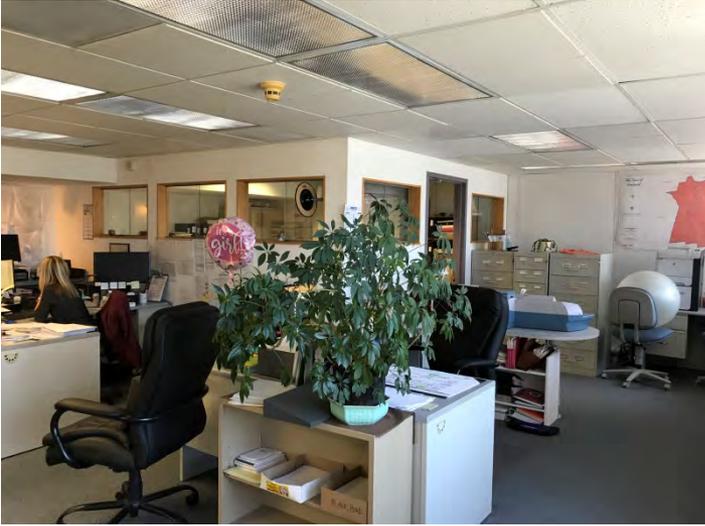
61. Town Clerk's Office

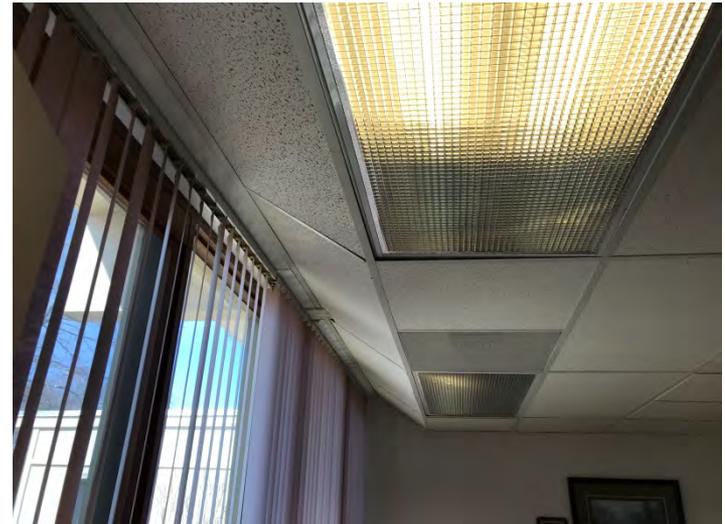
64. Town Accountant's Office

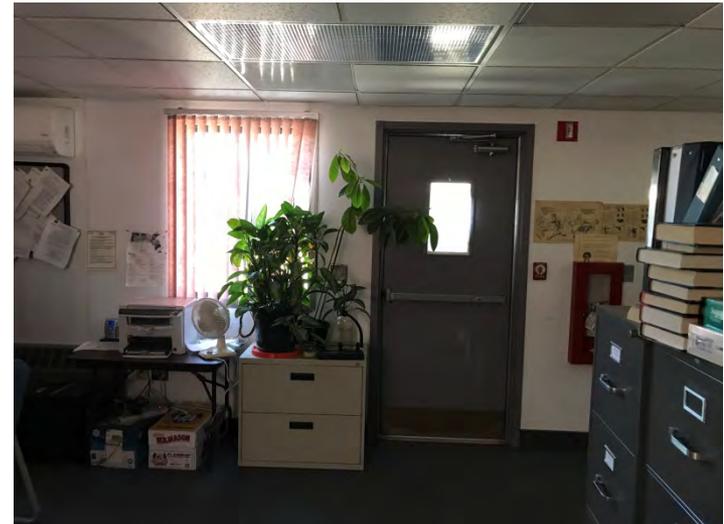
- Doors include 3 interior doors and one exterior door leading to a deteriorated wood landing and ramp in deteriorated condition. The doors are typical for the building and in good condition.

72. Assessor's Office Exterior door

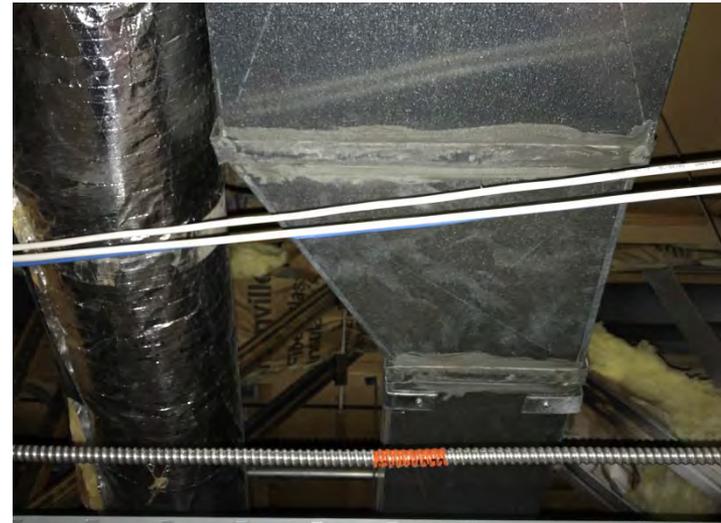
76. Assessor's Office- Above -ceiling dutwork

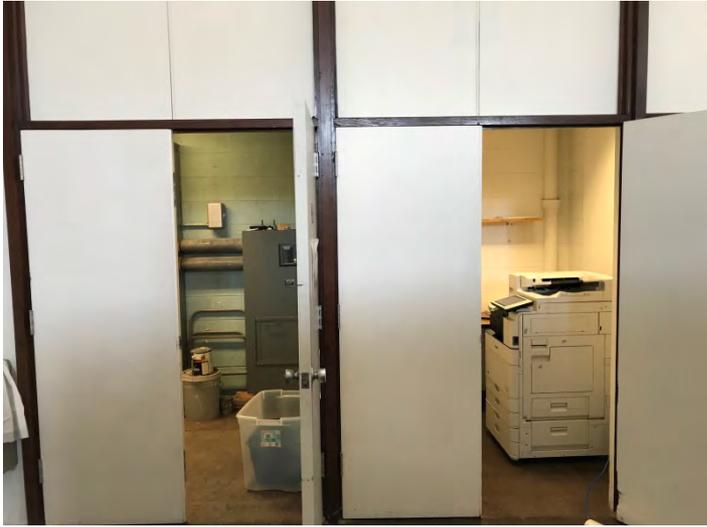
77. Electrical Room and Copy Room at West end of Assembly Area

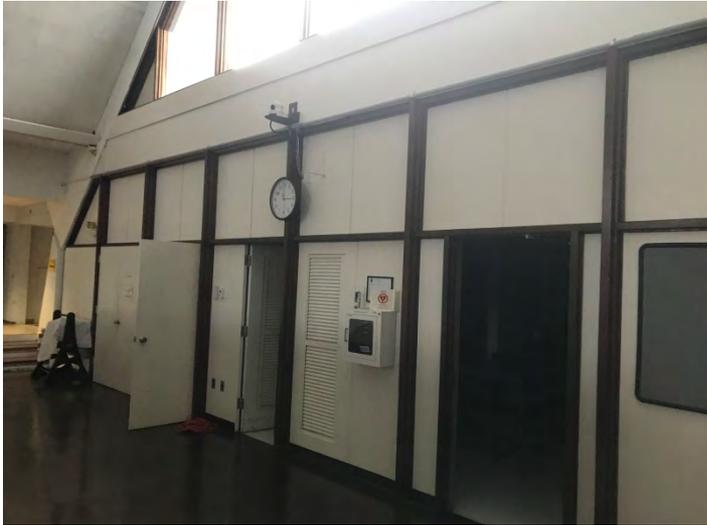
81. Doors to Kitchenette at west end of Assembly Area

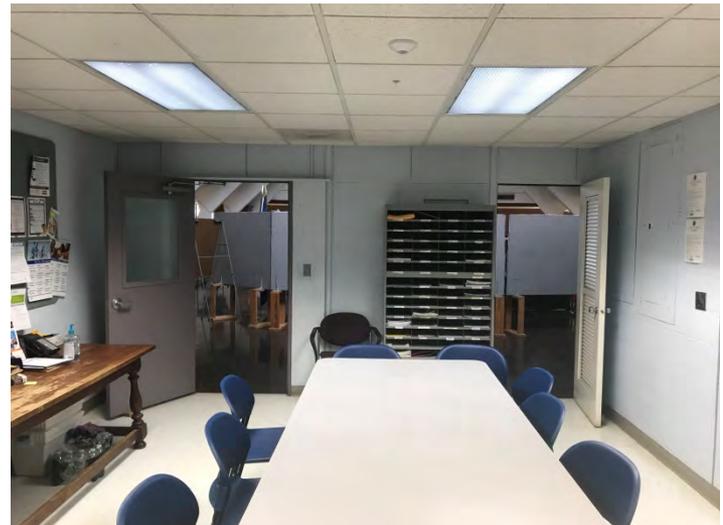
84. Entry door to Kitchenette

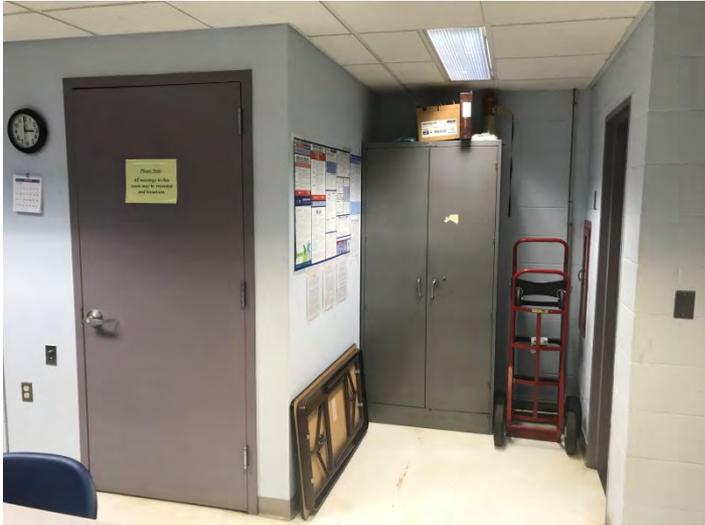
85. Niche at Kitchenette

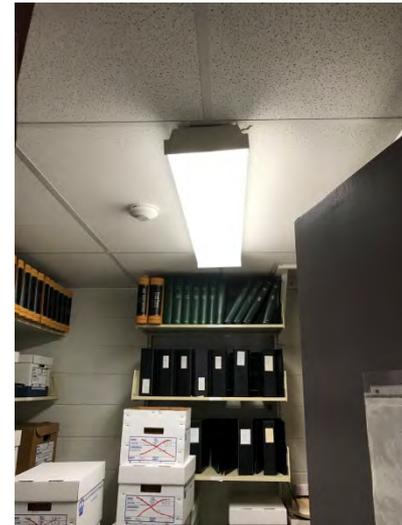
88. Storage Room off egress corridor

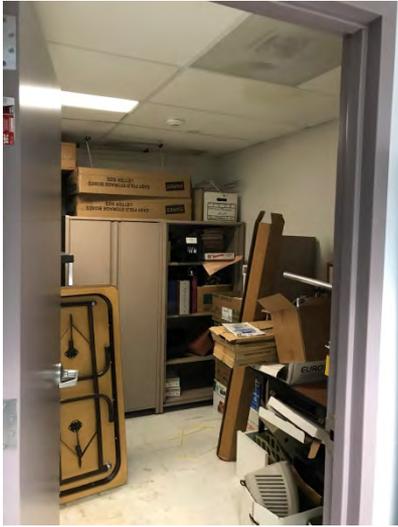
89. Storage Room off Kitchenette

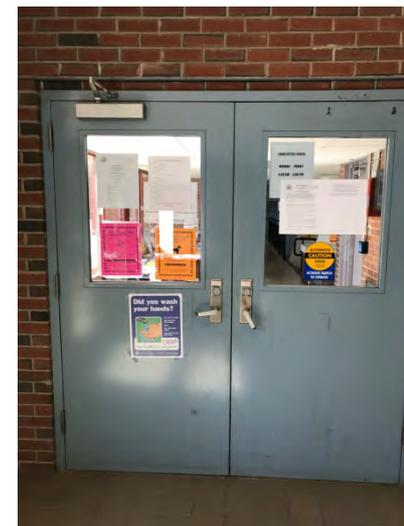
100. Doors to Hall 126 from Main Entry Vestibule
