RE: **Revised Notice of Intent**  
All States Materials Group Haul Road Improvements  
901 River Road, Deerfield, MA 01342

# ALL STATES MATERIALS GROUP HAUL ROAD IMPROVEMENT PROJECT

## NOTICE OF INTENT

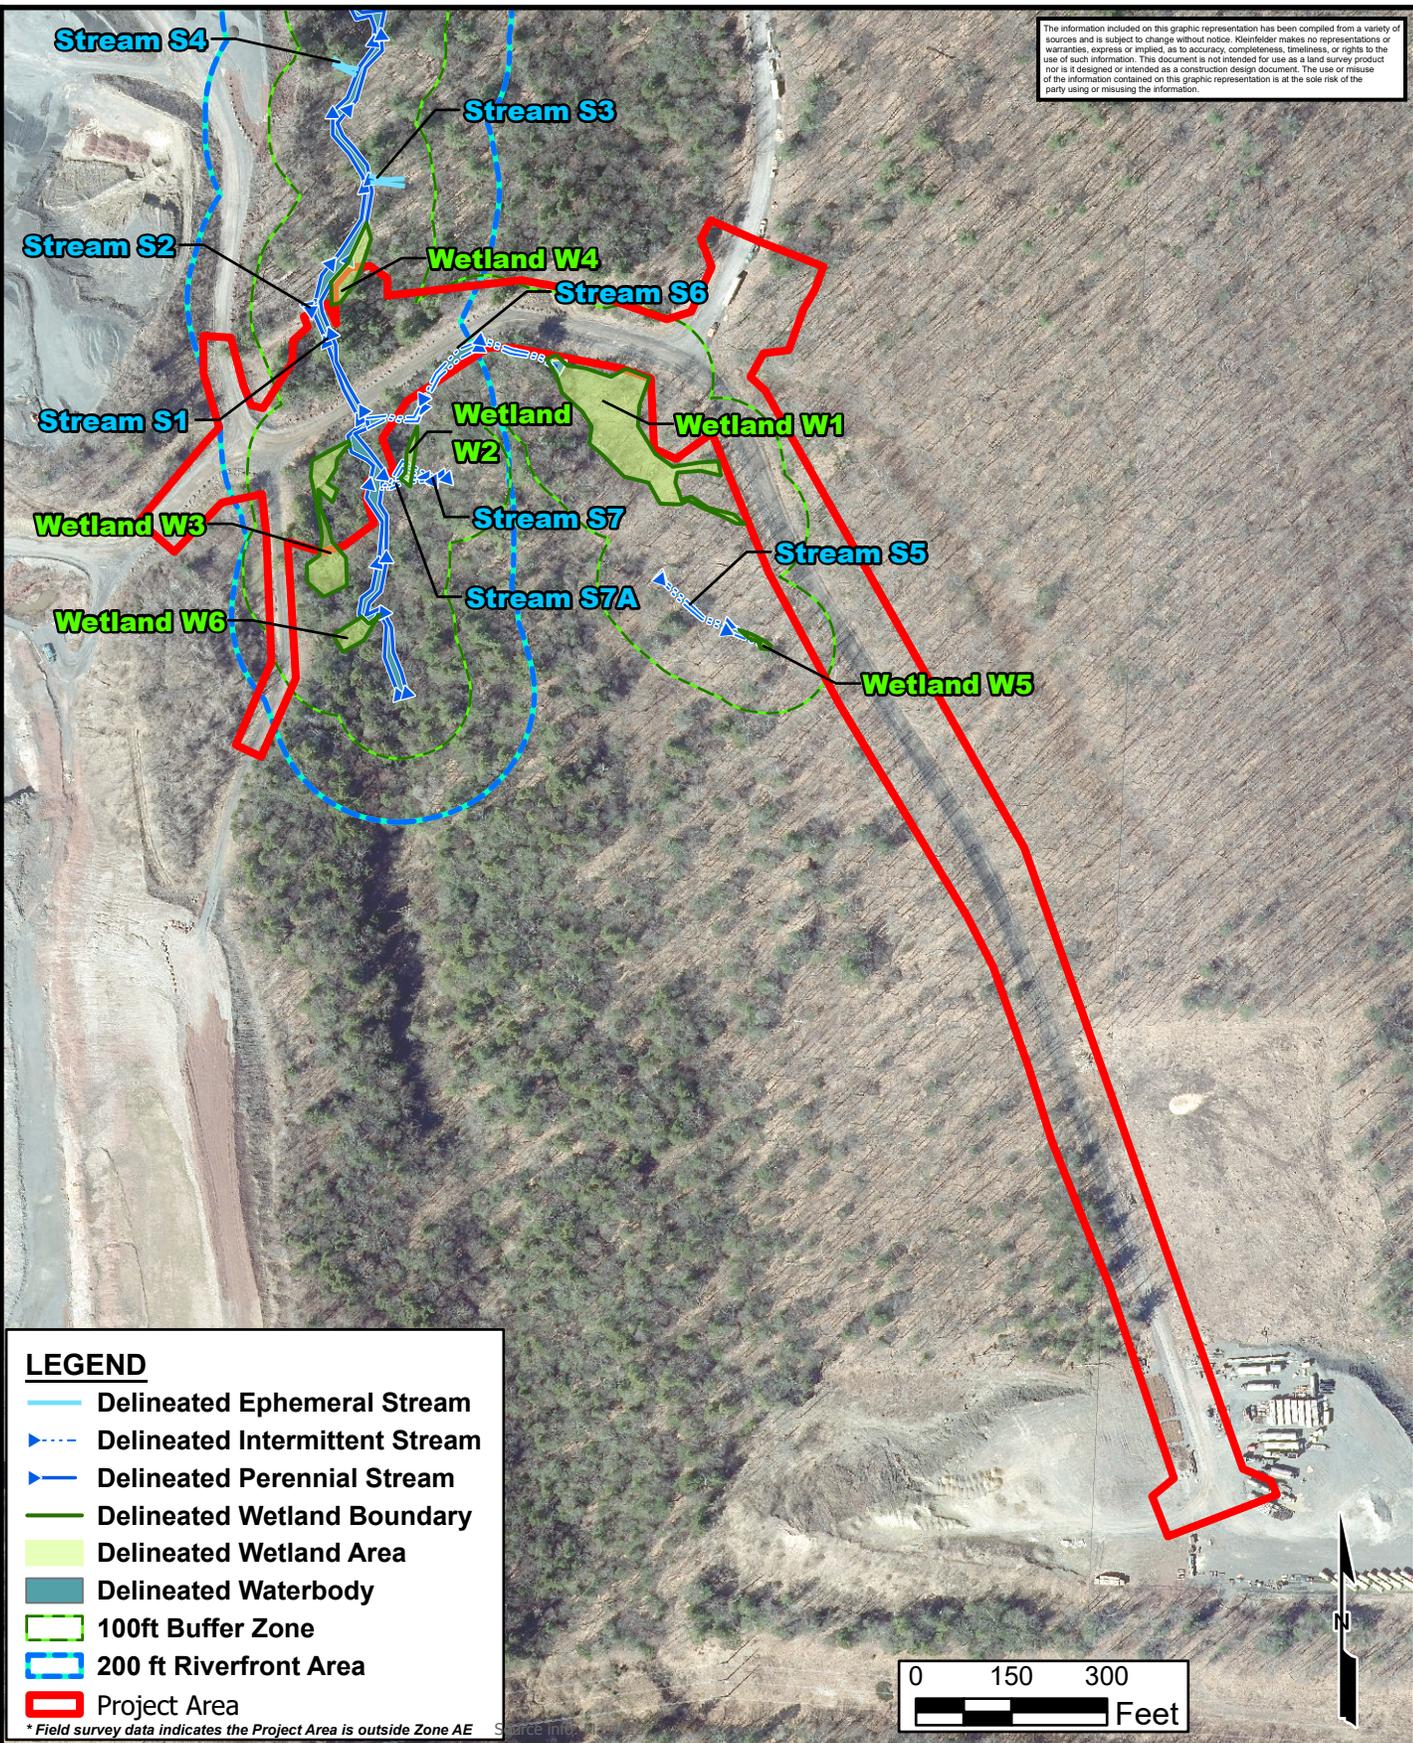
- Delineated Ephemeral Stream
- - - Delineated Intermittent Stream
- ▶ Delineated Perennial Stream
- Delineated Wetland Boundary
- Delineated Wetland Area
- Delineated Waterbody
- 100ft Buffer Zone
- 200 ft Riverfront Area
- Project Area

\* Field survey data indicates the Project Area is outside Zone AE

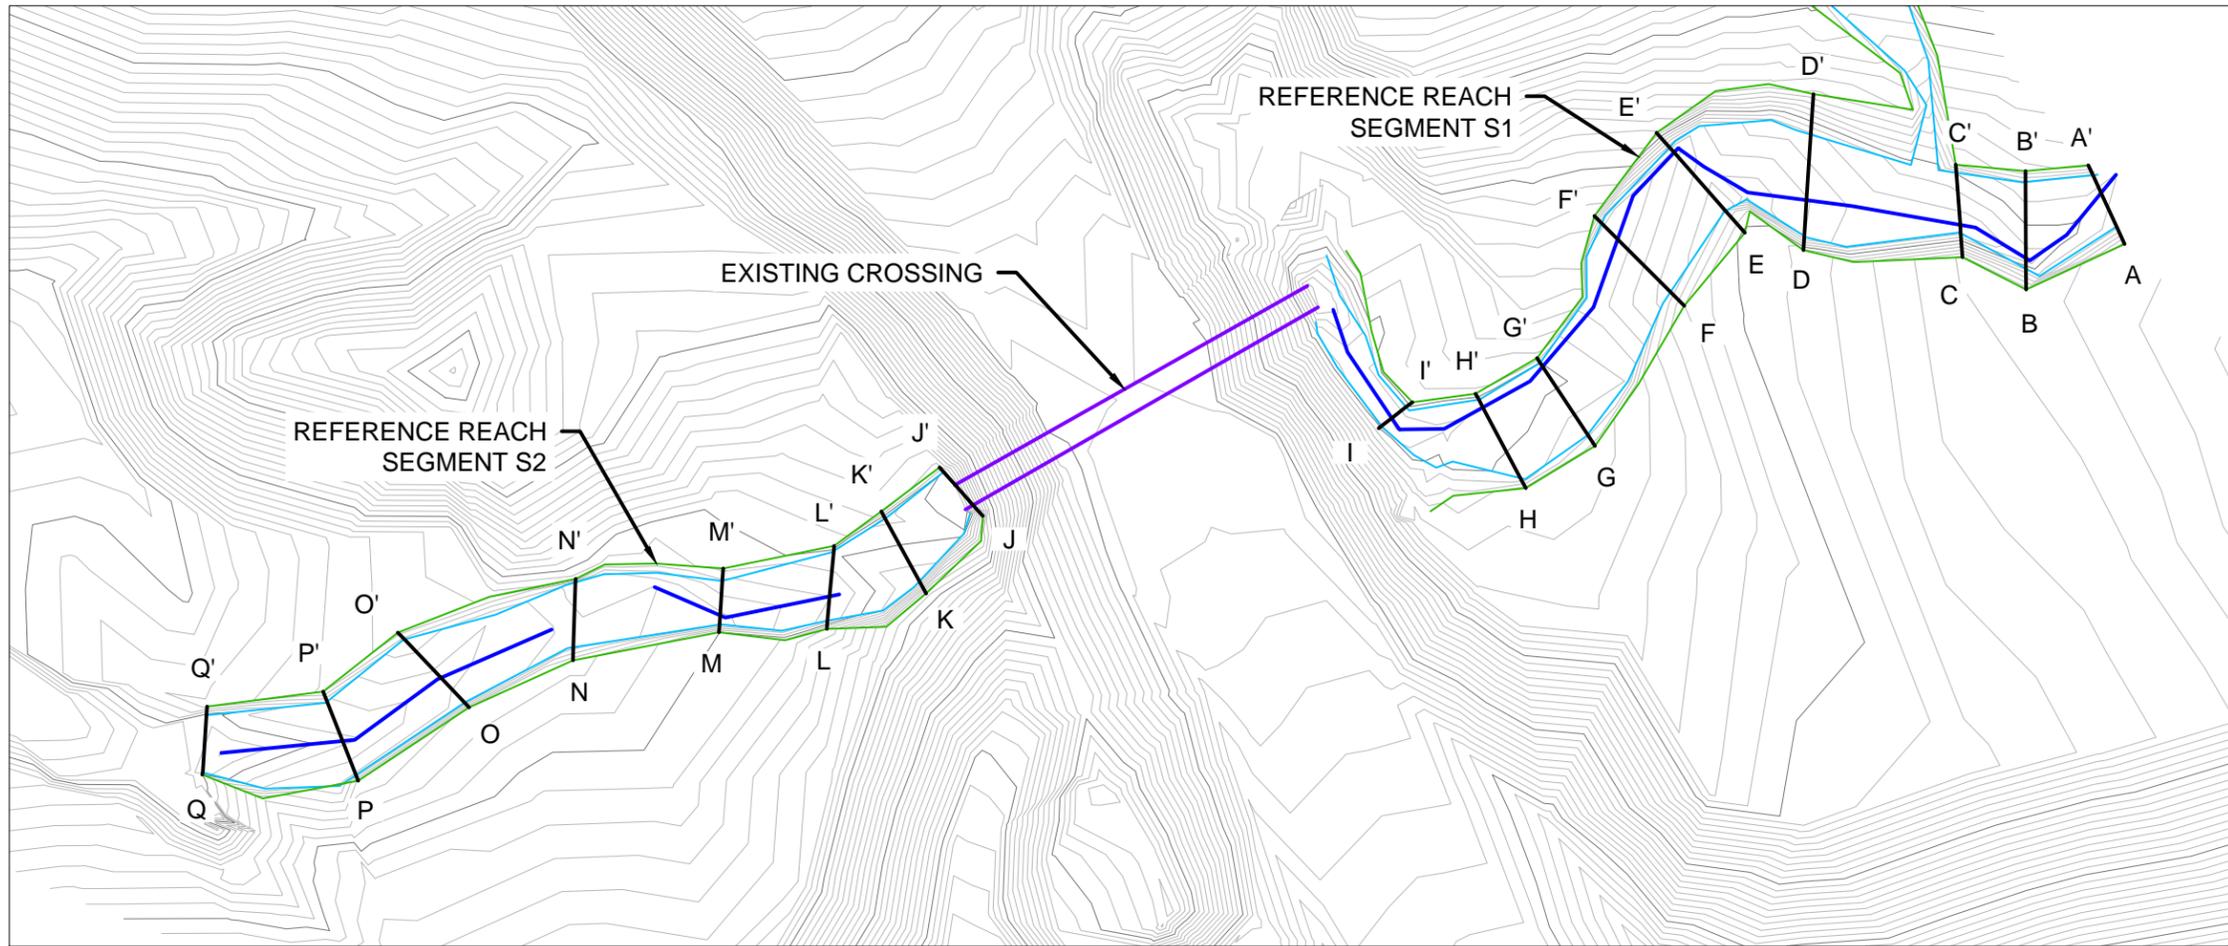
**PLAN**  
 SCALE: 1"=30'

- EXISTING STREAM CENTERLINE
- EXISTING STREAM TOP OF BANK
- EXISTING STREAM TOE OF BANK
- EXISTING CULVERT
- EXISTING MAJOR CONTOURS (5')
- EXISTING MINOR CONTOURS (1')
- CROSS-SECTION LOCATION

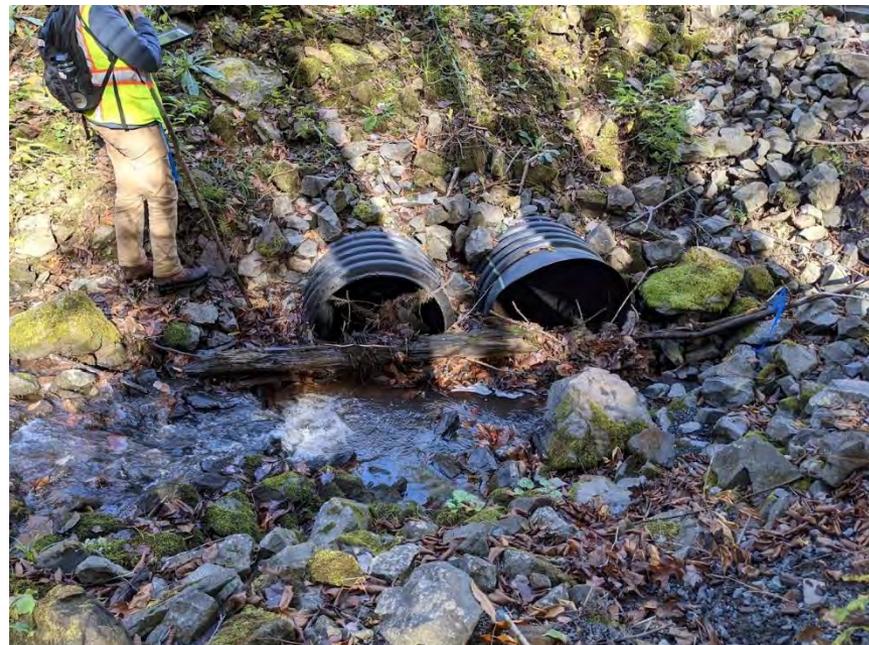
Photo 2: Stream S1 culvert inlet

**Haul Road Widening and Stream Crossing Replacement:** Once grading is completed and stormwater drains installed, the existing double barrel culvert would be replaced with a new, 84 The stream would be blocked on the upstream and downstream sides of the culvert by sandbag check dams during the culvert replacement. Water would then be pumped from the upstream side to the downstream side of the culverted crossing. ASMG would use suction strainers on the pump suction line and discharge hose to reduce the turbidity of the diverted water. Compost filter sock and/or haybales would be used at the end of the discharge hose to act as a sediment trap for any disturbed silt/sedimentation during diversion activities before entering the stream. ASMG would monitor water levels at the upstream and downstream dams to ensure the pump is adequately maintaining stream flow, as well as conduct visual inspection of the discharge area, to ensure water discharged into the stream has minimal turbidity. The stream bypass and culvert installation is expected to occur over approximately 48 hours. The applicant plans to self-perform the proposed work and has the ability to plan scheduled work around weather conditions. Additionally, this stream receives the majority of its hydrology from rain events and snow melt so it is not typically flowing water at its capacity even during the higher-flow period of the year. Installation of the culvert would be scheduled to minimize potential adverse impacts during high flow conditions.

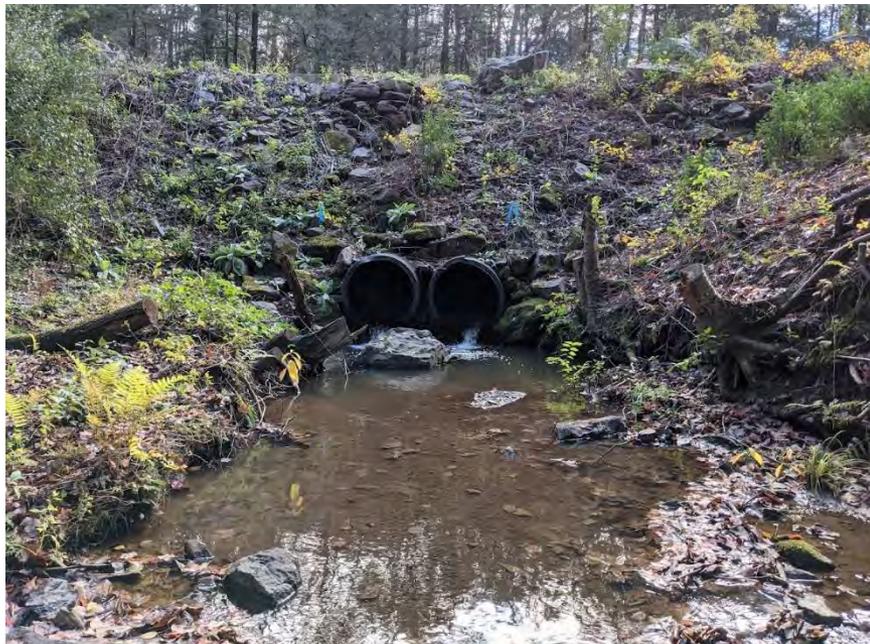
**Photo 3: Stream S1 culvert outlet**
