# ROAD SAFETY AUDIT

Greenfield Road (US Route 5, MA Route 10) / North Main  
Street / Mill Village Road

Town of Deerfield

November 14, 2024

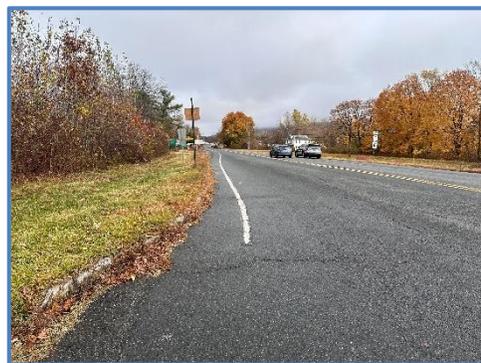
*Greenfield Road Bypassing Traffic* – Several audit participants noted that queues regularly form for left-turning vehicles along both the Greenfield Road northbound and southbound approaches within the general-purpose travel lane. Whereas the overwhelming majority of vehicles along the corridor are travelling straight through the intersection, many vehicles will bypass the queued left-turning vehicle(s) utilizing the widened lane width and shoulders on each side of the roadway. The width of the travel lanes and shoulders provide a comfortable bypassing condition where many of the vehicles doing this maneuver can do so without reducing a significant amount of speed.

**Image 2: Greenfield Road southbound travel lane widening on approach to intersection.**

4. Evaluate left-turn lane warrants, following the reopening of the North Main Street railroad bridge, to determine the applicable condition for the installation of left-turn lanes along both Greenfield Road approaches. Left-turn lanes may allow left-turn vehicles to stack separately from through movements on the corridor leading to a clearer anticipation of bypassing through vehicles and reduce the offset between each of the left turn queues on the Greenfield Road approaches to the intersection.

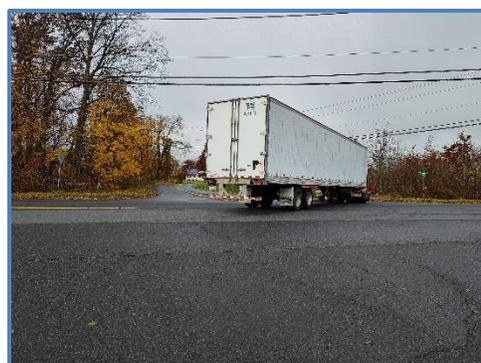
*Farm Equipment and Heavy Commercial Vehicles* – Participants noted that the intersection had significant heavy commercial vehicle usage and that the intersection experiences turning maneuvers for farm equipment vehicles who are attempting to access agricultural land areas particularly on Mill Village Road and North Main Street. Farm equipment vehicles typically travel at a much lower speed compared to a traditional vehicle which may not be anticipated by drivers. The presence of these vehicles, especially through left turn maneuvers, contributes to driver frustration and bypassing traffic within the wider pavement area.

**Image 3: Consistent heavy vehicle movements at intersection including tractor-trailer maneuvers.**

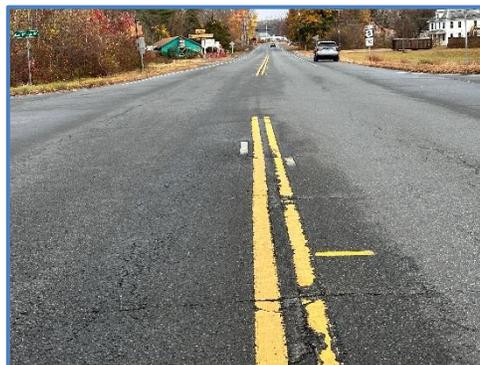
**High Operating Speeds** – The edge-to-edge cross-sectional width of Greenfield Road varies; however, the cross-section approaching the intersection increases up to 55-feet at the intersection with enough space for the roadway to operate with effectively 4 lanes with shoulders across the roadway width. Greenfield Road was described by participants as ‘runway’ by audit participants based on its straightaway / tangent nature, the lack of other side-friction elements, and modest daily / hourly traffic volumes for the regional arterial nature of the corridor. The ‘runway’ feel contributes to high operating speeds that were confirmed through speed data collected prior to the RSA. The 85<sup>th</sup> percentile speeds were measured upwards of 10 mph above the posted speeds which itself is 45 mph adjacent to an even higher 50-mph speed zone.

**Image 4: Straightaway alignment and widened pavement area of Greenfield Road contributes to high operating speeds.**

10. Increase speed enforcement in the vicinity of the intersection along Greenfield Road where higher speeds are observed.
11. Modify the cross-section of Greenfield Road in the vicinity of the intersection to reduce the overall width of pavement surface both by narrowing travel lanes and shoulders. [See #2 – *Greenfield Road Cross Section & Visibility*]

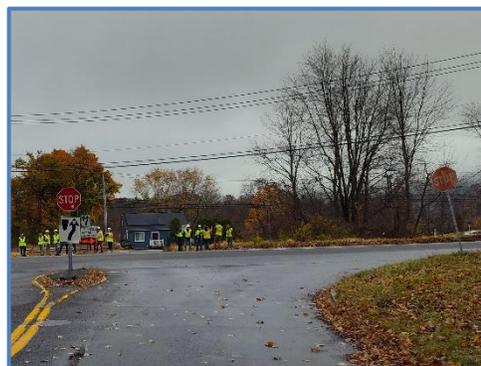
*Stop Signs and Stop Lines* – Dual stop signs (R1-1) are provided along both the Mill Village Road eastbound and North Main Street westbound approaches with the second supplemental stop sign located within the raised median island for each approach. Each of the stop signs located on the far-right of the approaches are in a faded condition with no clear reflectivity present which is concerning as this sign is the more critical of the dual stop signs as it would be the sign first seen by a driver approaching around the horizontal curves that leads into the intersection for each approach. The Mill Village Road eastbound approach has a faded stop line that is only visible in a couple of spots at the time of the RSA while the North Main Street stop line is nonexistent.

**Image 5: Faded Stop Signs Mill Village Road at Greenfield Road.**

25. Consider LED enhanced intersection and ‘Stop Ahead’ warning signage to extend the visibility and importance of the downstream traffic condition.
26. Replace the faded stop signs (R1-1) on the right side of both North Main Street and Mill Village Road on each approach to the intersection.

27. Replace or install stop lines on both the North Main Street and Mill Village Road approaches.
28. Reconstruct the raised median islands along both the North Main Street and Mill Village Road approaches to provide consistent width and curb reveal for sufficient lateral offset to signage. Position ‘Keep Right’ (R4-7) signs to each end of the island with a 4-foot height to the bottom of sign. Reposition the stop signs (R1-1) in the islands to align with the corresponding stop lines. Remove all other signage from the raised median islands.

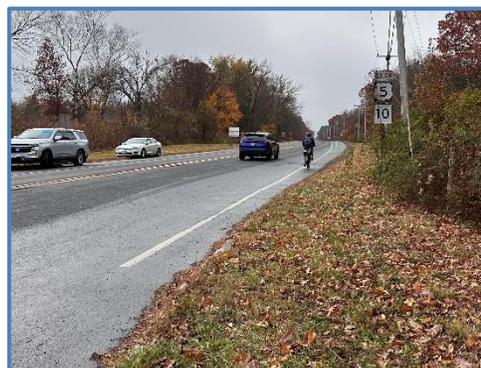
*Continuity of Bicycle Accommodations* – Bicycle lanes are provided on Greenfield Road beginning in the southbound direction and ending in the northbound direction approximately 250 feet south of the intersection. Currently there are no traffic signs to indicate to drivers or cyclists that the bicycle lanes are beginning or ending. Bicycle lanes are not provided north of the intersection on Greenfield Road but the approximately 4 to 5-foot shoulders north of the intersection may be used by some cyclists as bicycle accommodation. Note that the area of bicycle accommodation near the intersection is regularly utilized for bypassing traffic as previously noted in the RSA.

**Image 6: Narrow shoulder transitioning to southbound bike lane on Greenfield Road.**

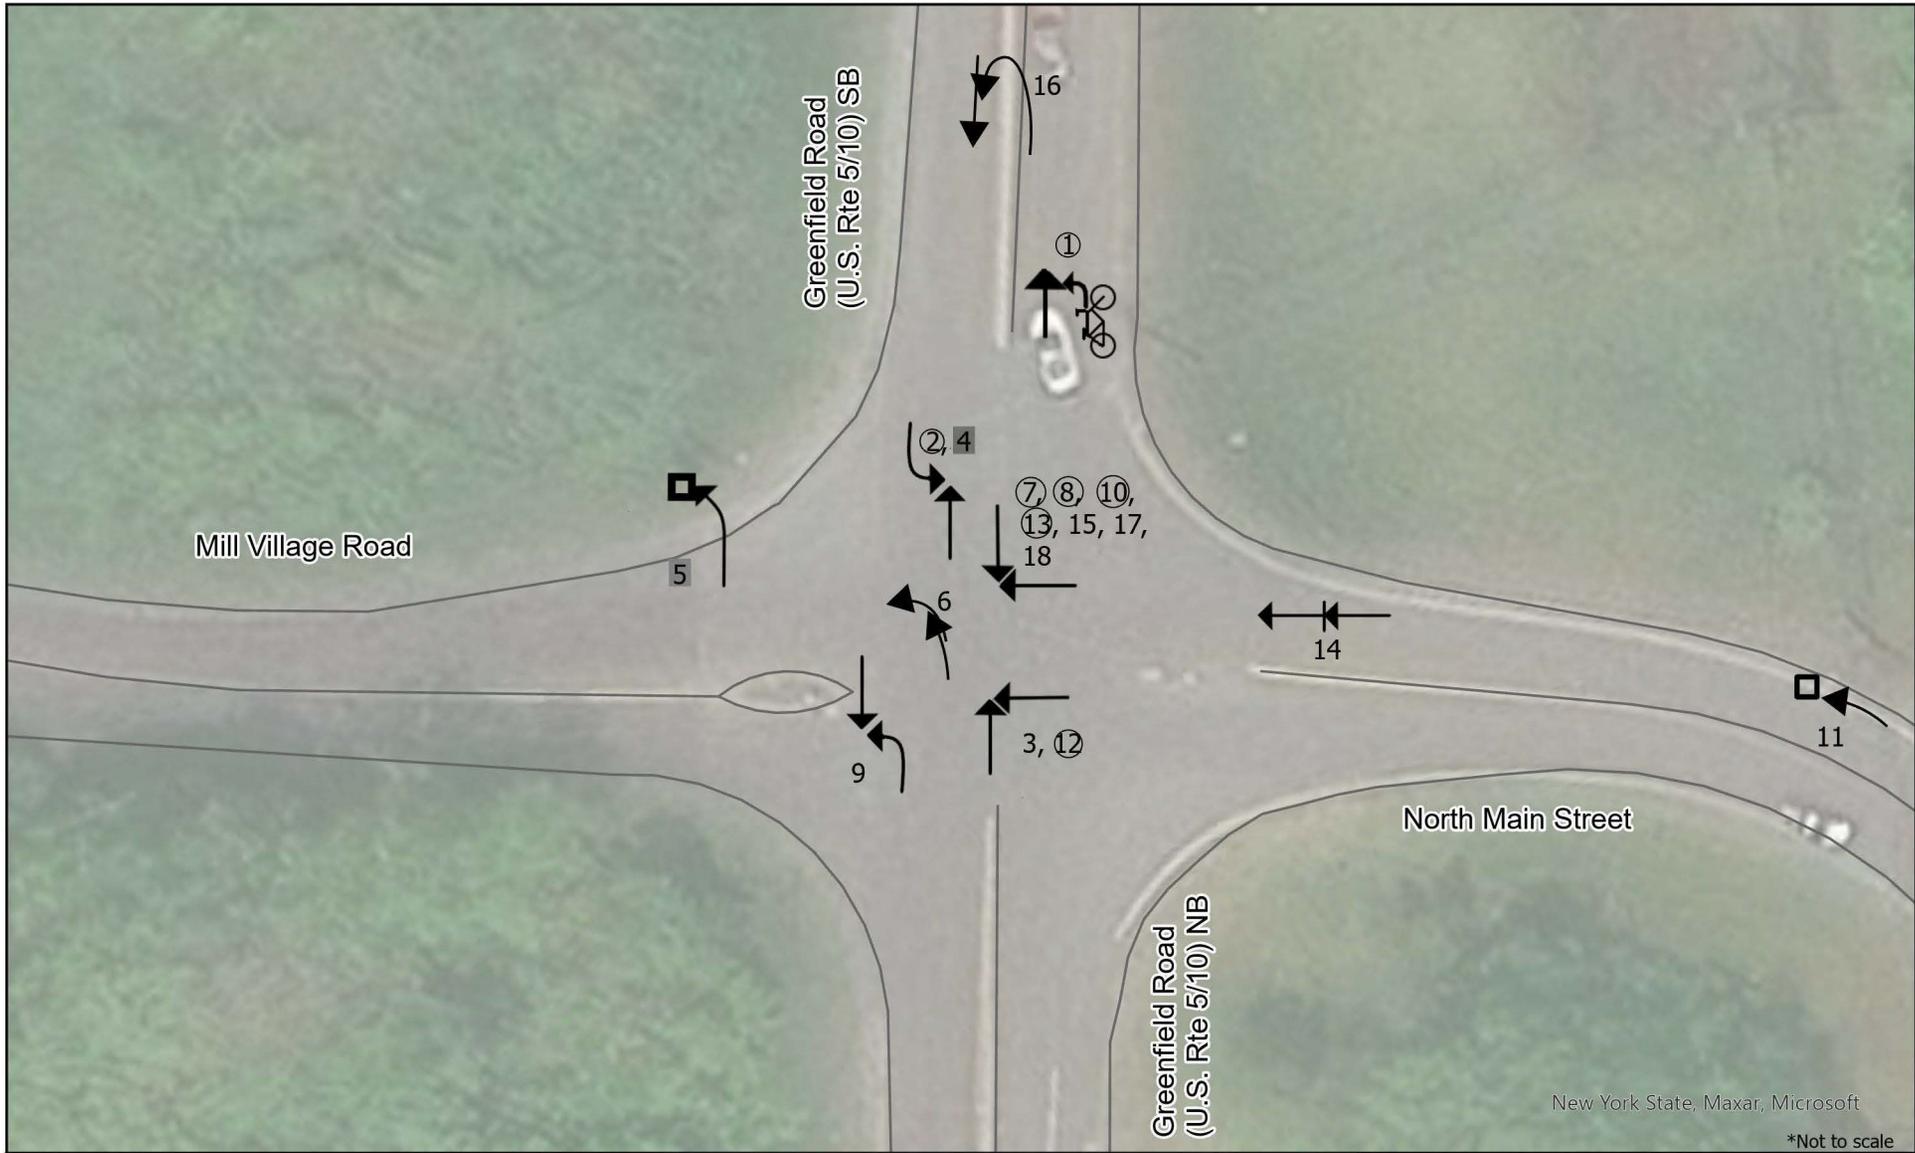
#	mm/dd/yy	Day	hh:mm	Type	Type	Type	Type	Type	Type	#	#	#	
1	07/19/18	Thursday	6:35 PM	Single vehicle crash	Daylight	Clear	Dry	No improper driving	Non-fatal injury	28			V1 and Cyclist 1 traveling WB on N Main St and turning right onto Greenfield Rd NB. Once both parties have completed the turn, Cyclist 1, who was still clipped into their pedals, attempts U-turn to return to the intersection and travel WB onto Mill Village Road. Cyclist 1 collides with passenger rear of V1.
2	04/13/19	Saturday	12:17 PM	Angle	Daylight	Clear	Dry	Failed to yield right of way	Non-fatal injury	16	54	53	V1 headed southbound on Greenfield Rd; V2 traveling NB on Greenfield Rd. V1 attempts to turn left onto N Main St and V2 collides with passenger side front of V1. Following this collision, V1 collides with V3 which was stopped at the stop sign on N Main St WB.
3	11/12/19	Tuesday	7:36 AM	Angle	Daylight	Rain	Wet	Failed to yield right of way	No Injury	72	24		V1 traveling NB on Greenfield Rd, V2 traveling WB on N Main to Mill Village. V2 pulls into Greenfield Rd and brakes, resulting in a collision.

4	12/11/19	Wednesday	5:06 PM	Angle	Dark - roadway not lighted	Clear	Dry	Failed to yield right of way	No Injury	24	54		V2 traveling NB on Greenfield Rd, V1 traveling SB on Greenfield Rd. V1 attempts to turn left onto N Main Street and collides with V2. Operator of V1 claims she does not see V2, and operator of V2 claims that V1 cut them off as V1 was attempting to turn.
5	07/10/20	Friday	9:51 PM	Single vehicle crash	Dark - lighted roadway	Clear	Dry	Physical impairment	No Injury	27			V1 traveling NB on Greenfield Rd. V1 attempts a left turn onto Mill Village Road, but fails to complete the turn and leaves the right side of the roadway. Operator of V1 arrested for OUI.
6	09/07/20	Monday	5:27 PM	Angle	Daylight	Clear	Dry	Inattention	No Injury	62	51		V2 attempts left turn from Greenfield Rd NB onto Mill Village Road. V1 attempts same turn at same time and collides with the driver's side rear of V2.

7	10/04/20	Sunday	3:30 PM	Angle	Daylight	Clear	Dry	Failed to yield right of way	Non-fatal injury	24	57		V1 traveling WB stopped on North Main Street. MC1 (motorcycle) traveling SB on Greenfield Rd. V1 attempts to cross WB from North Main to Mill Village and is struck by MC1 heading SB on Greenfield Rd.
8	06/08/21	Tuesday	3:08 PM	Angle	Daylight	Cloudy	Dry	Failed to yield right of way	Non-fatal injury	34	56		V1 traveling WB on N Main St; V2 traveling SB on Greenfield Rd. V1 enters intersection to travel to Mill Village Road and collides with driver's side front of V2.
9	08/03/21	Tuesday	1:49 PM	Angle	Daylight	Clear	Dry	Failed to yield right of way	No Injury	17	36	35	V1 traveling NB on Greenfield Rd, V2 traveling SB on Greenfield Rd. V1 attempts to make left turn onto Mill Village Road into the path of V2 and V2 collides with passenger front of V1. Operator of V1 leaves vehicle and it collides with V3 stopped at Mill Village Road EB.

10	08/17/21	Tuesday	2:34 PM	Angle	Daylight	Clear	Dry	Inattention	Non-fatal injury	17	48		V1 attempts to cross WB from North Main Street to Mill Village Road and collided with V2 (tractor-trailer) heading SB on Greenfield Rd after an attempt to avert the crash. Witnesses state that V1 crossed in front of V2 after stopping.
11	05/04/22	Wednesday	8:36 AM	Single vehicle crash	Daylight	Rain	Wet	Failure to keep in proper lane or running off road	No Injury	26			V1 headed NB on North Main Street towards intersection. While bearing left at the curve, V1 leaves the roadway and strikes the guardrail due to rainy conditions. Police report states that speed was not a contributing factor.
12	07/20/22	Wednesday	3:58 PM	Angle	Daylight	Cloudy	Dry	Failed to yield right of way	Non-fatal injury	86	40	34	V1 attempts to cross WB from North Main to Mill Village and strikes V2 heading NB on Greenfield Rd. After this impact, V2 skids into the SB lane of Greenfield Rd and collides with V3 heading SB.

13	05/23/23	Tuesday	4:47 PM	Angle	Daylight	Clear	Dry	Failed to yield right of way	Non-fatal injury	16	41		V2 traveling SB on Greenfield Rd; V1 traveling WB from N Main Street to Mill Village Road. V1 attempts to navigate around a third uninvolved vehicle attempting to turn right onto Greenfield Rd NB and travels through the intersection, colliding with V2. Operator of V1 states that visibility was obstructed by third uninvolved vehicle before collision.
14	07/07/23	Friday	9:51 AM	Rear-end	Daylight	Clear	Dry	Inattention	No Injury	39	49		V1 and V2 traveling WB on North Main Street and stopped at stop sign. V1 begins to enter intersection to turn right onto Greenfield Rd, then stops. V2 fails to stop and rear-ends V1.
15	07/11/23	Tuesday	4:59 PM	Angle	Daylight	Clear	Dry	Inattention	No Injury	31	38		V1 traveling WB from North Main Street to Mill Village Road; V2 traveling SB on Greenfield Rd. V1 attempts to cross the intersection to Mill Village Road and strikes V2 in the driver's side front. Operator of V1 states that they did not see V2.

16	08/09/23	Wednesday	4:28 PM	Angle	Daylight	Clear	Dry	Failed to yield right of way	No Injury	74	Unknown		V1 traveling SB on Greenfield Rd; V2 traveling NB. V2 executes U-turn to travel SB and strikes driver's side rear of V1. V1 left the scene.

#	mm/dd/yy	Day	hh:mm	Type	Type	Type	Type	Type	Type	#	#	#	
17	09/26/23	Tuesday	2:39 PM	Angle	Daylight	Clear	Dry	Failure to keep in proper lane or running off road	No Injury	67	45		V1 traveling EB from Mill Village Road to N Main St; V2 traveling SB on Greenfield Rd. V2 attempts to pass queue of left-turning vehicles in order to continue south on Greenfield Rd while V1 is completing navigation of intersection. V2 strikes passenger side rear of V1.
18	10/20/23	Friday	3:27 PM	Angle	Daylight	Rain	Wet	Failed to yield right of way	No Injury	71	24		V2 traveling SB on Greenfield Rd, V1 traveling WB from North Main Street to Mill Village Road. Other motorist on Greenfield Rd SB had stopped to allow V1 into intersection; V2 navigates around stopped vehicle and collides with V1 passenger side. The impact pushes V1 into the stop sign on Mill Village Road. Courtesy crash.
