Update on Bloody Brook and Sugarloaf Brook Watershed Analysis

Town of Deerfield

Municipal Vulnerability Preparedness (MVP)
Core Group Meeting

May 7, 2025

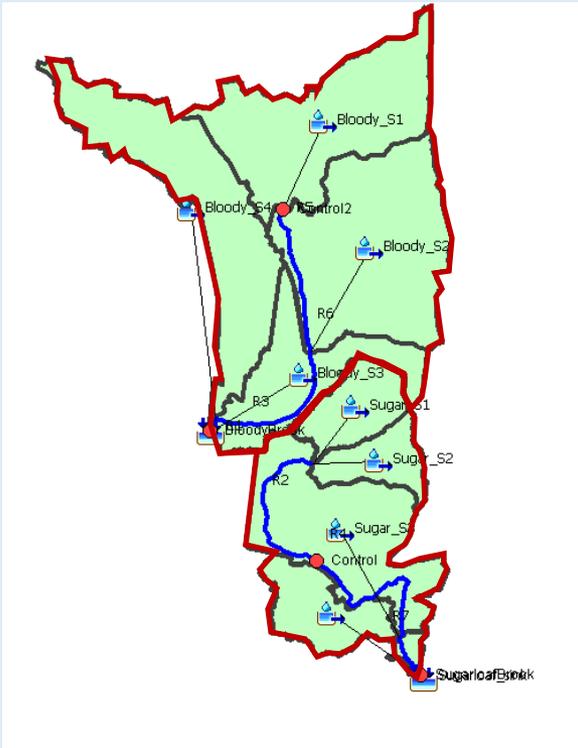
Hydrologic Model

Hydrology - Estimate inflow to Site from the watershed

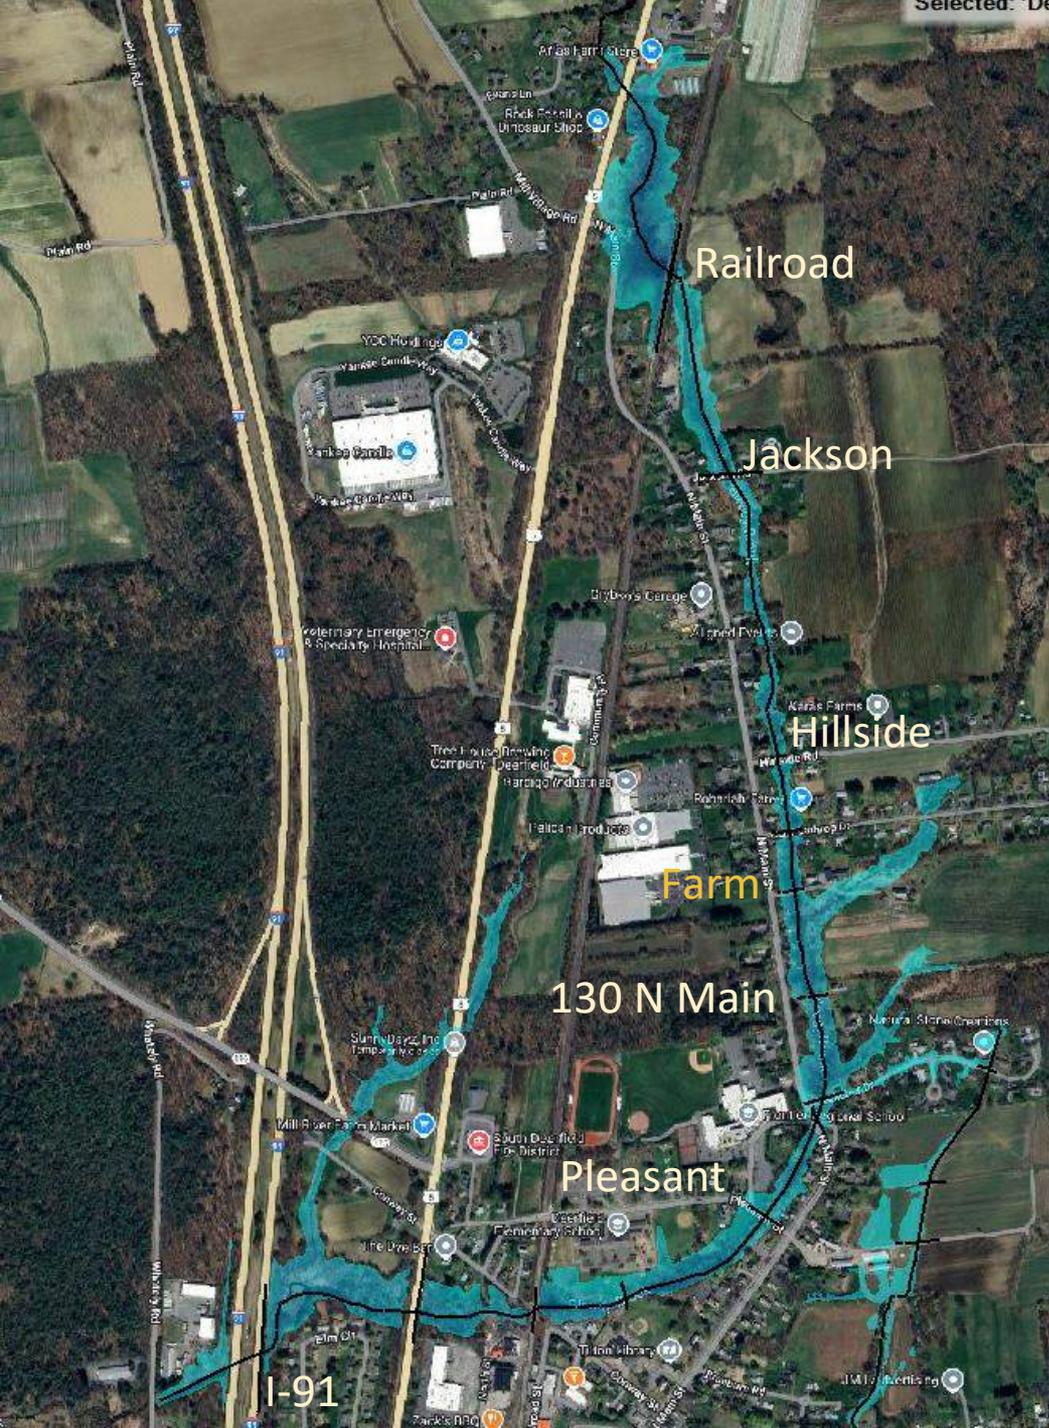
Bloody Brook

25-year flow event

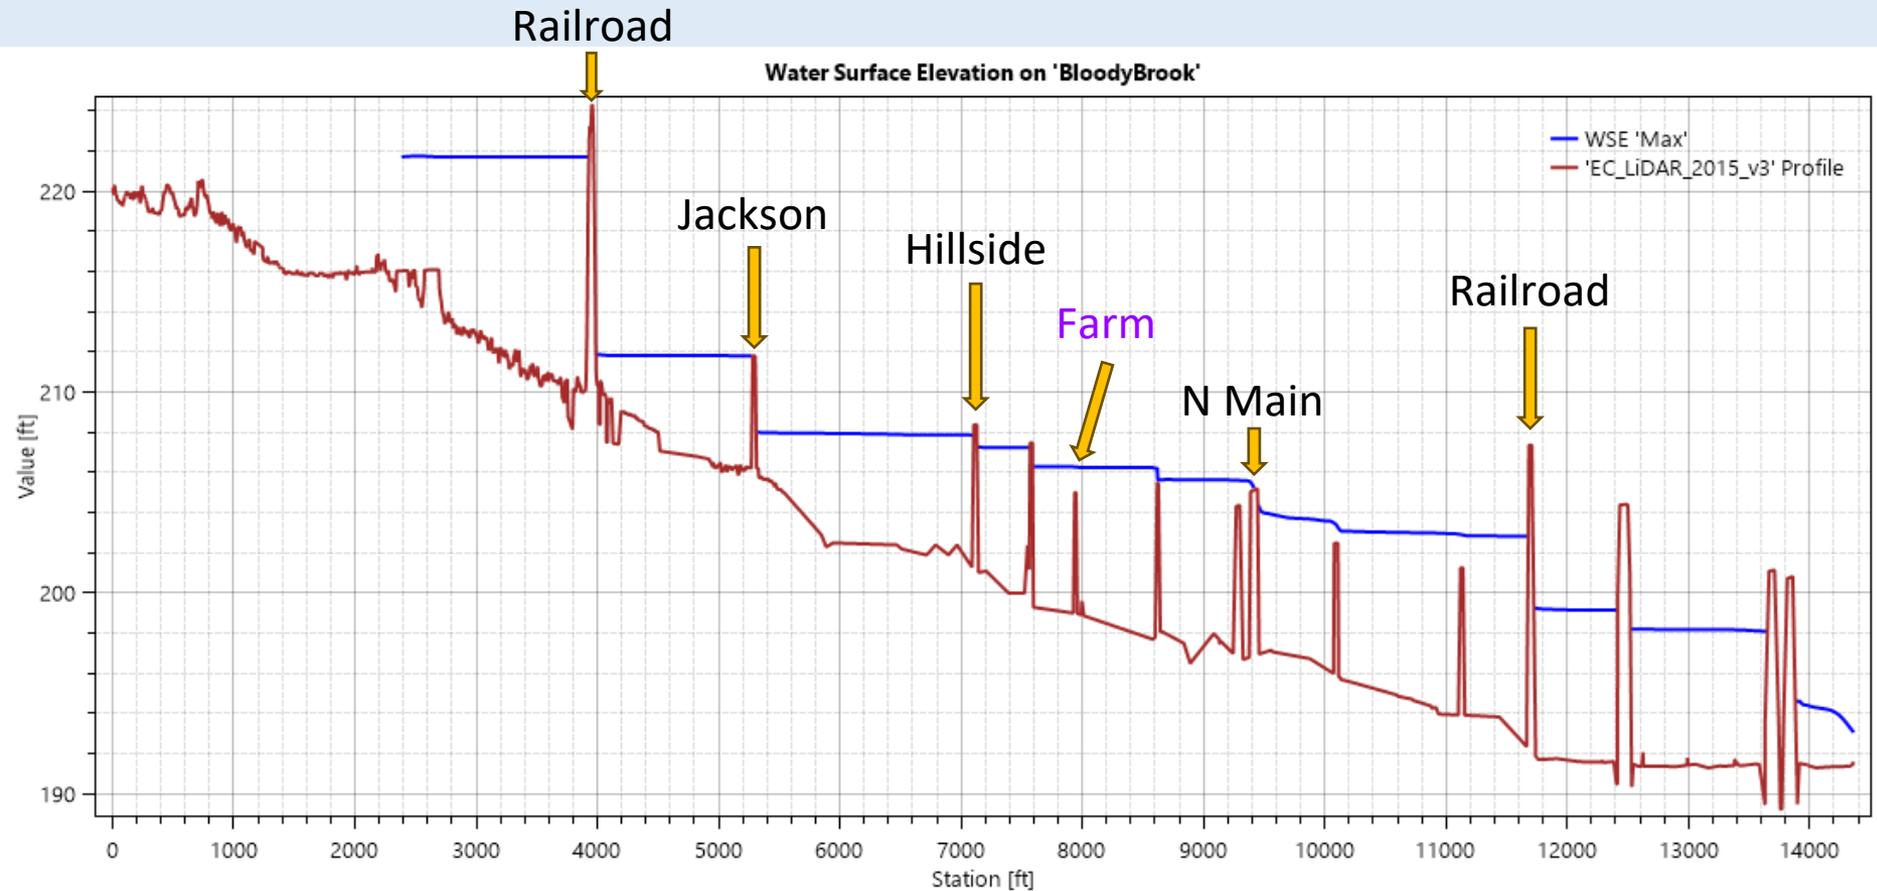
Longitudinal Stream Profile

Present 100-year flow event

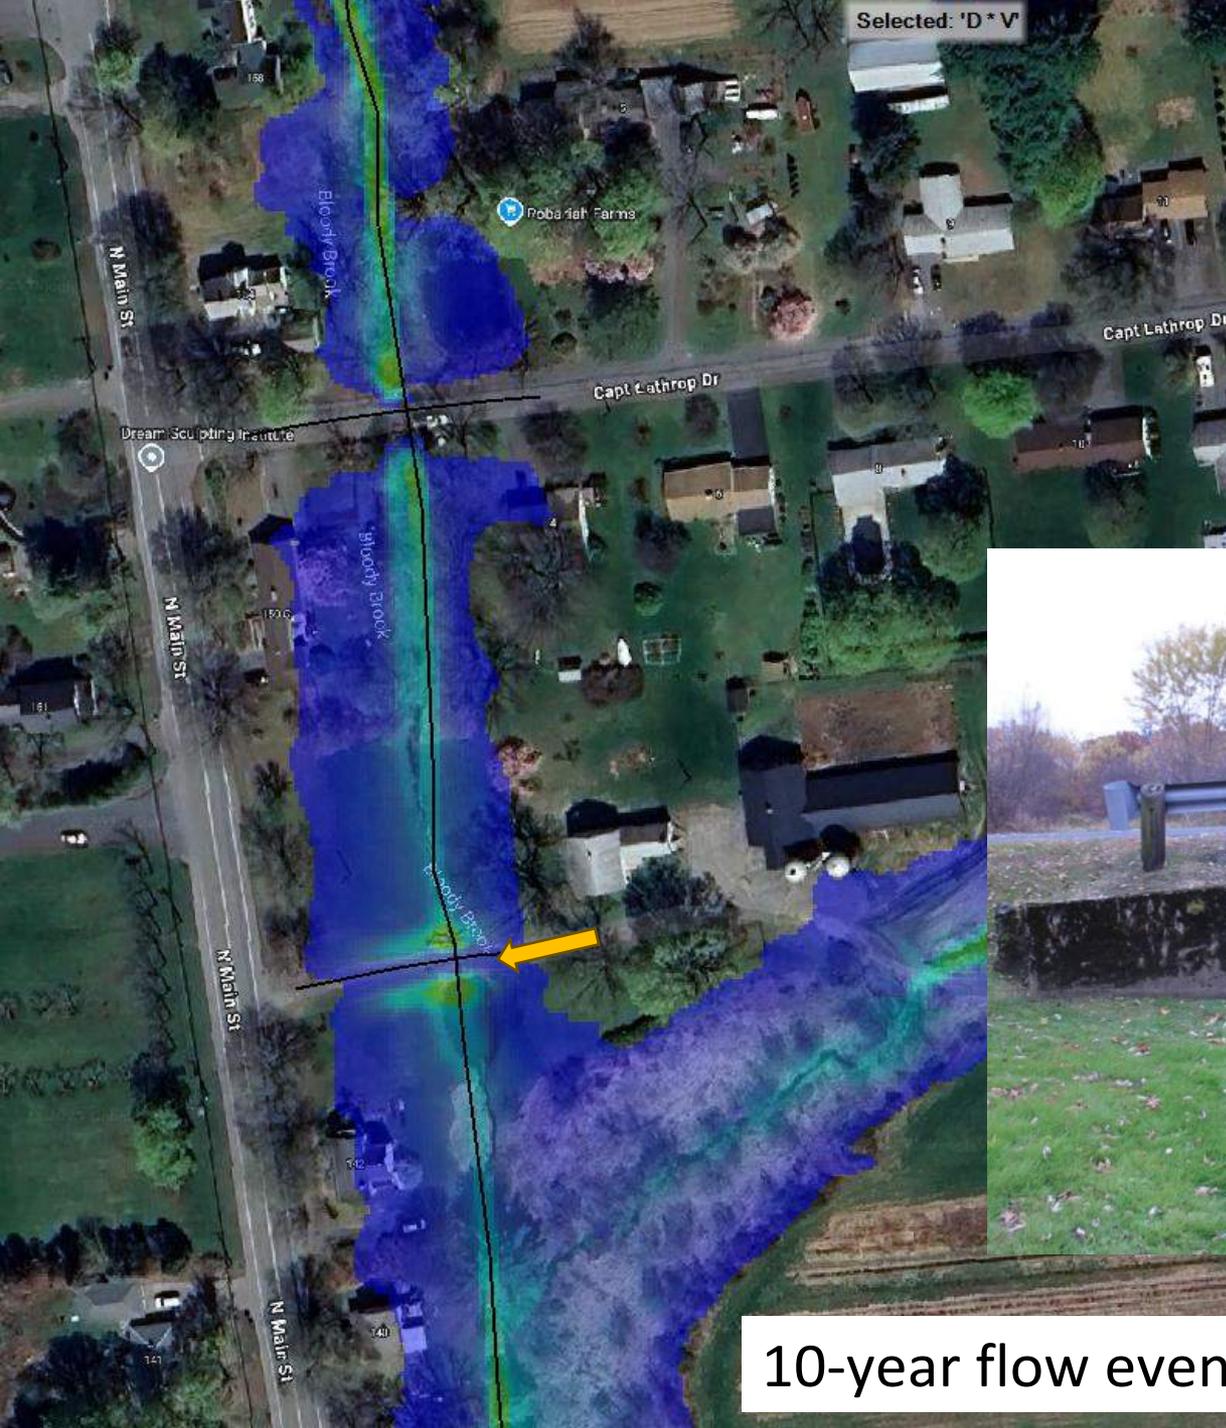
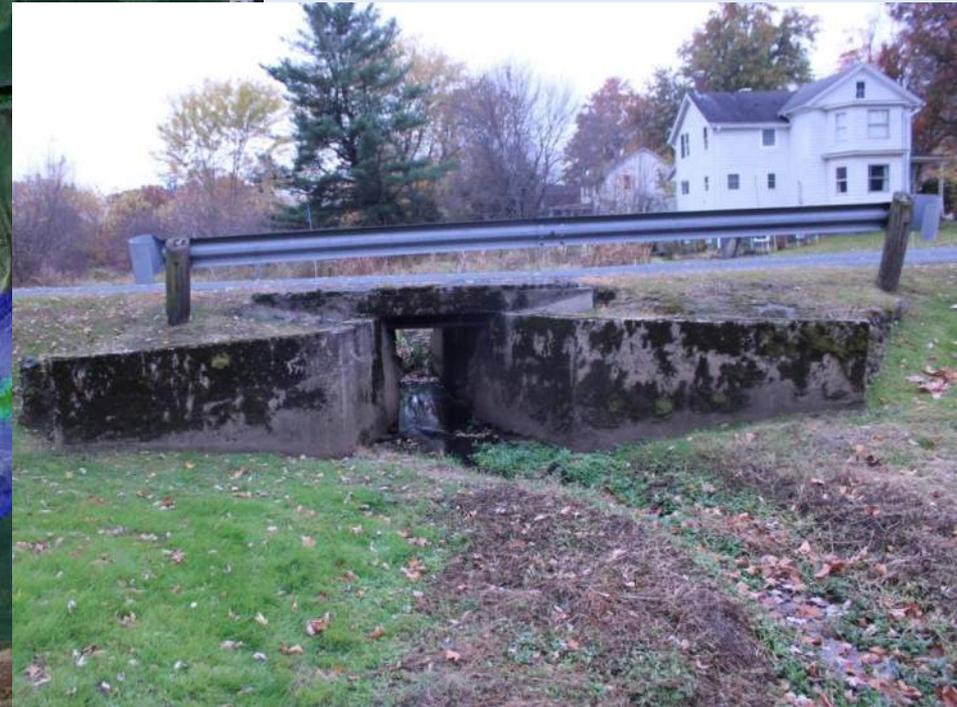
Private Drive Bloody Brook Farm

10-year flow event

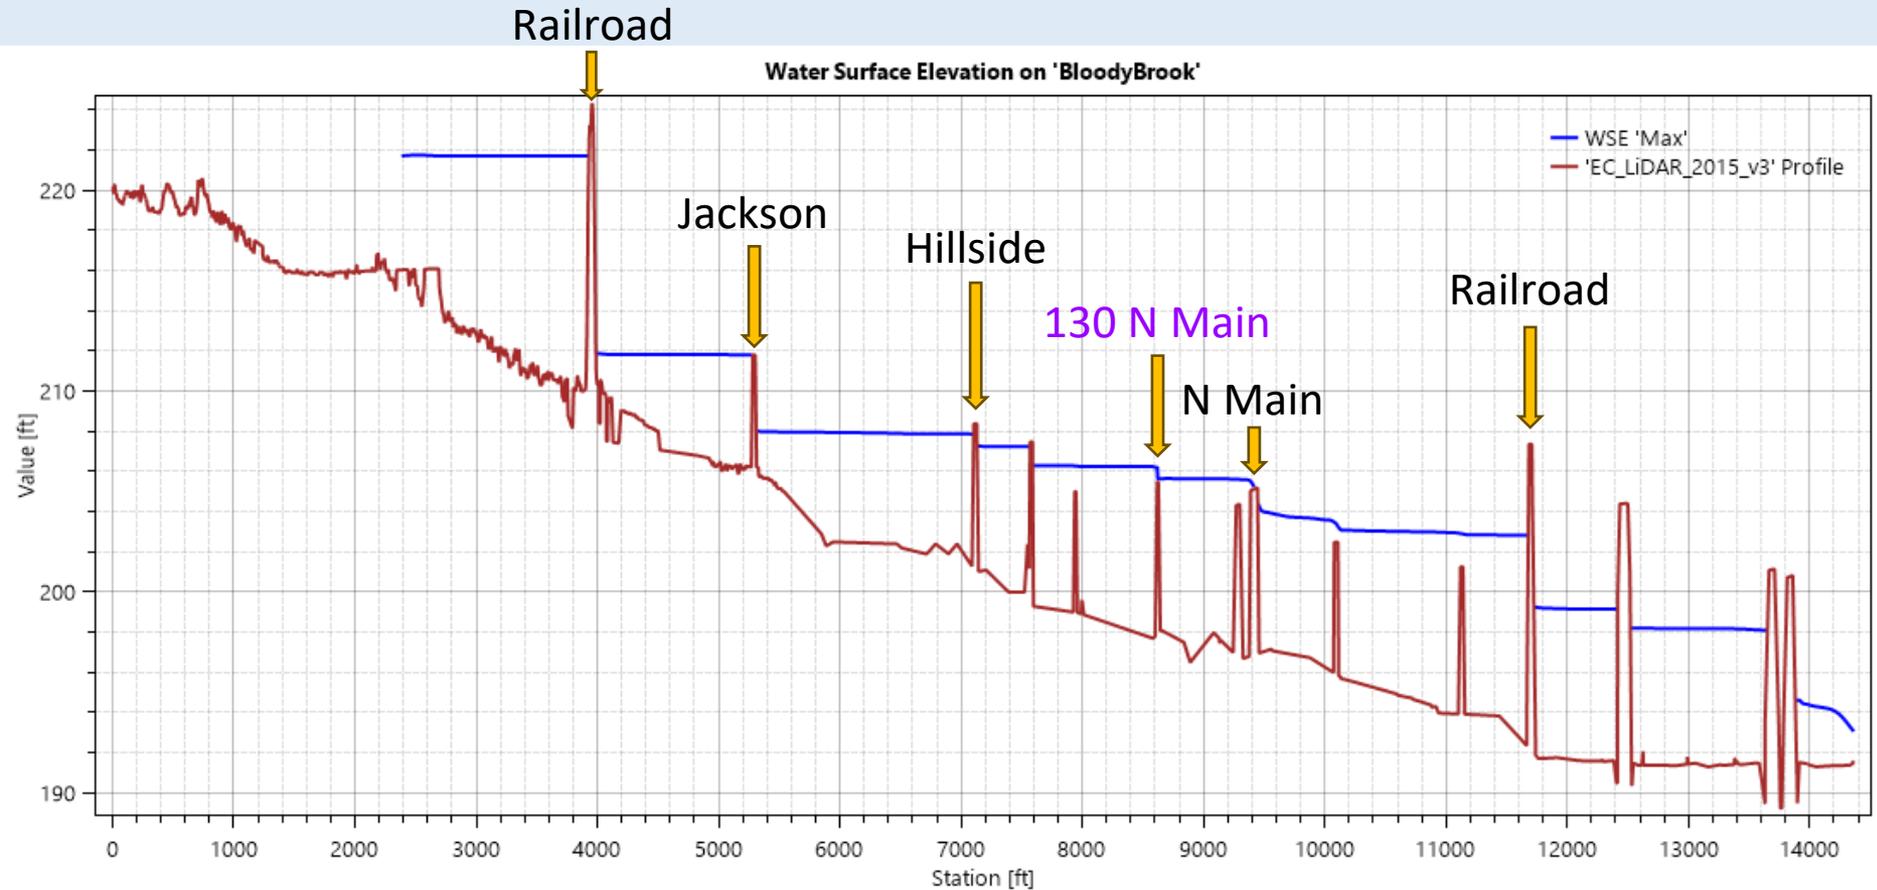
Longitudinal Stream Profile

Present 100-year flow event

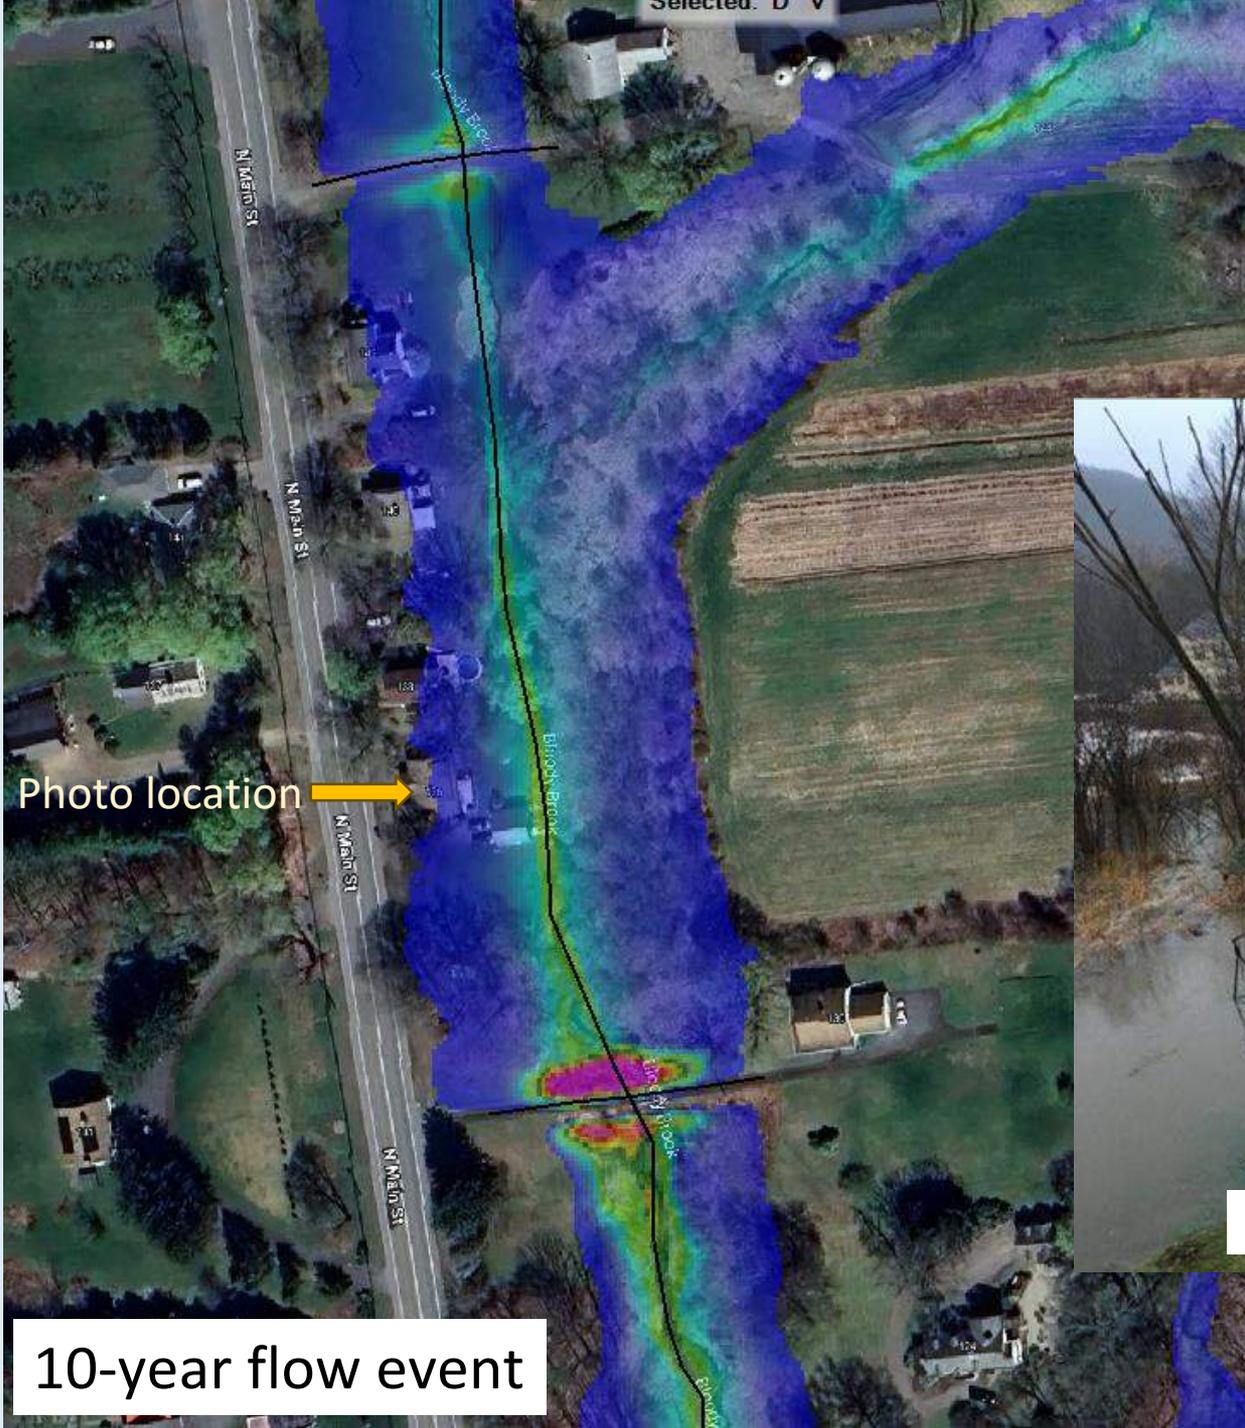
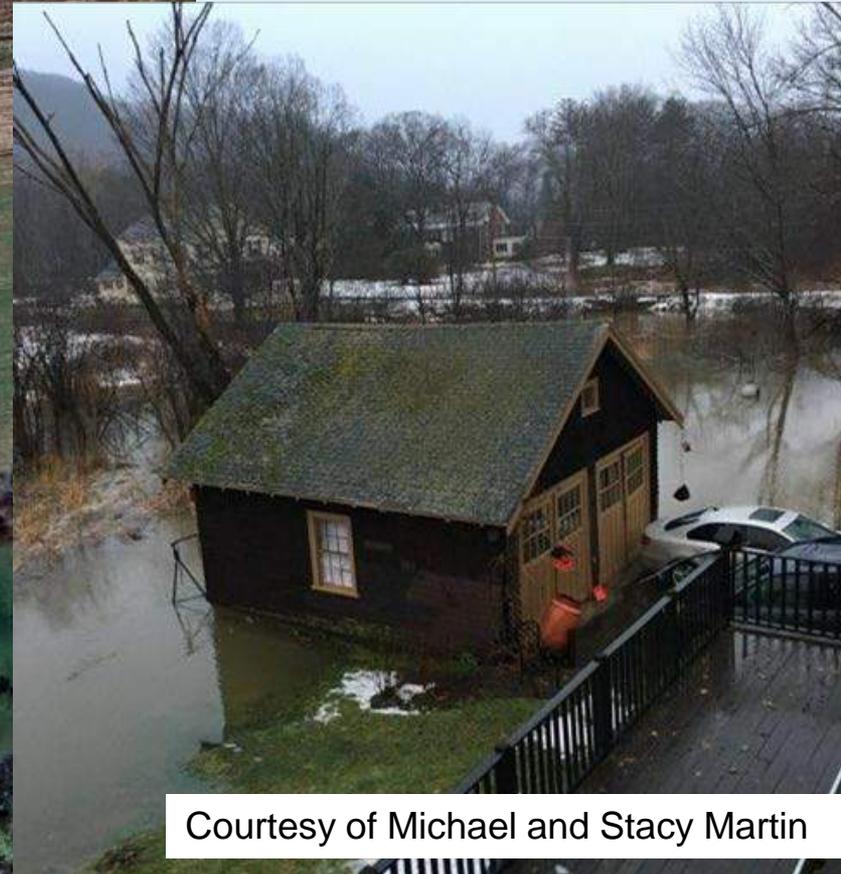
Private Drive 130 N. Main St

Photo location

10-year flow event

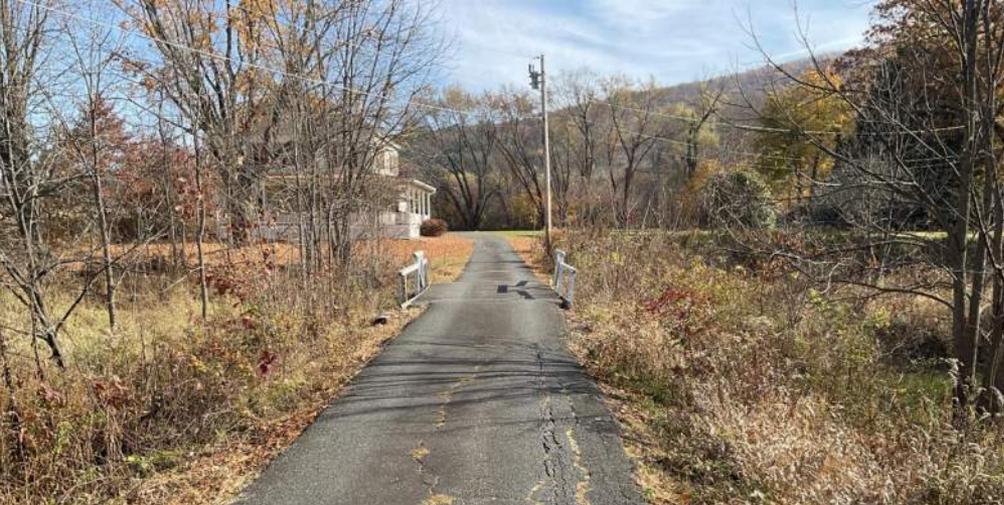
Private Drive 130 N. Main St

Cross-Section Name in HEC RAS	Distance Upstream from Bloody Brook outlet (mi)	Min. Top of Road Elevation	Average Maximum Value in Cross Section	Flood Return Period															
				Present							Late Century (2090)								
				1yr	2yr	5yr	10yr	25yr	50yr	100yr	500yr	1yr	2yr	5yr	10yr	25yr	50yr	100yr	500yr
130N Main St Driveway	1.1	205.0	WSE (ft)	205.6	205.7	205.8	205.9	206.0	206.0	206.3	207.2	205.8	205.9	206.1	206.0	206.9	207.2	207.4	208.0
			Overtopping Depth (ft)	0.6	0.7	0.8	0.8	1.0	1.0	1.2	2.2	0.8	0.9	1.0	0.9	1.9	2.1	2.3	3.0
			Velocity (ft/s)	5.3	5.5	5.6	6.0	4.4	6.1	5.9	5.9	5.6	5.7	5.7	5.7	5.9	5.9	5.9	5.8
			DV (ft ² /s)	2	3	3	3	4	4	4	4	3	3	4	3	4	4	4	5

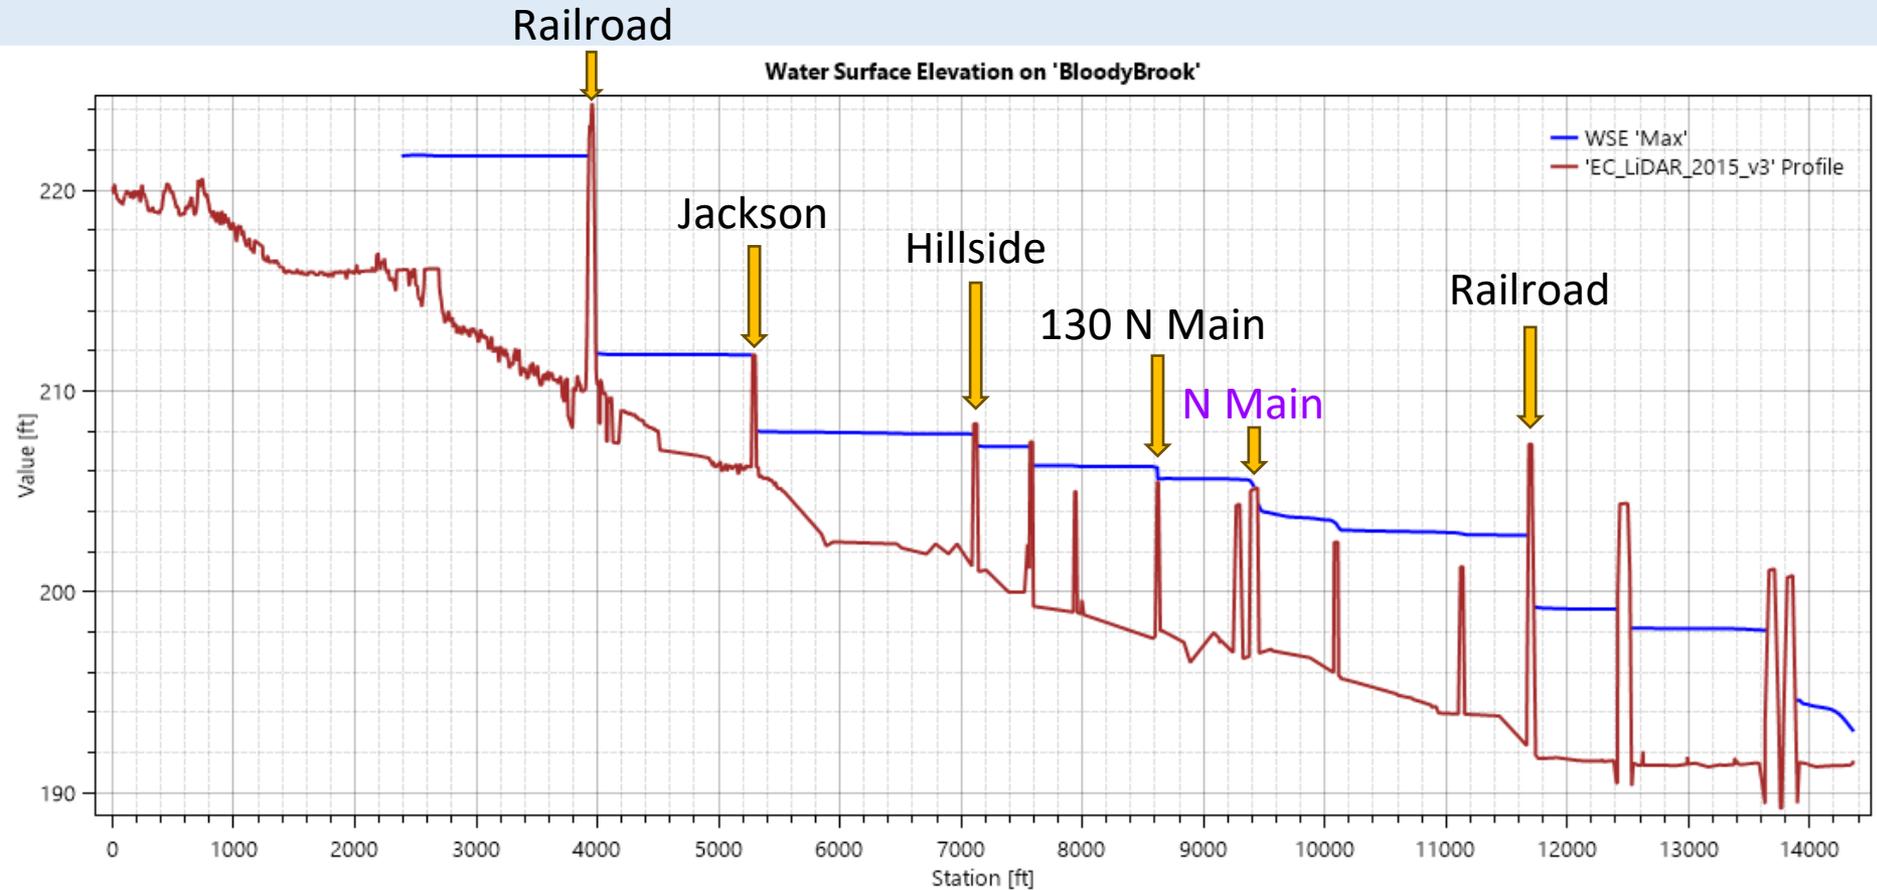
Longitudinal Stream Profile

Present 100-year flow event

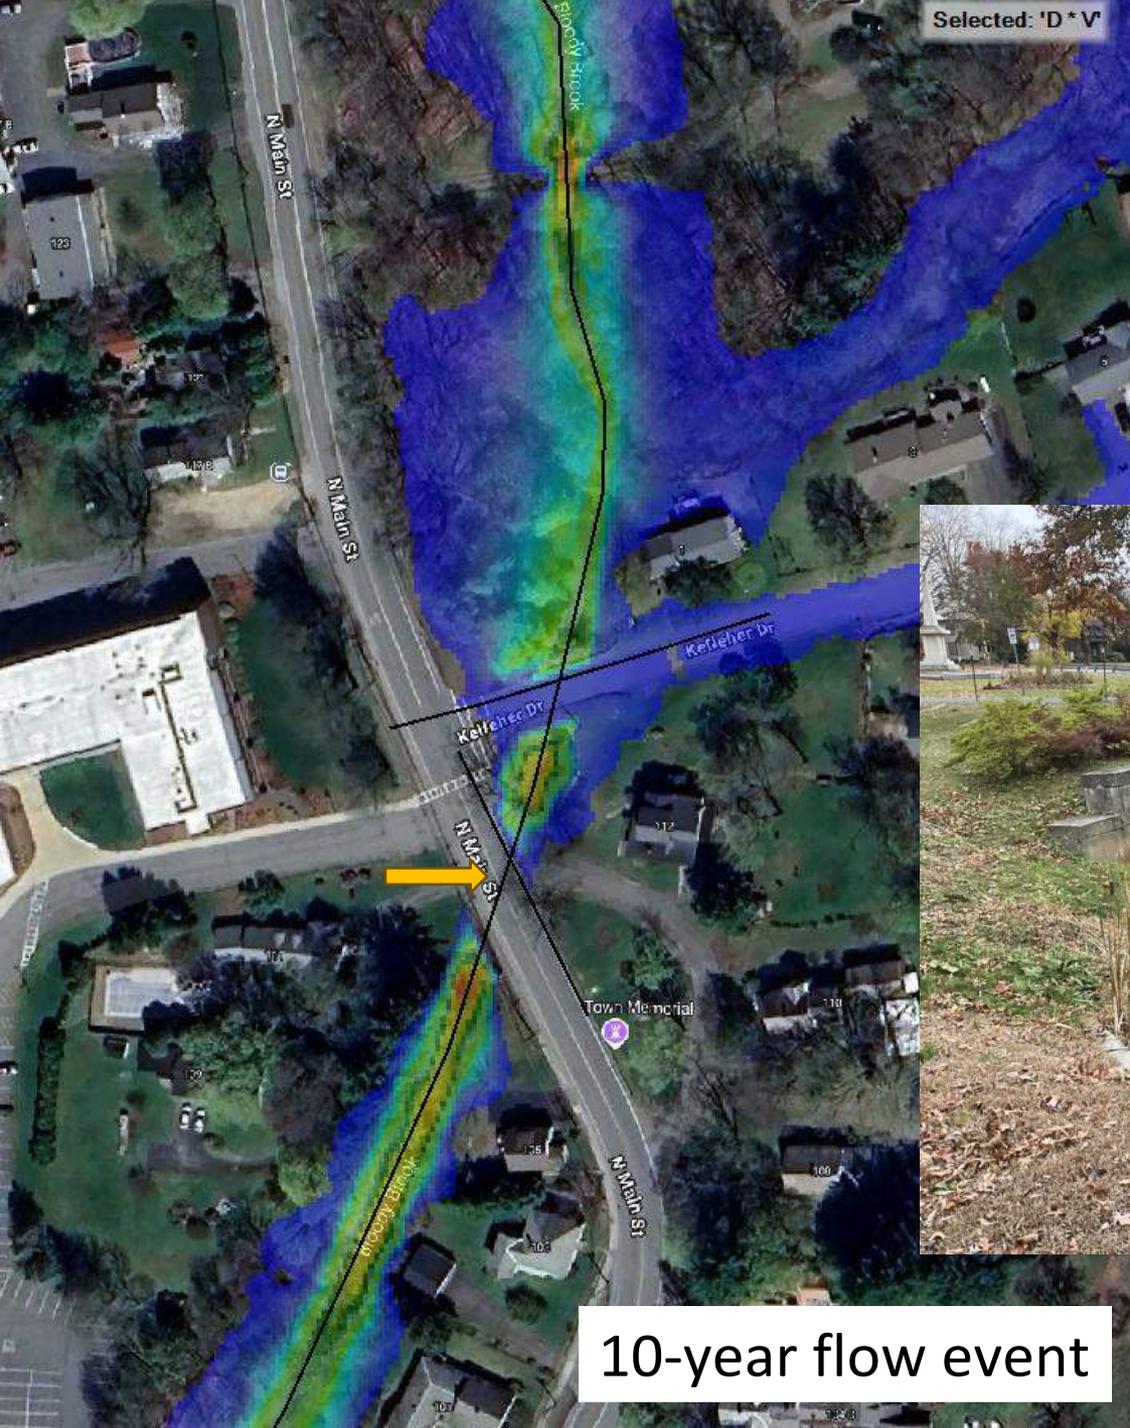
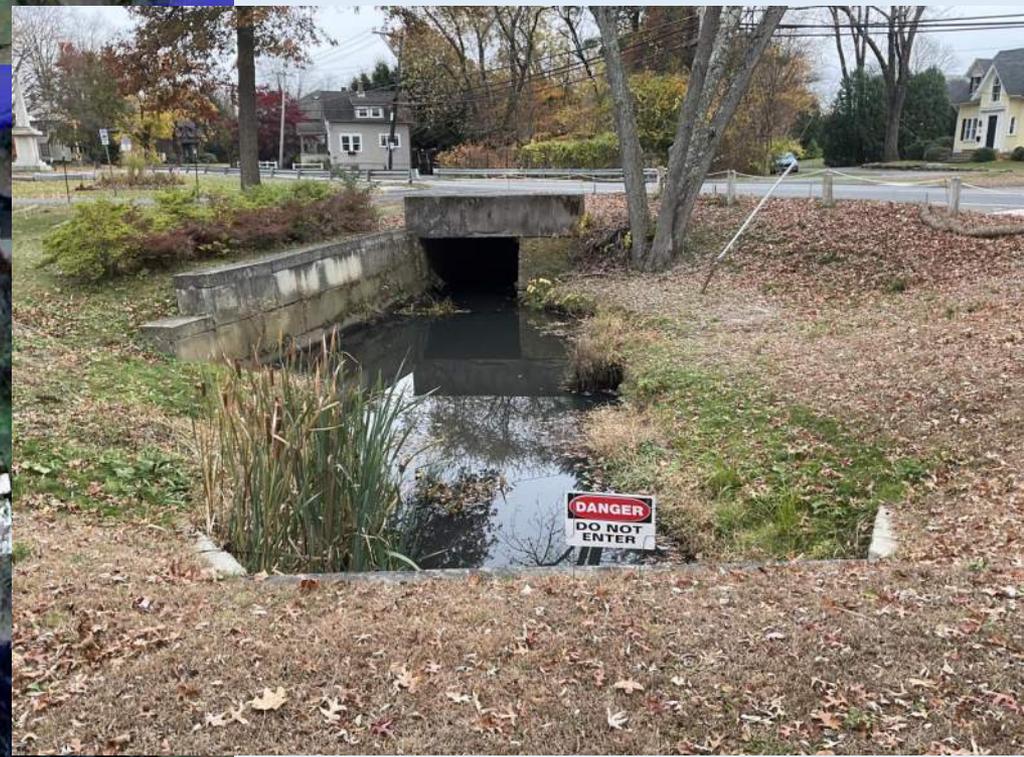
N. Main St culvert

Selected: 'D * V'

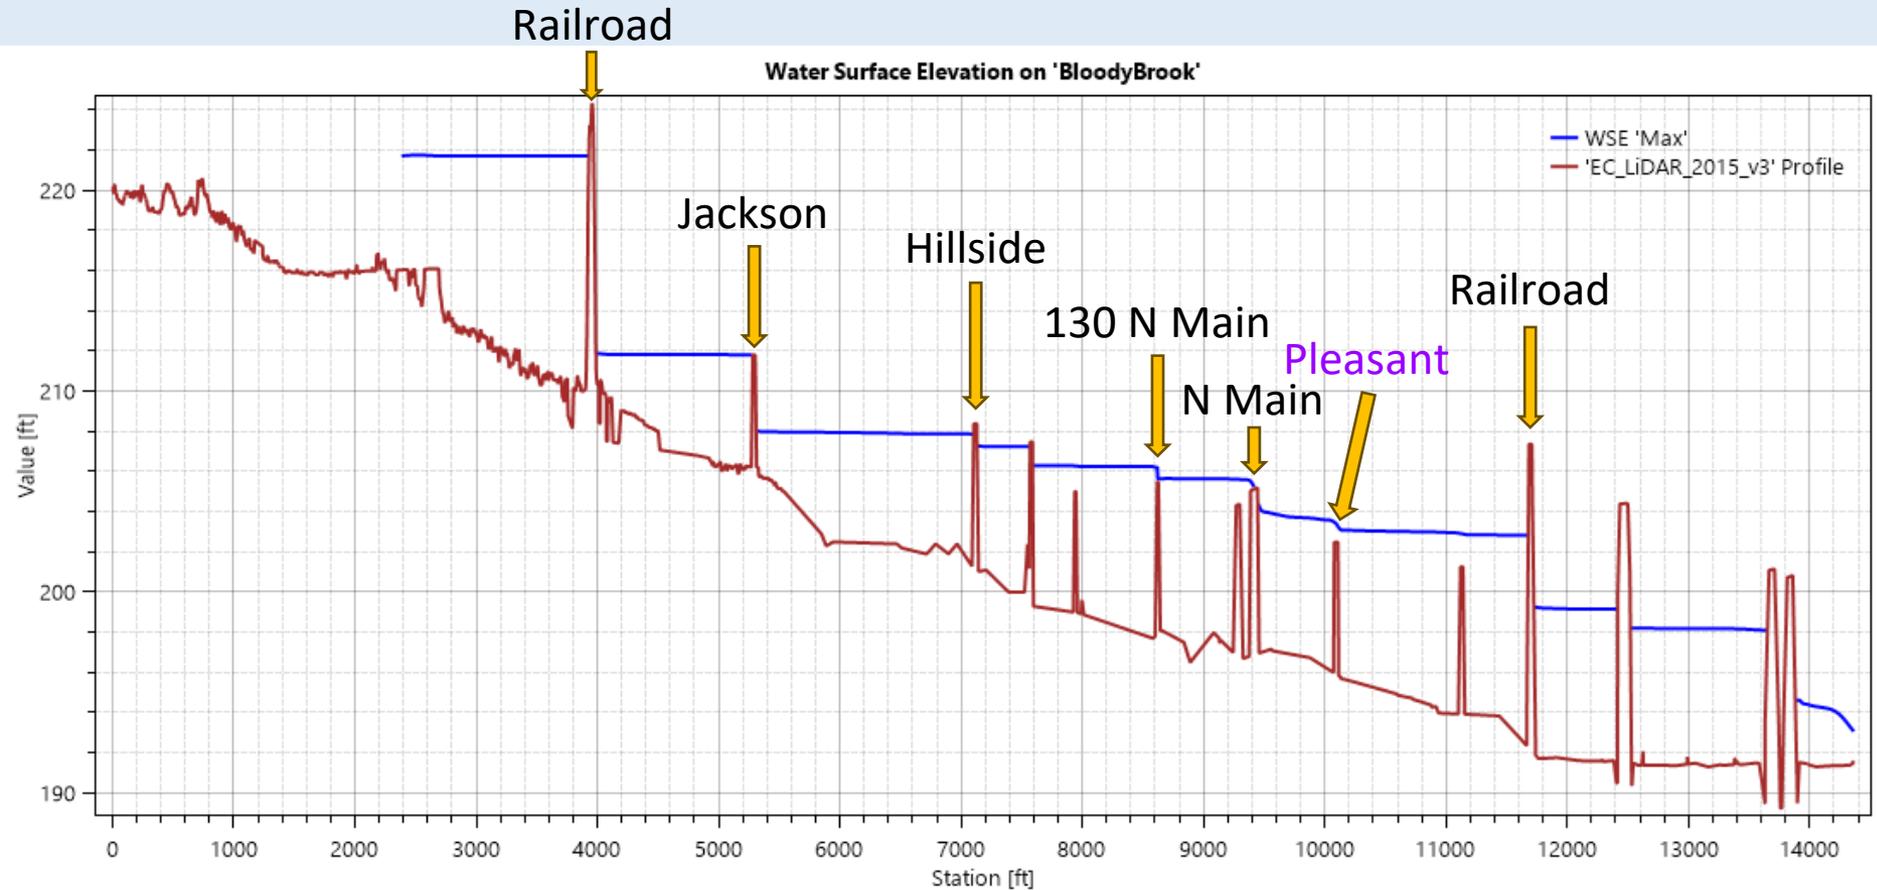
Longitudinal Stream Profile

Present 100-year flow event

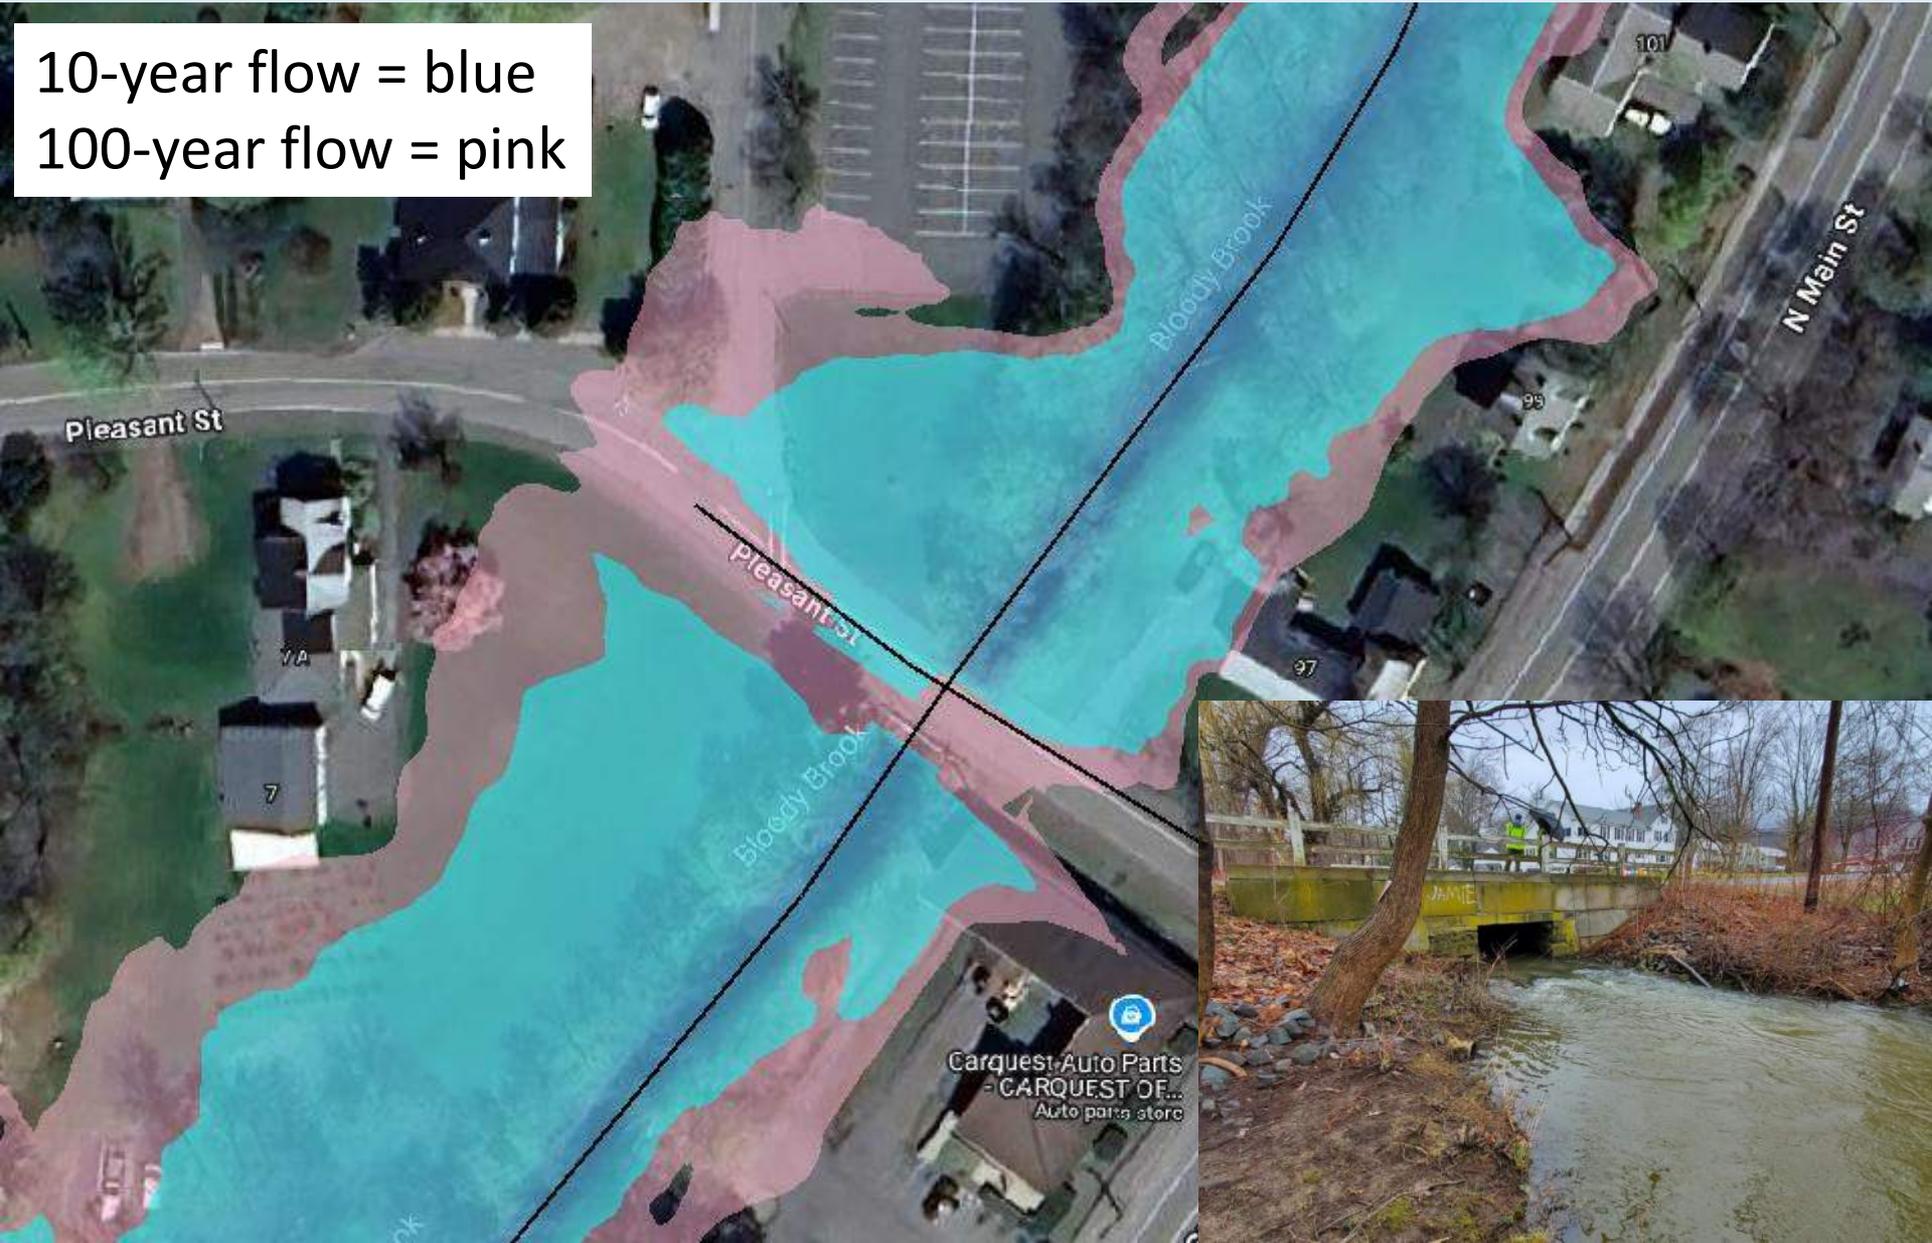
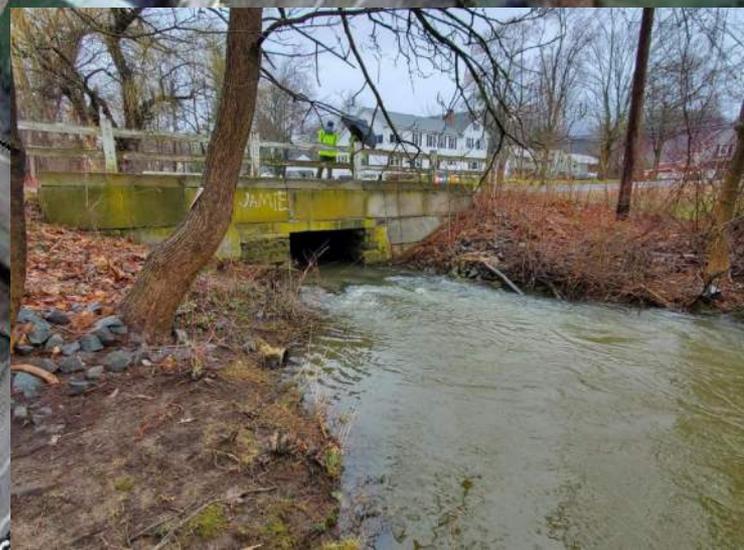
Pleasant St culvert

10-year flow = blue
100-year flow = pink

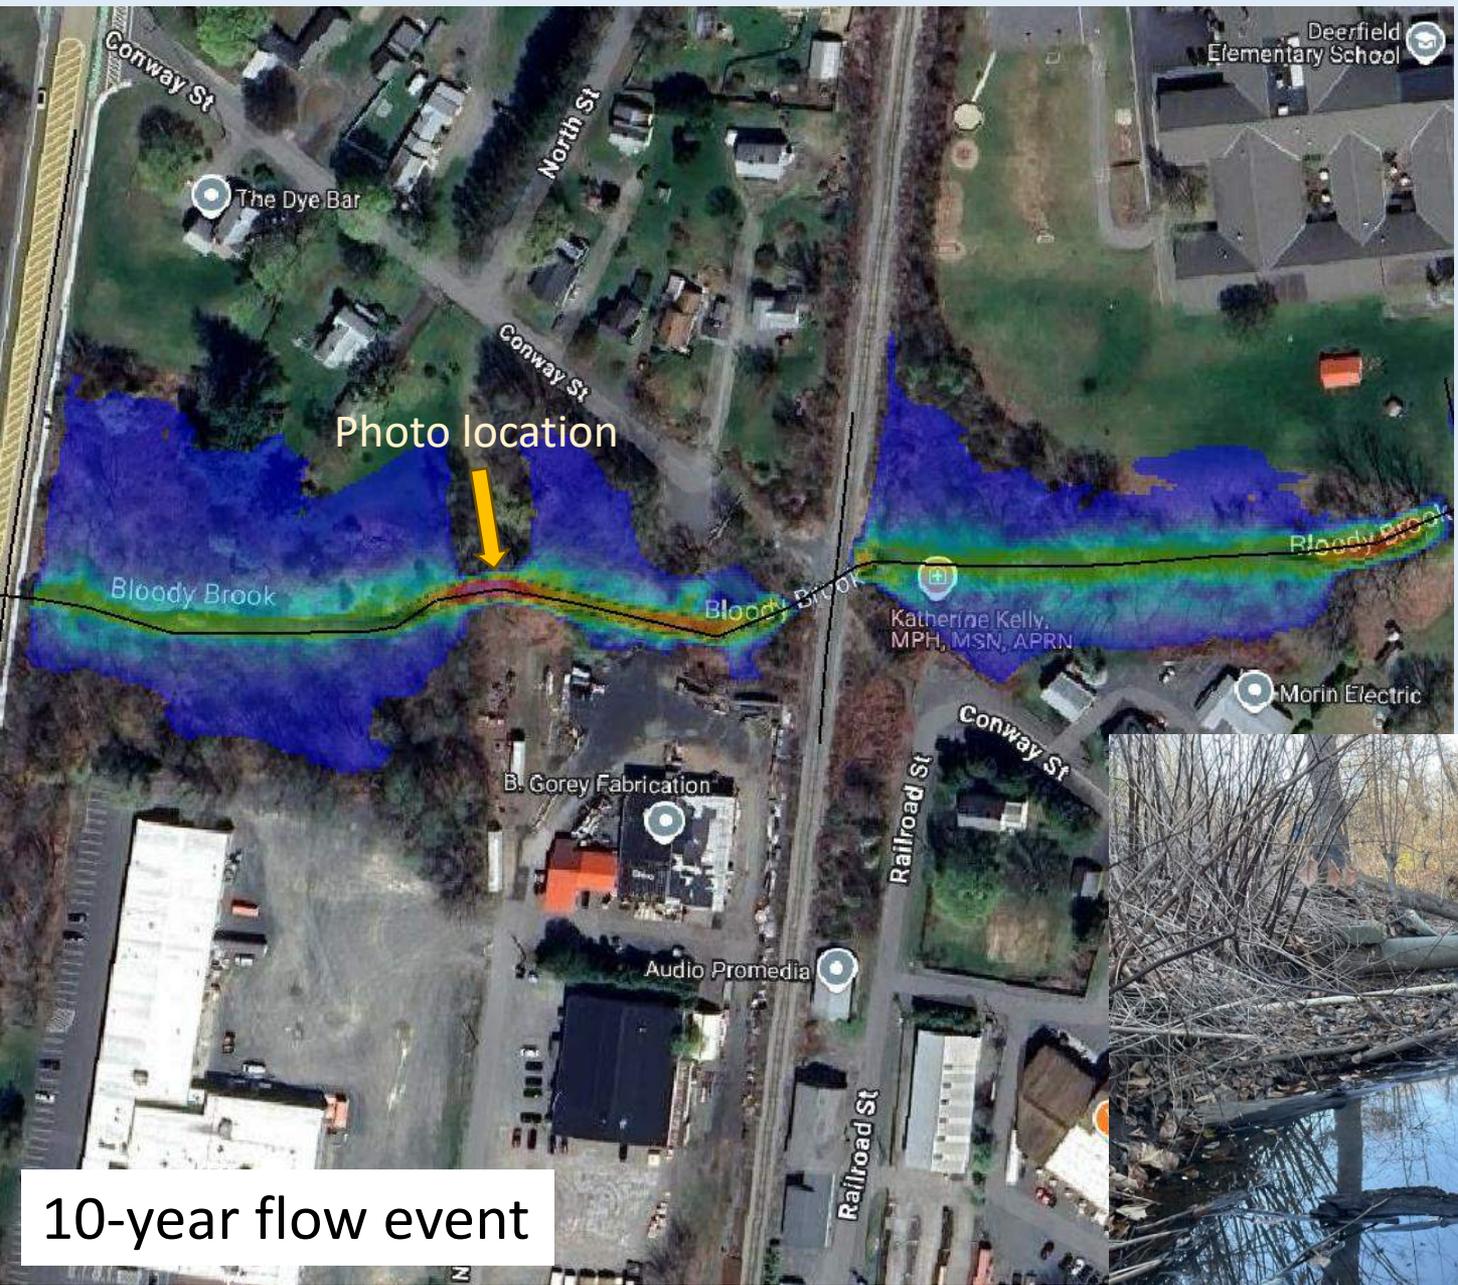
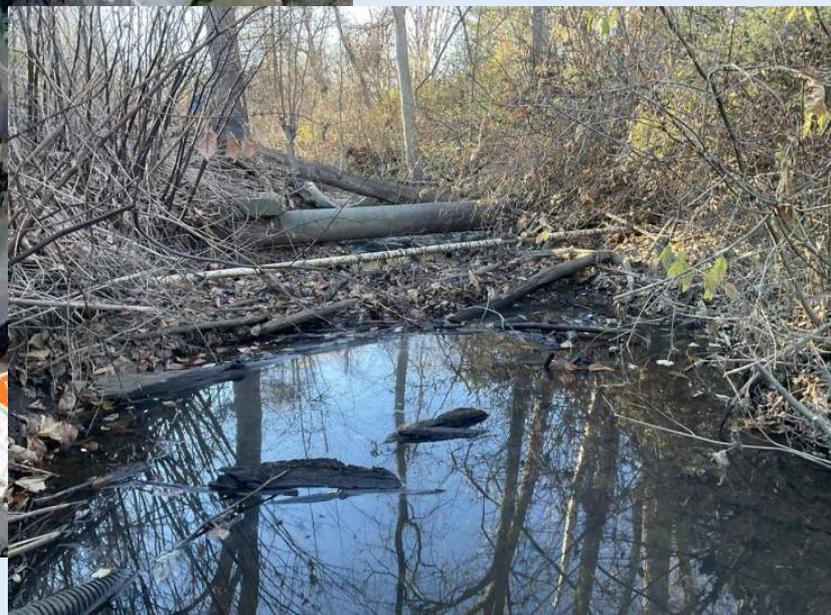
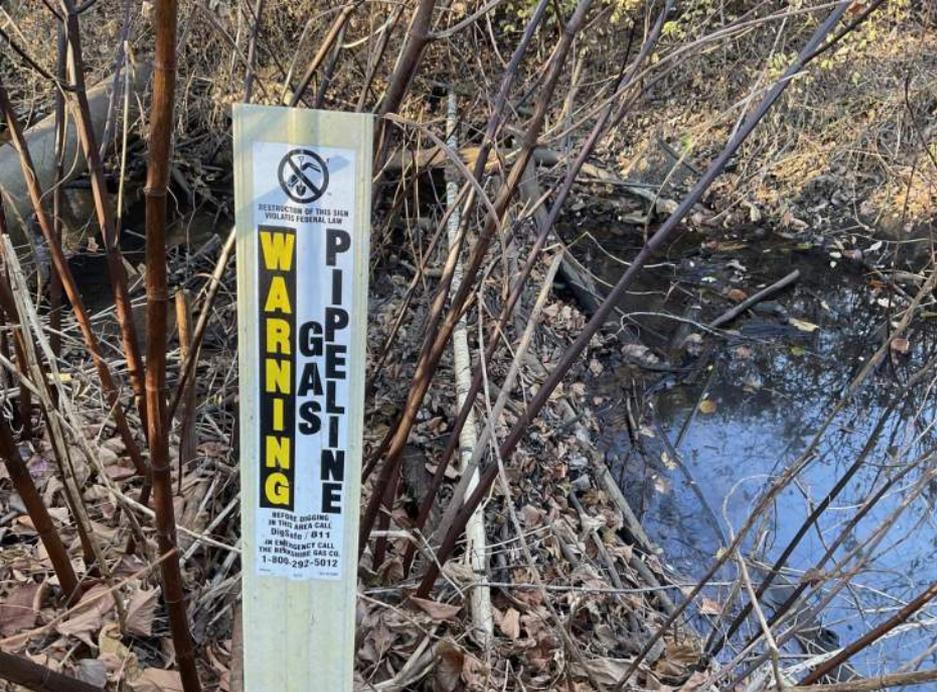
North St Crossing

10-year flow event
