Update on Bloody Brook and Sugarloaf Brook Watershed Analysis

Town of Deerfield

Municipal Vulnerability Preparedness (MVP)
Core Group Meeting

May 7, 2025

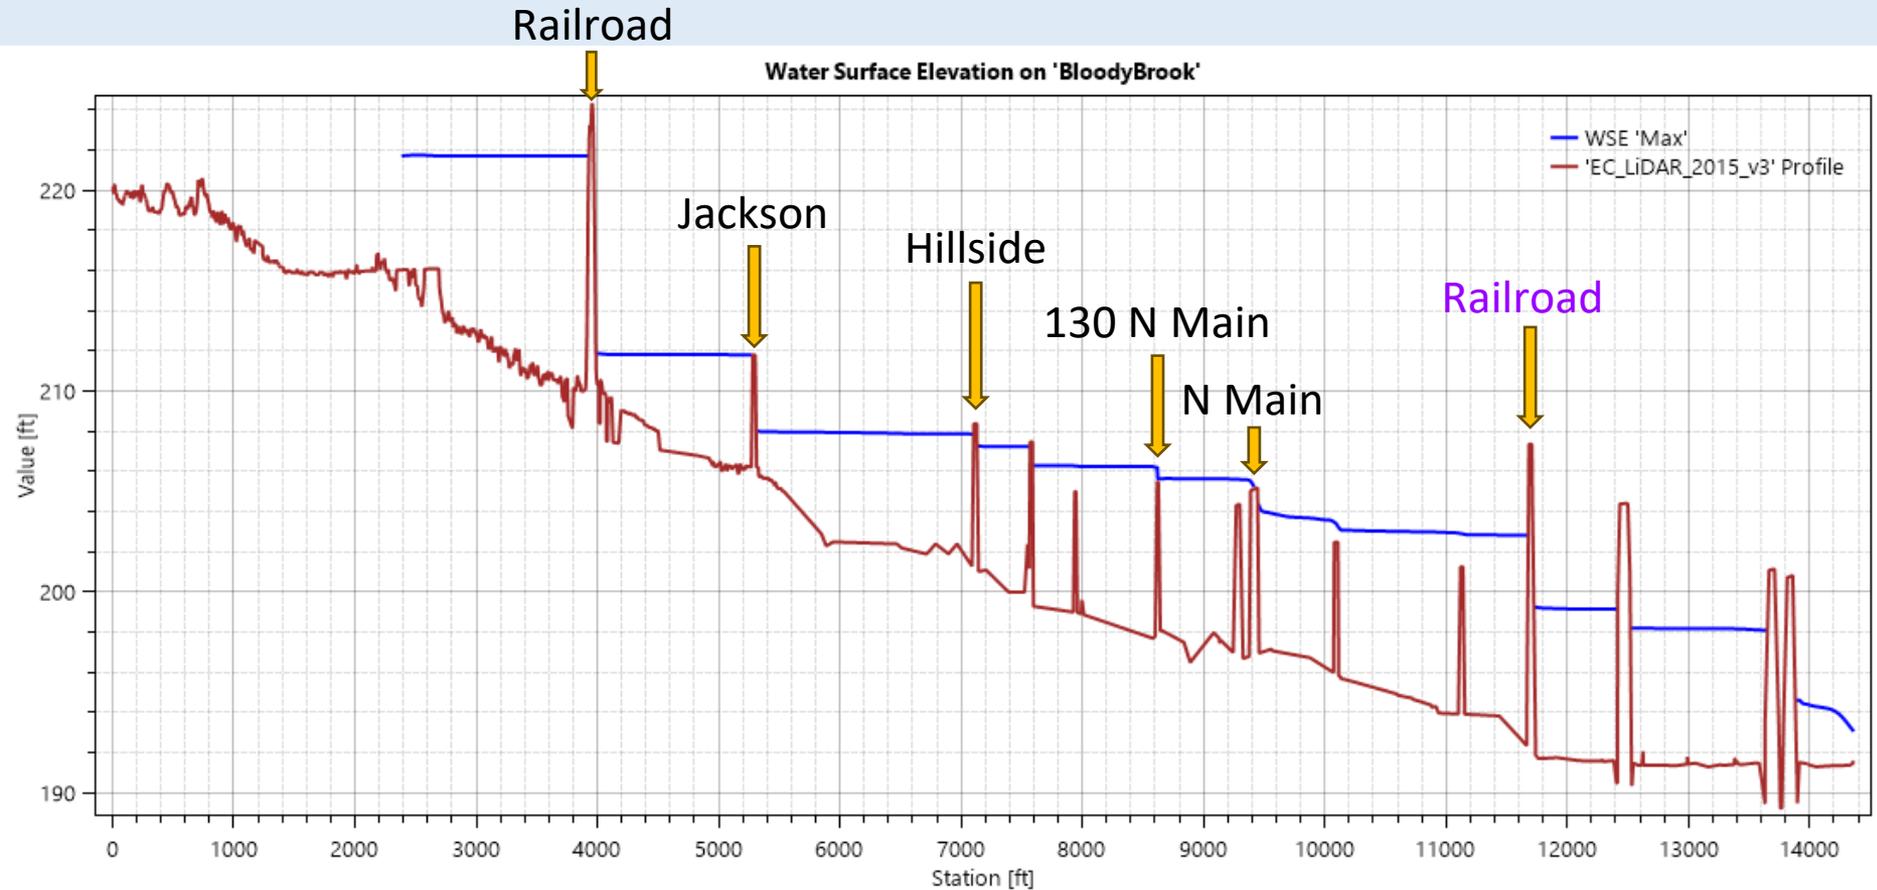
Longitudinal Stream Profile

Present 100-year flow event

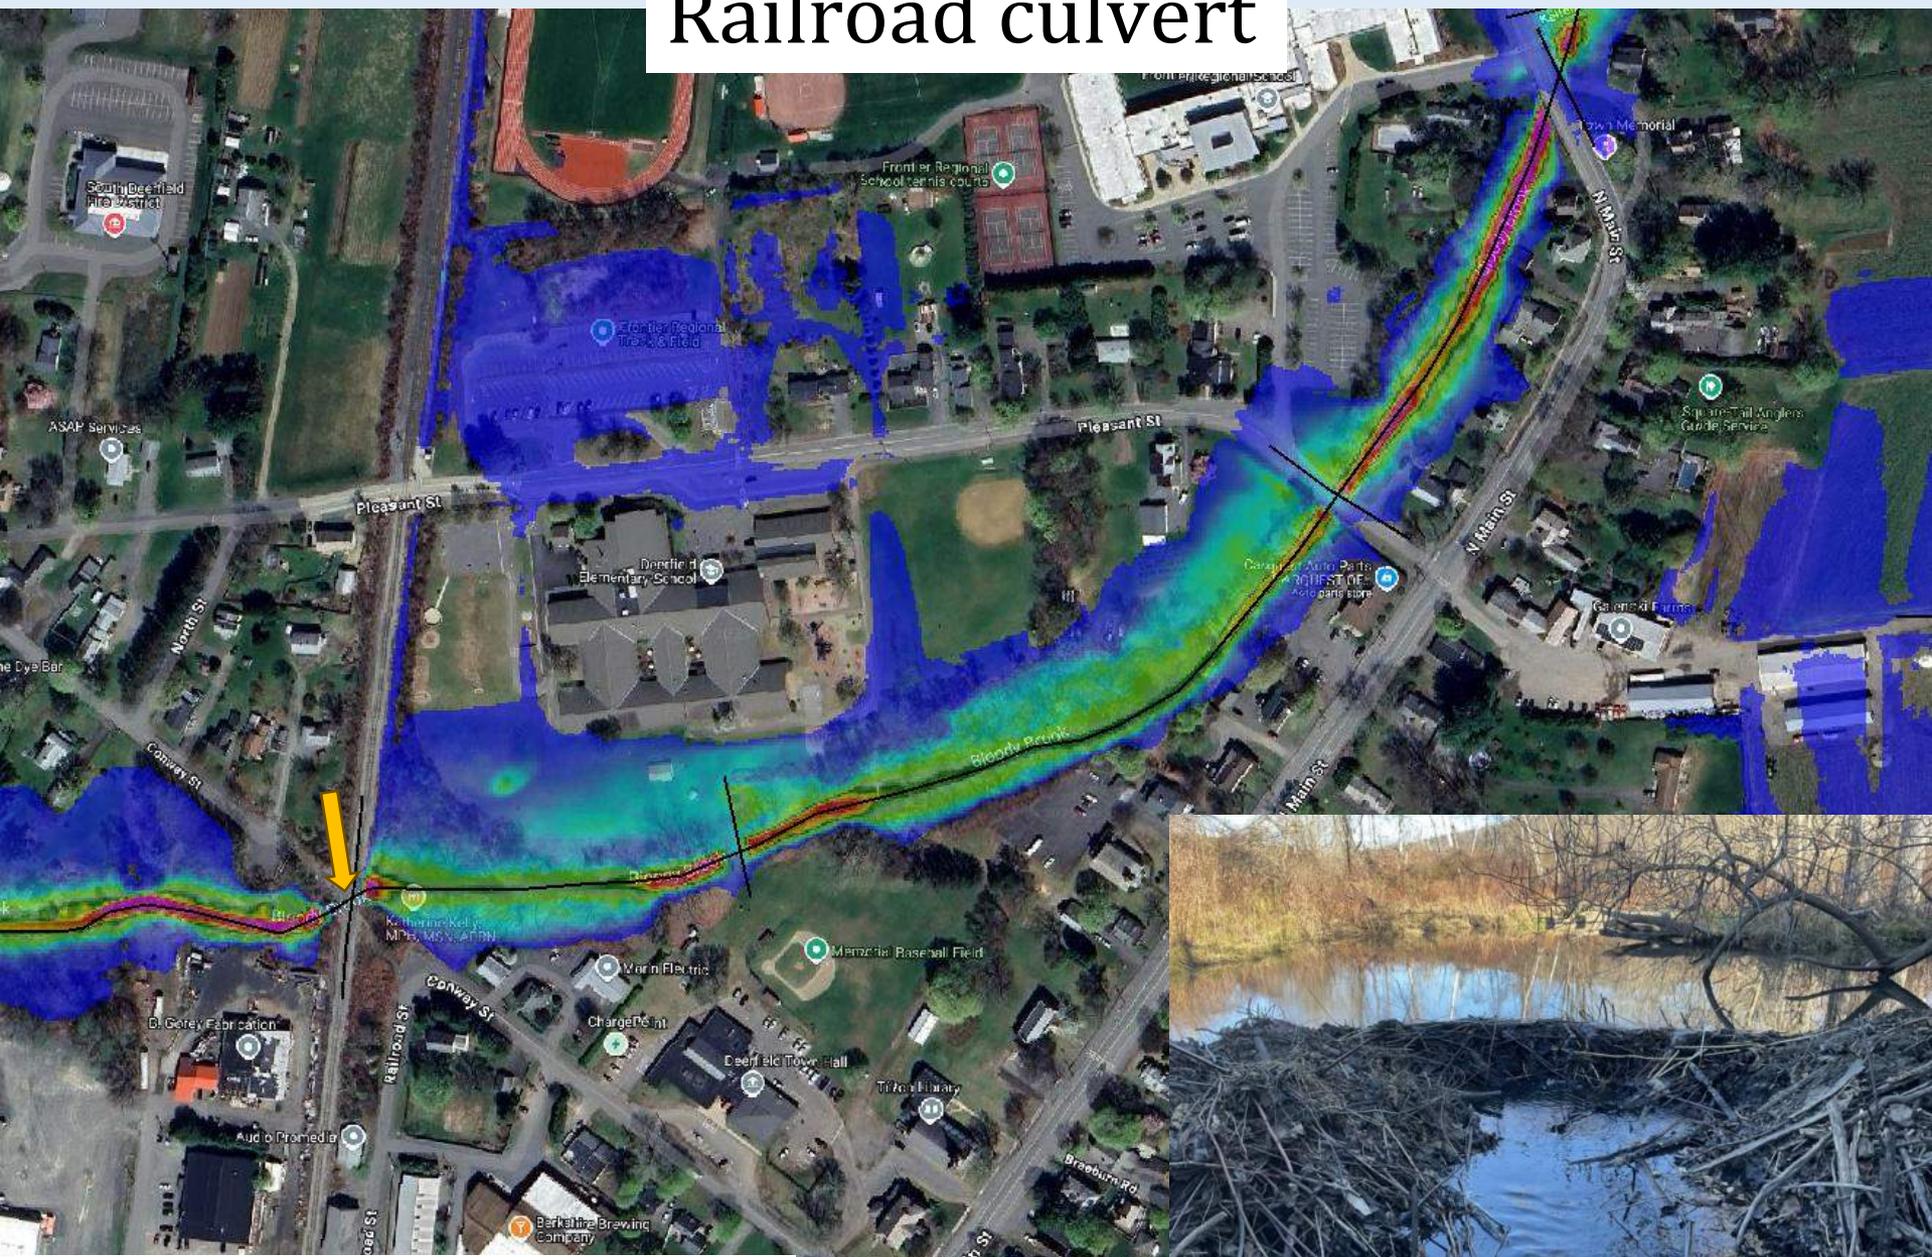
Railroad culvert

10-year flow event

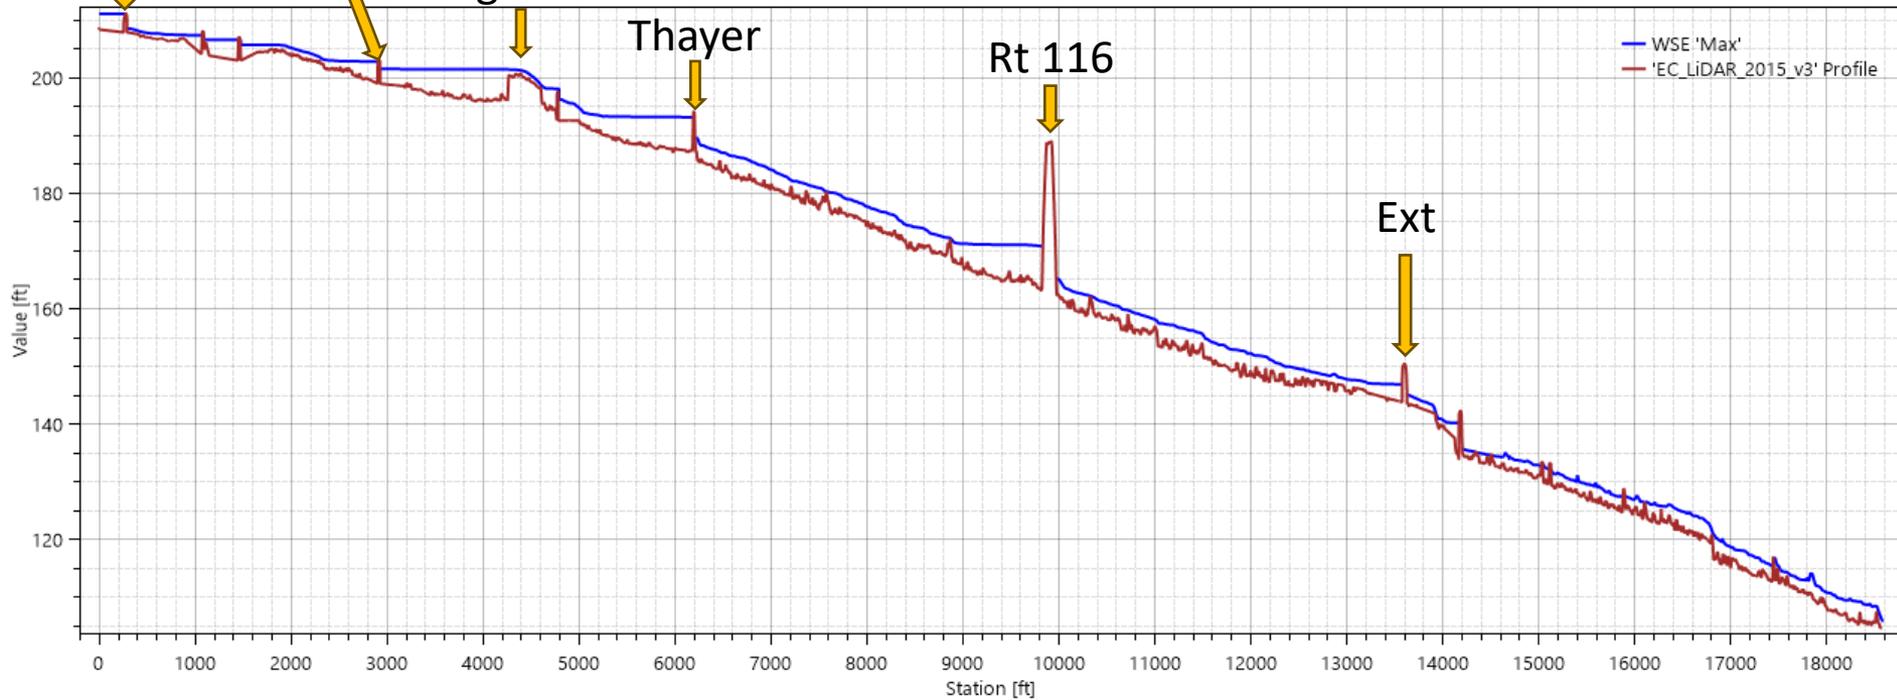
Longitudinal Stream Profile

Water Surface Elevation on 'SugarloafBrook'

Present 100-year flow event

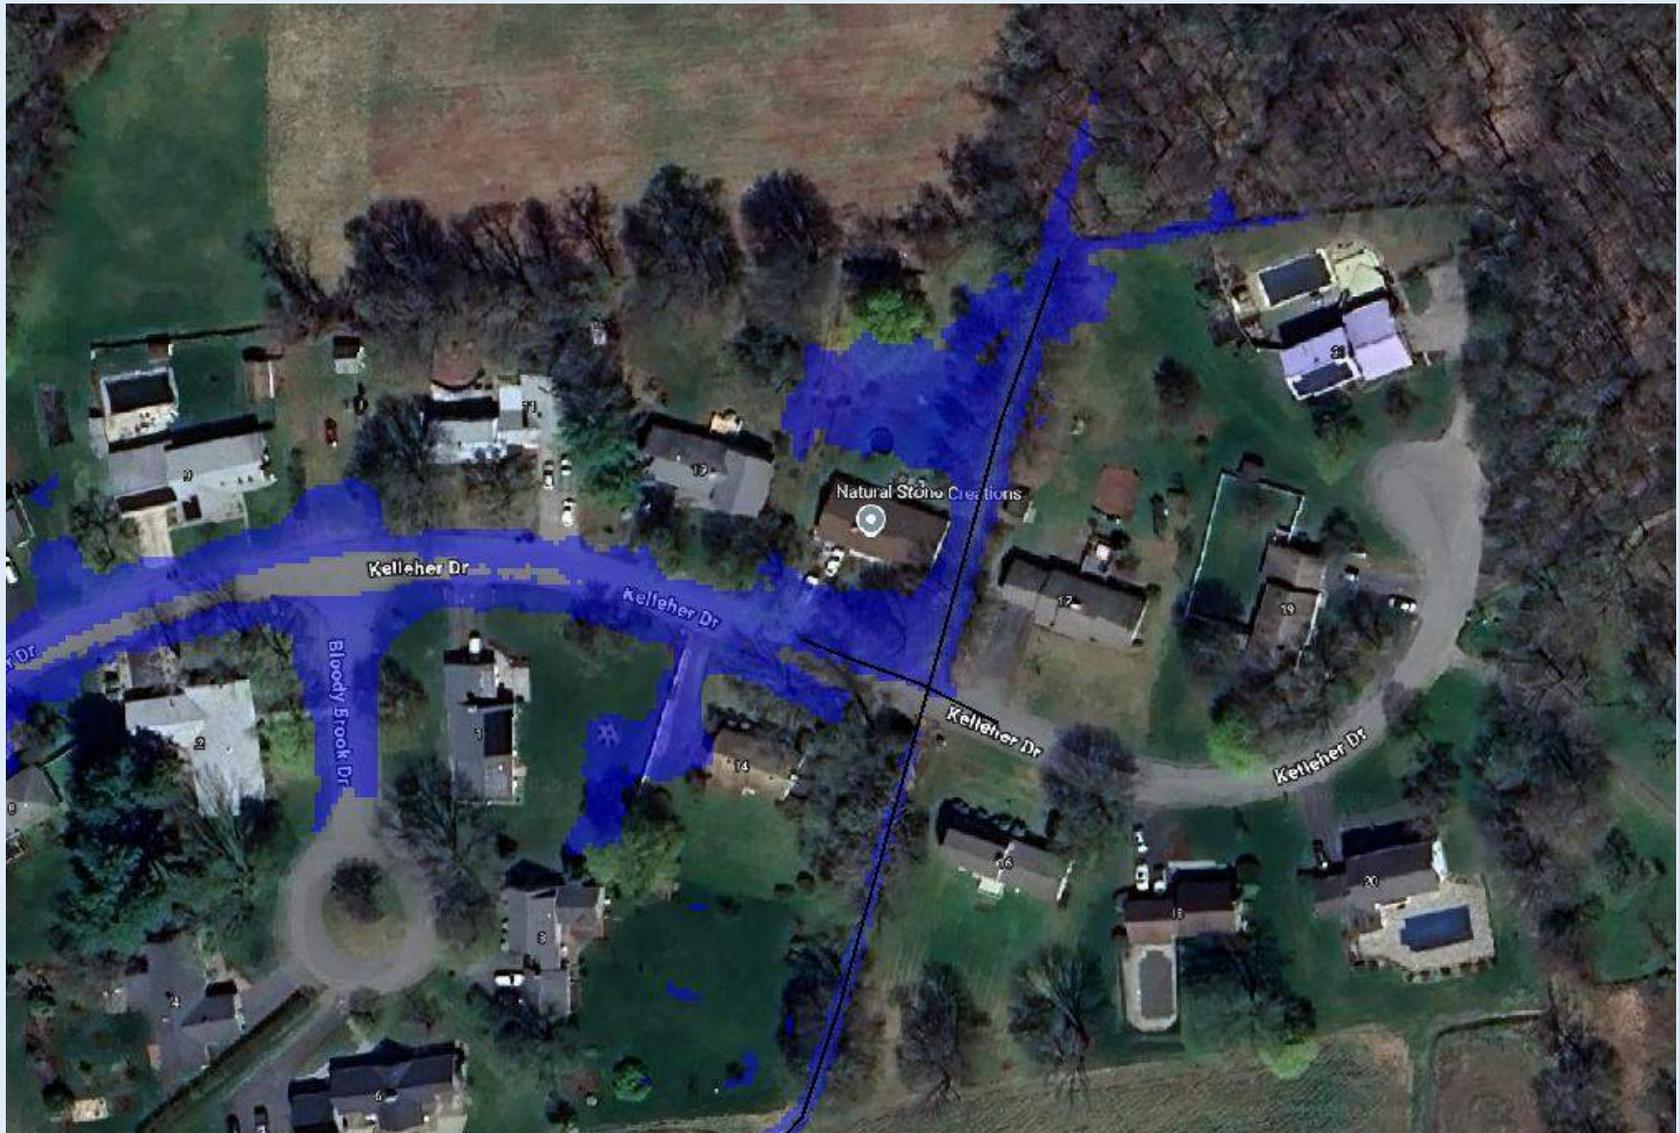
Kelleher St culvert

Existing culvert = 13in wide x 7in high (crushed)

10-year flow event

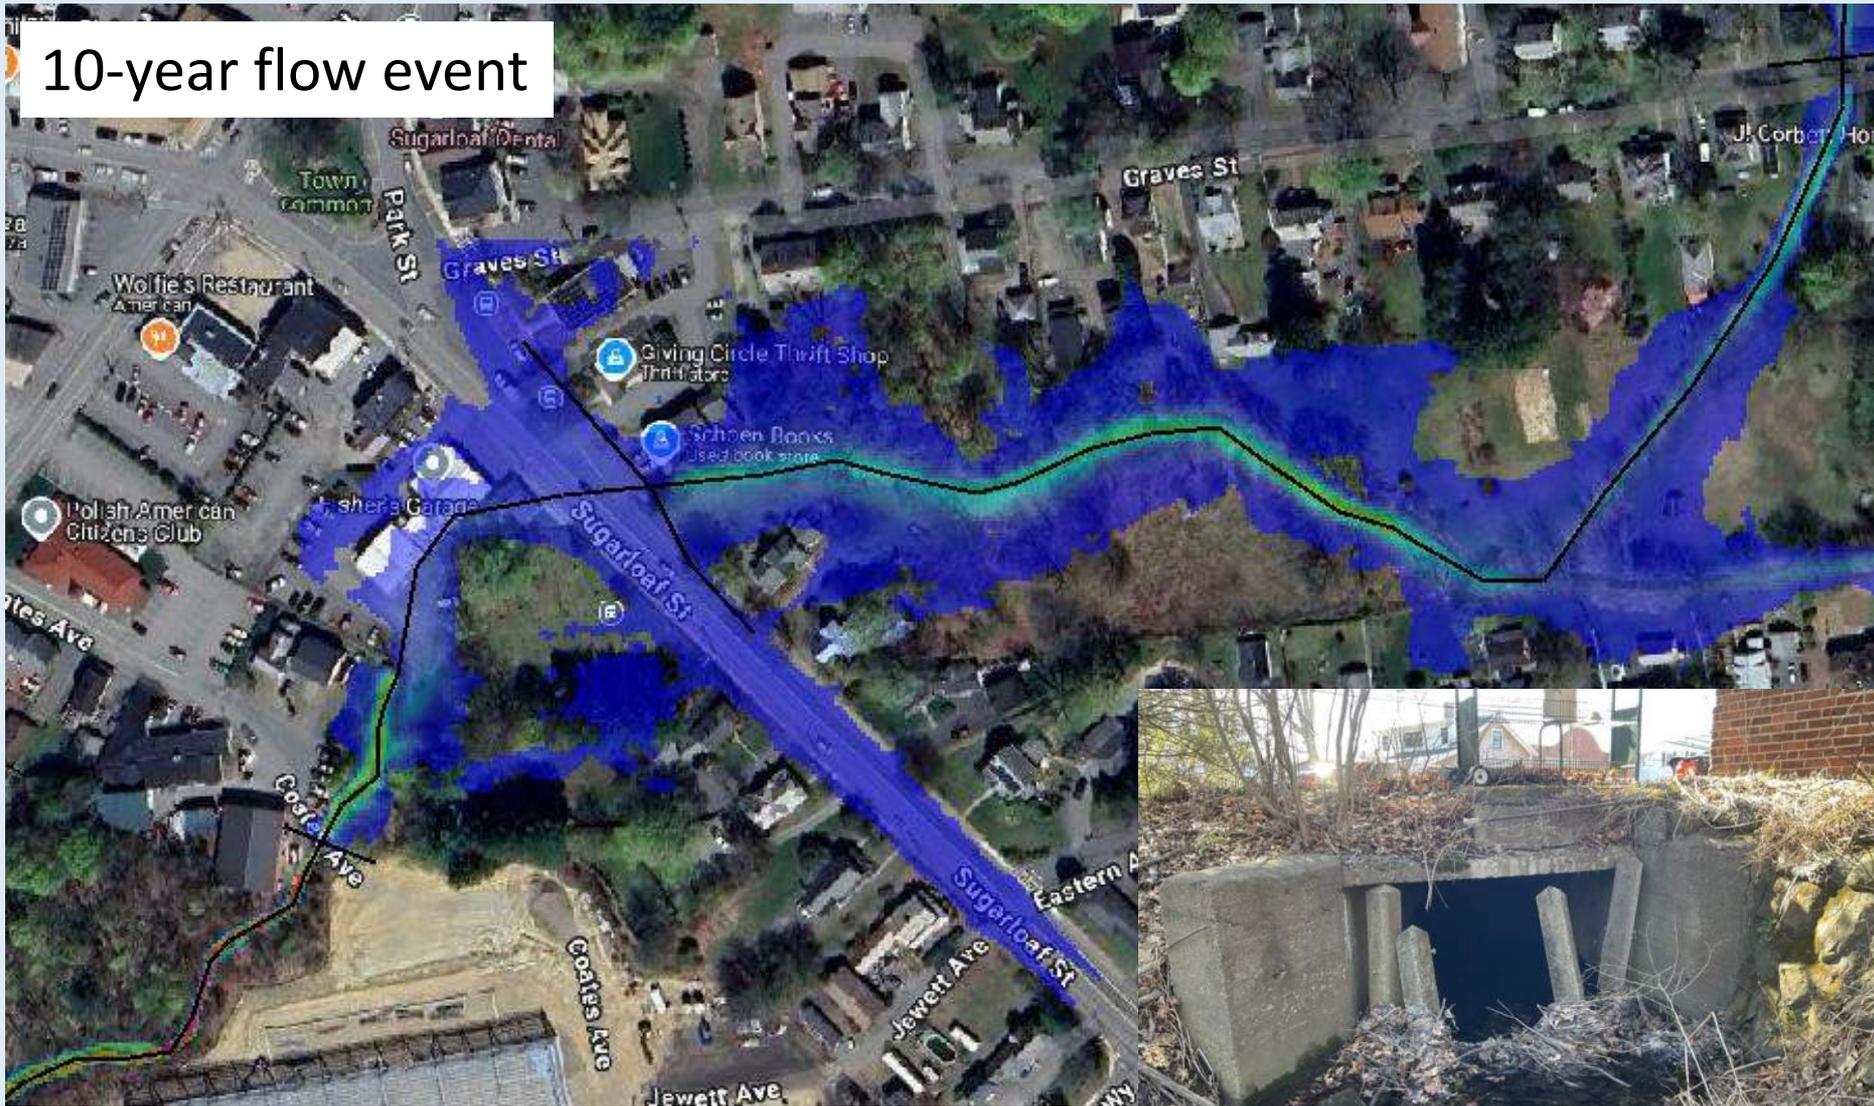
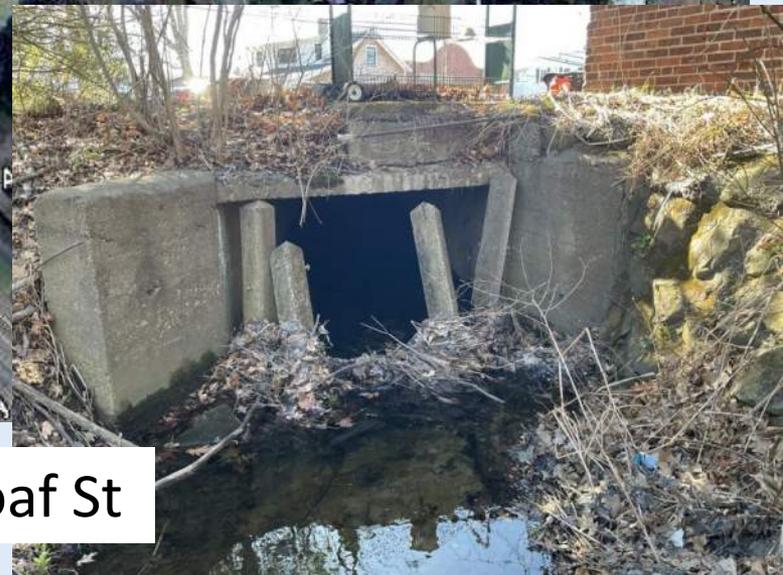
Sugarloaf St culvert

10-year flow event

Water depths up to 16 inches over Sugarloaf St

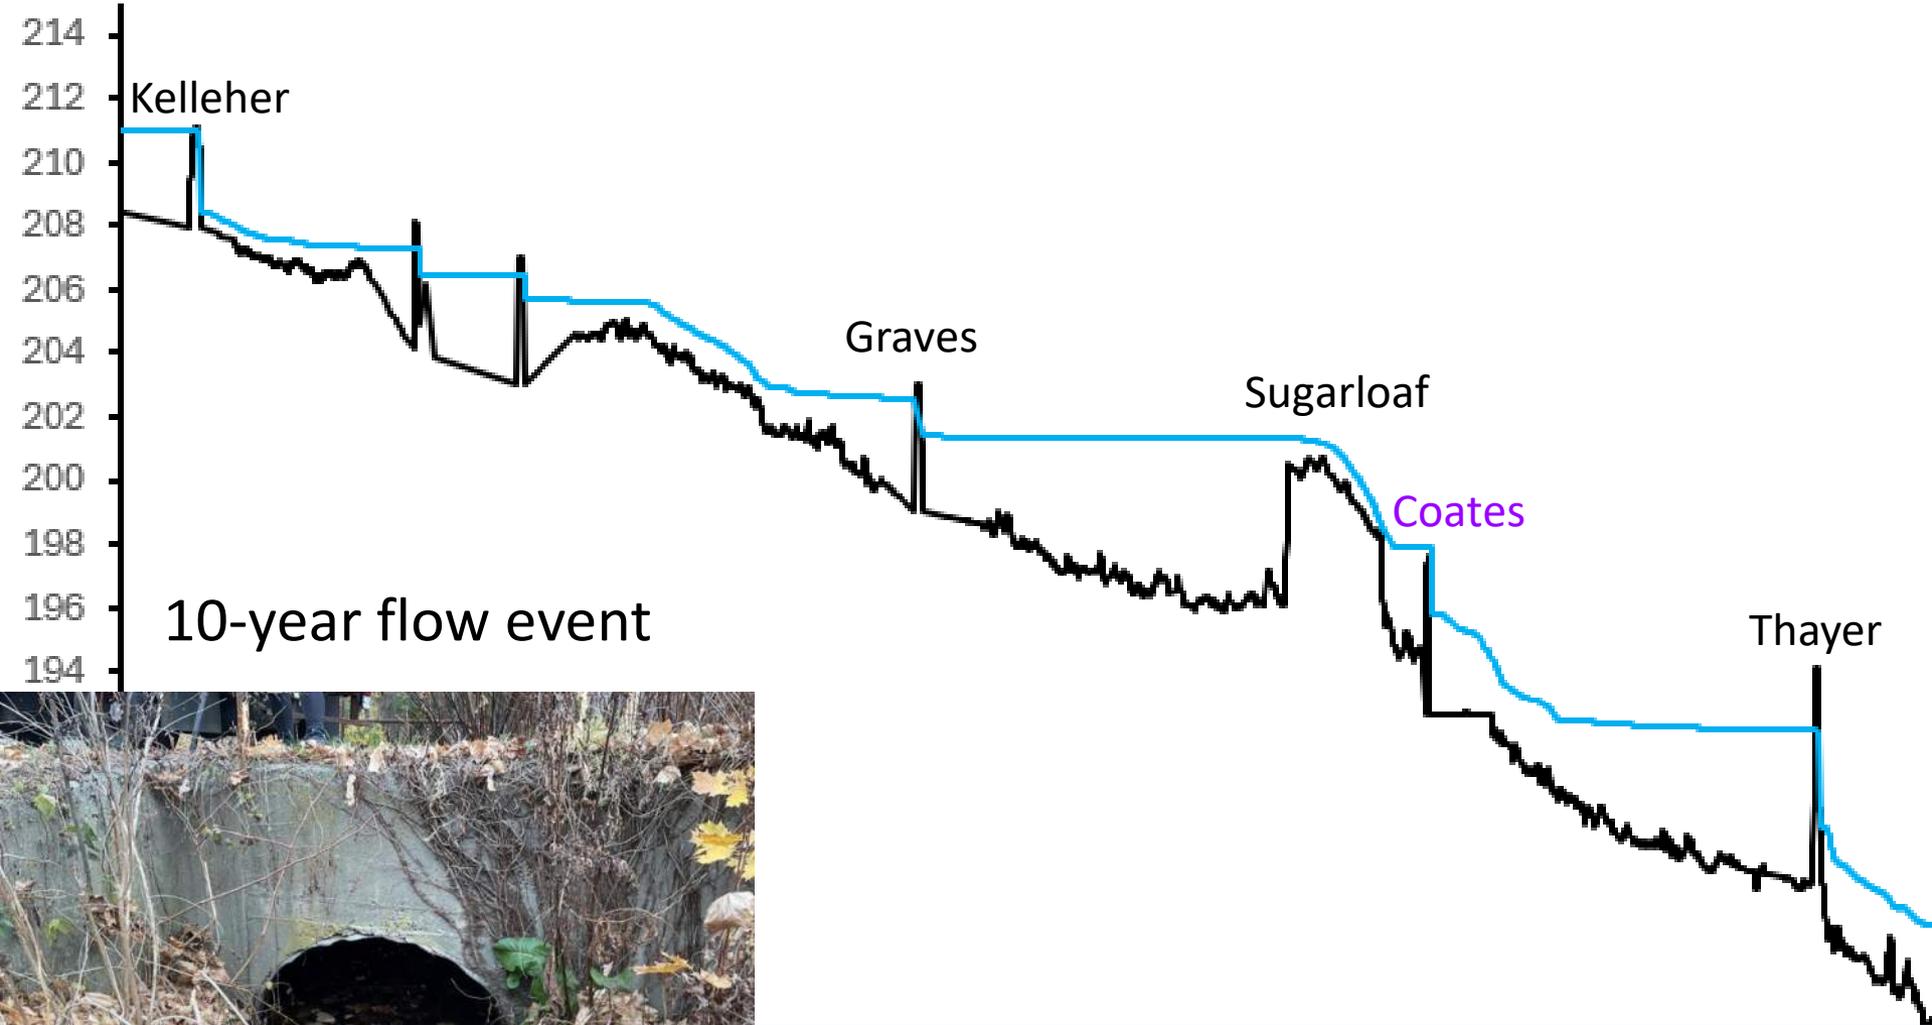
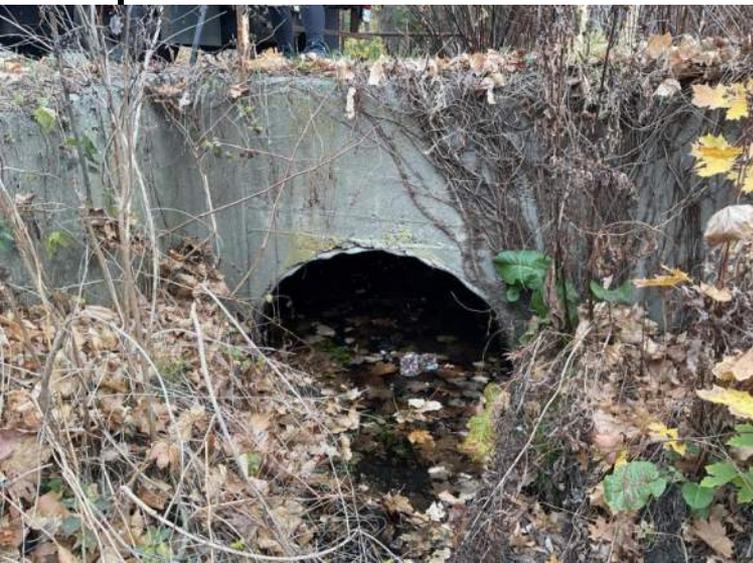
Coates Ave culvert

48in wide x 30in high
Filled halfway w sand

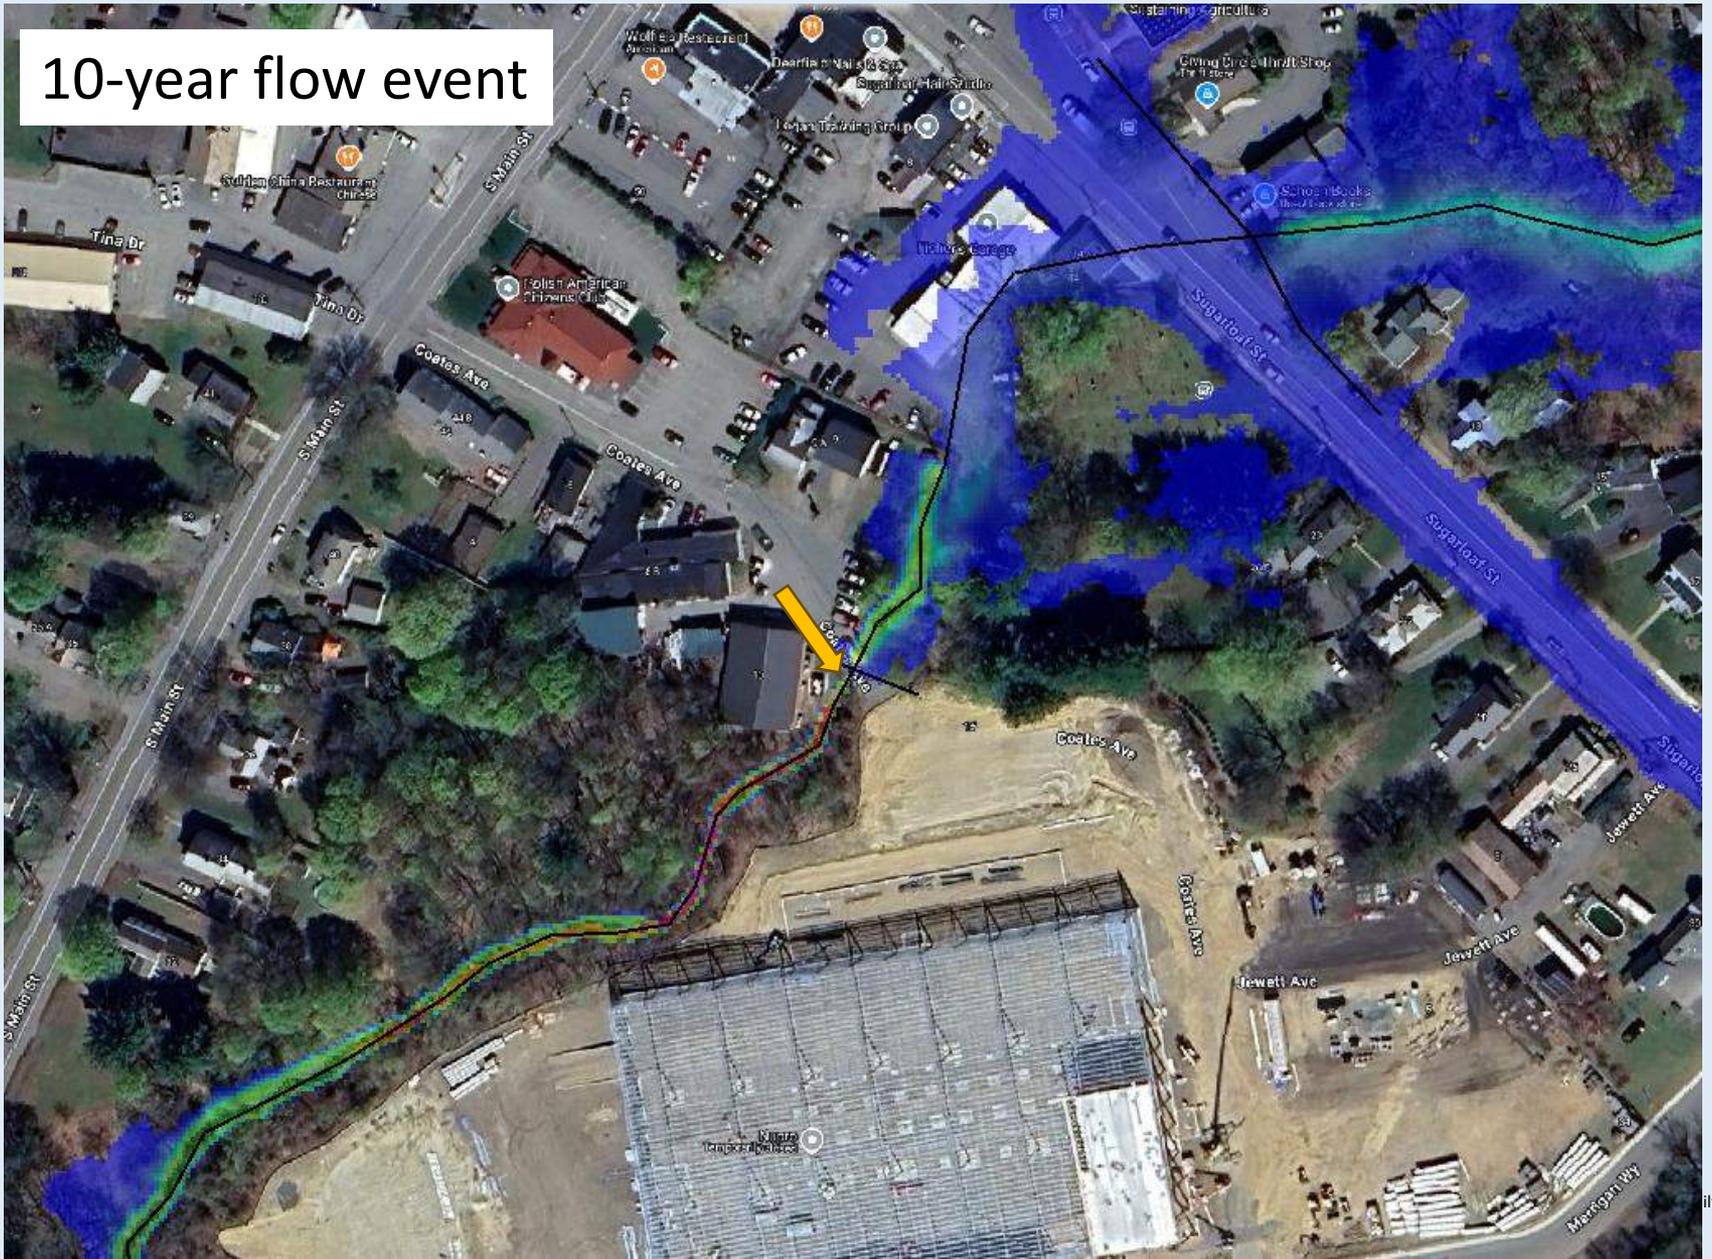
Coates Ave culvert

10-year flow event

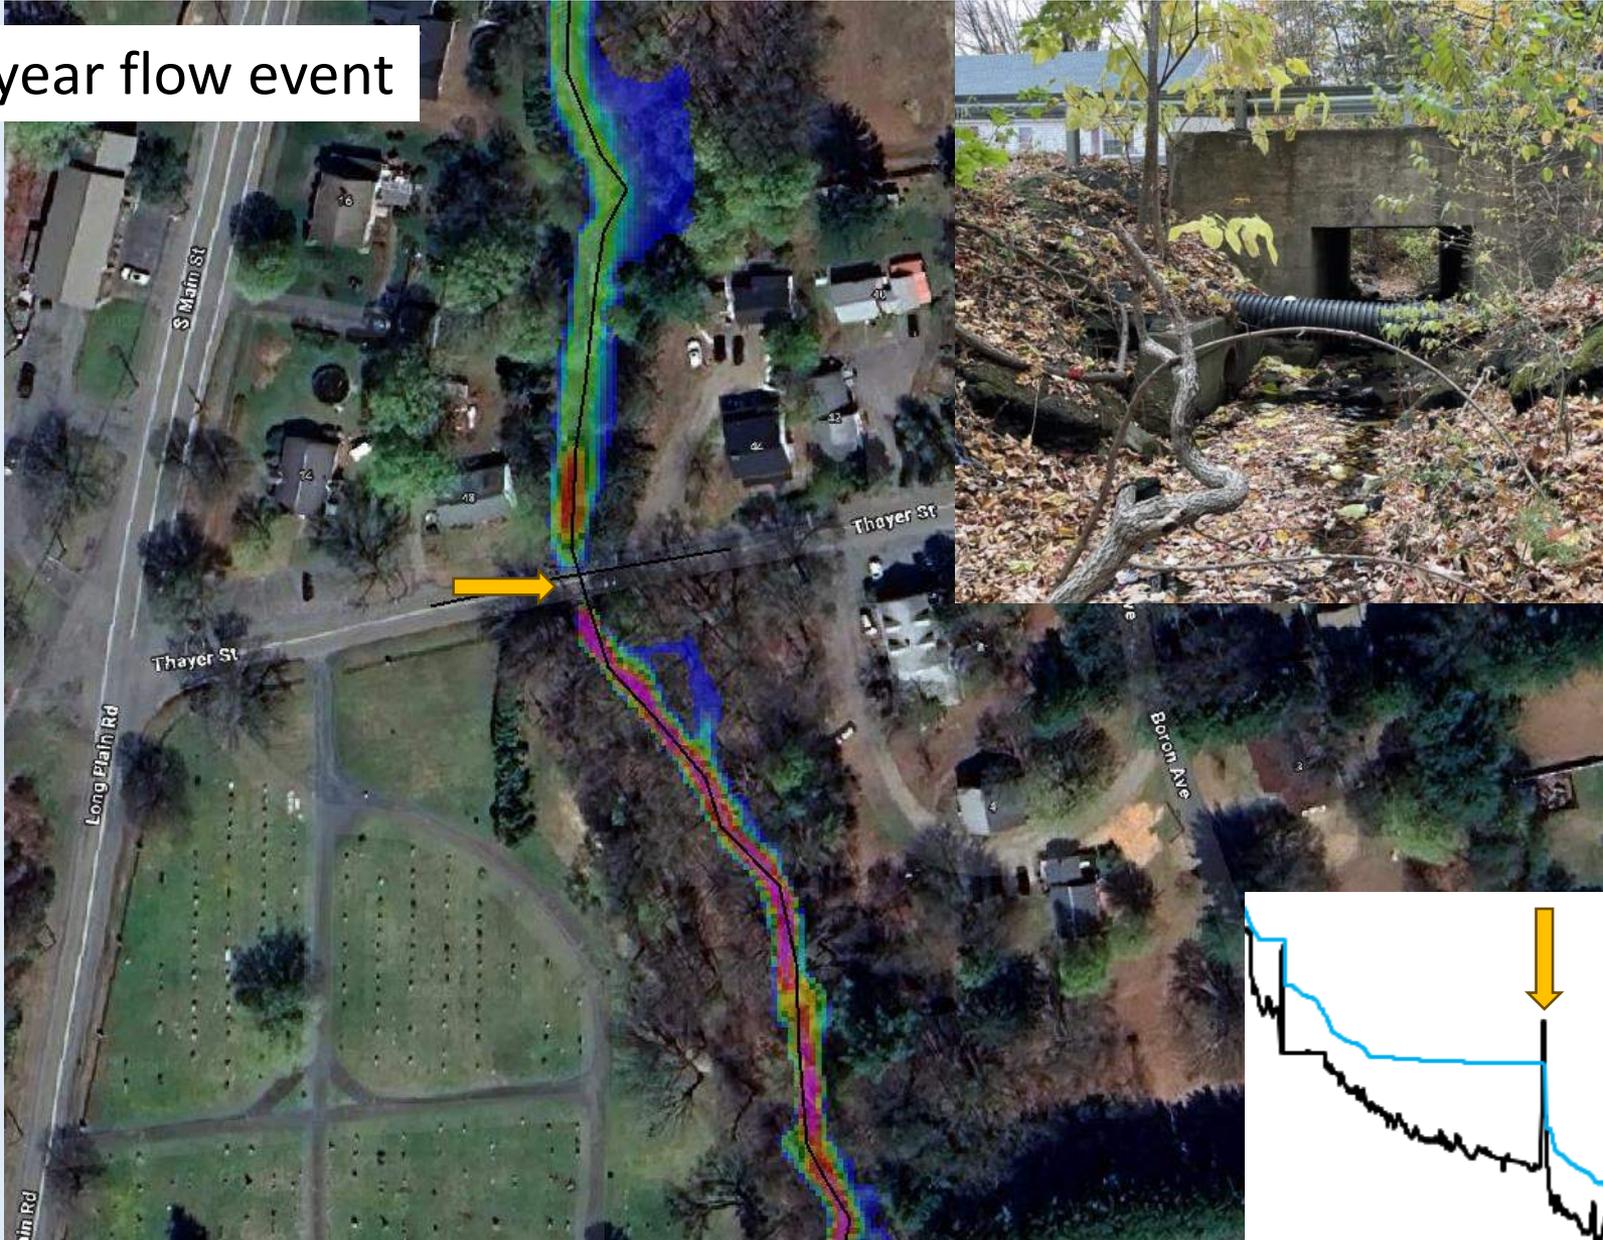
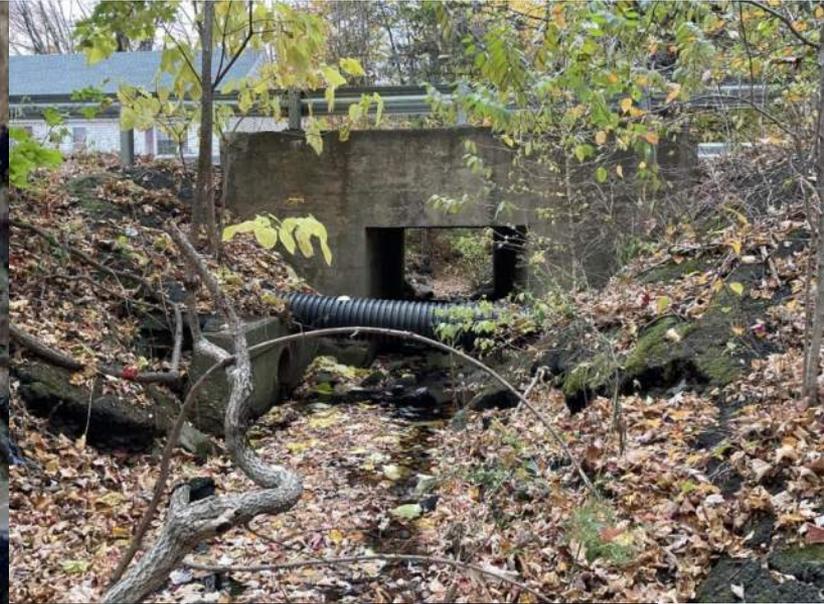
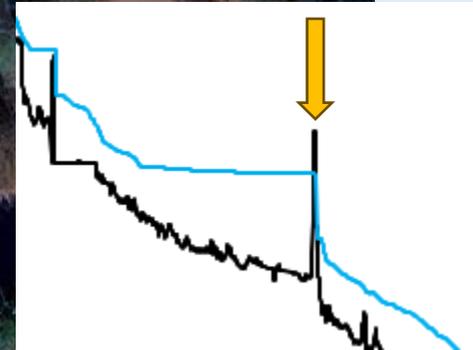
Thayer St culvert

10-year flow event

Thayer St	10	12	14	6' wide x 5.75' high open bottom concrete box

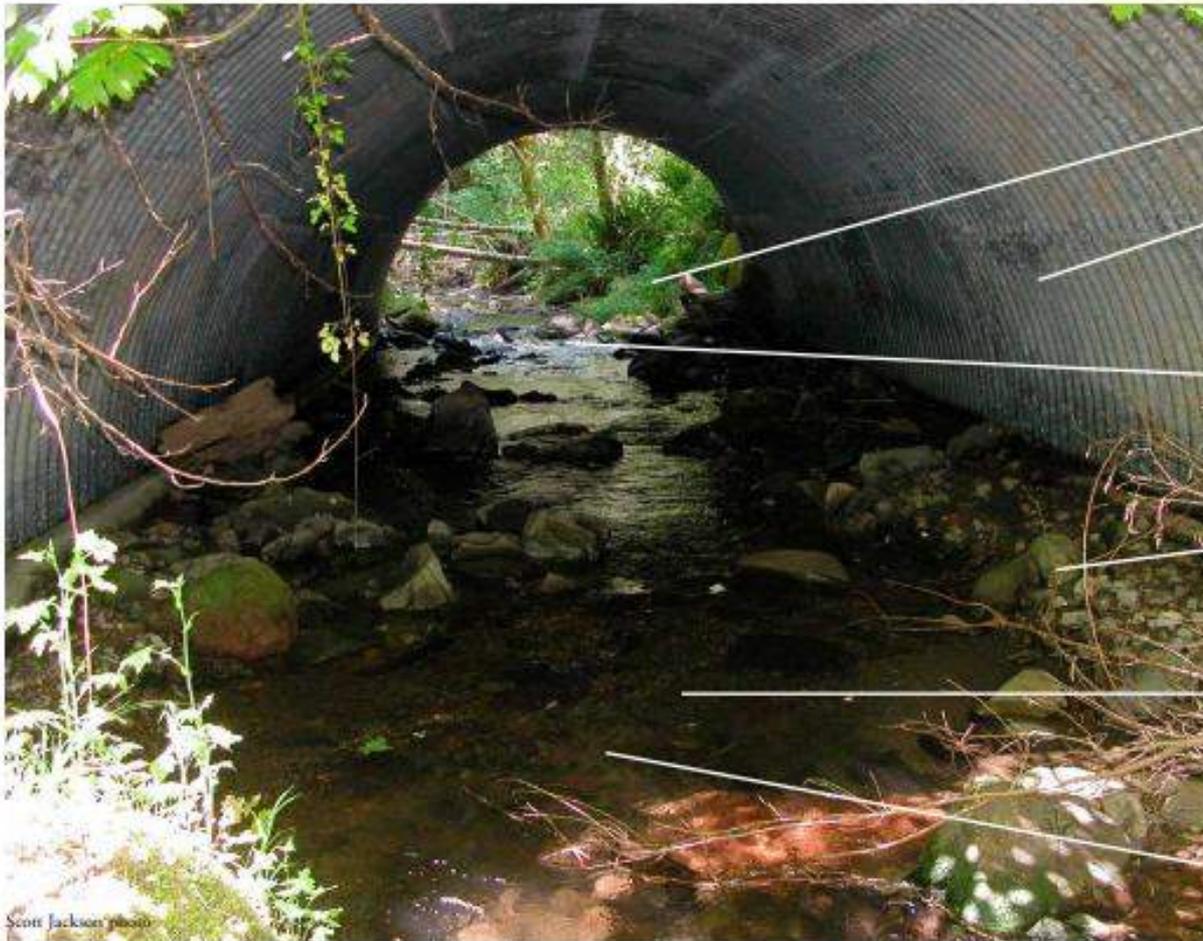
A Well Designed Crossing

Large size suitable for handling high flows

Open-arch design preserves natural stream channel

Openness ratio greater than 0.5m, suitable for most settings

Crossing span helps maintain dry passage for wildlife

Water depth and velocity are comparable to conditions upstream and downstream

Natural substrates create good conditions for stream-dwelling animals

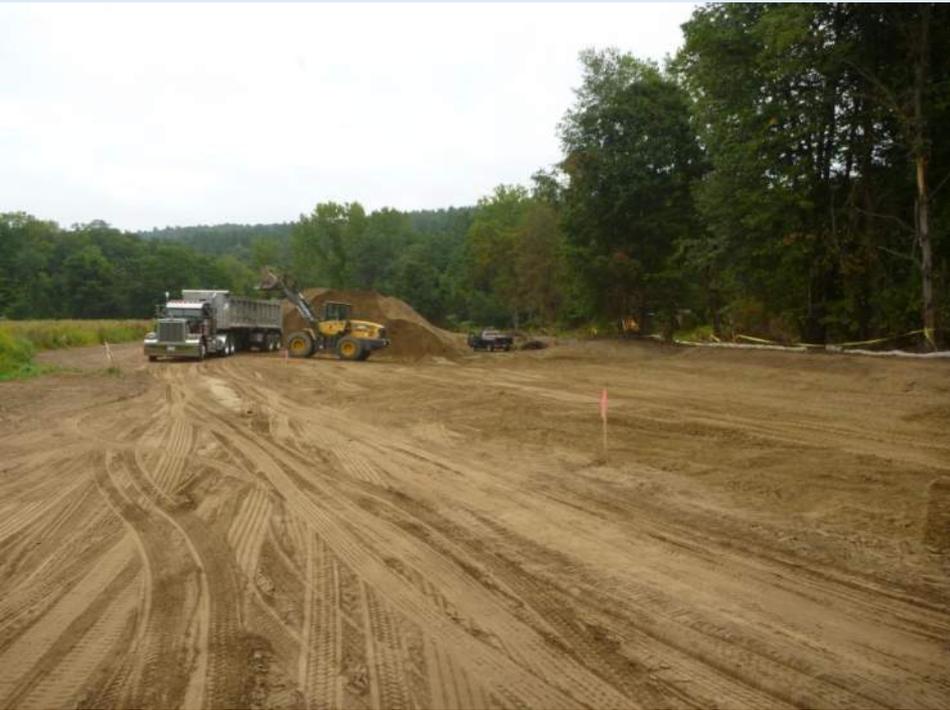
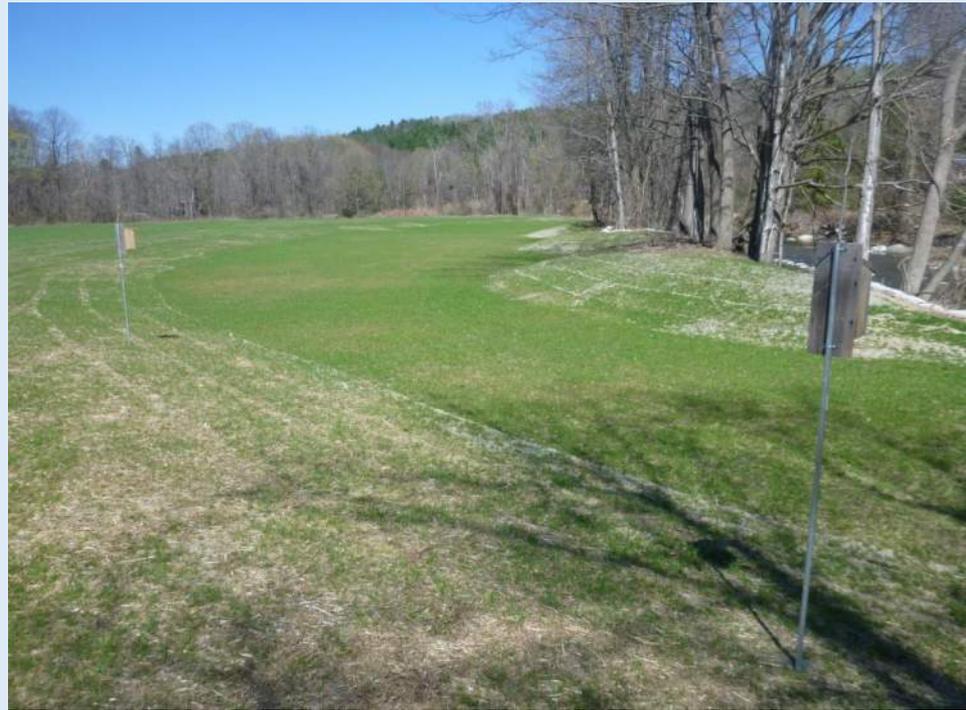
South River Meadow – Conway, MA

2016 Restoration

- Lowered floodplain 3 feet; removed 3500 cu.yd. sediment/loam
- Invasive species mitigation
- 2020 native trees/shrubs planting (Friends of the South River)

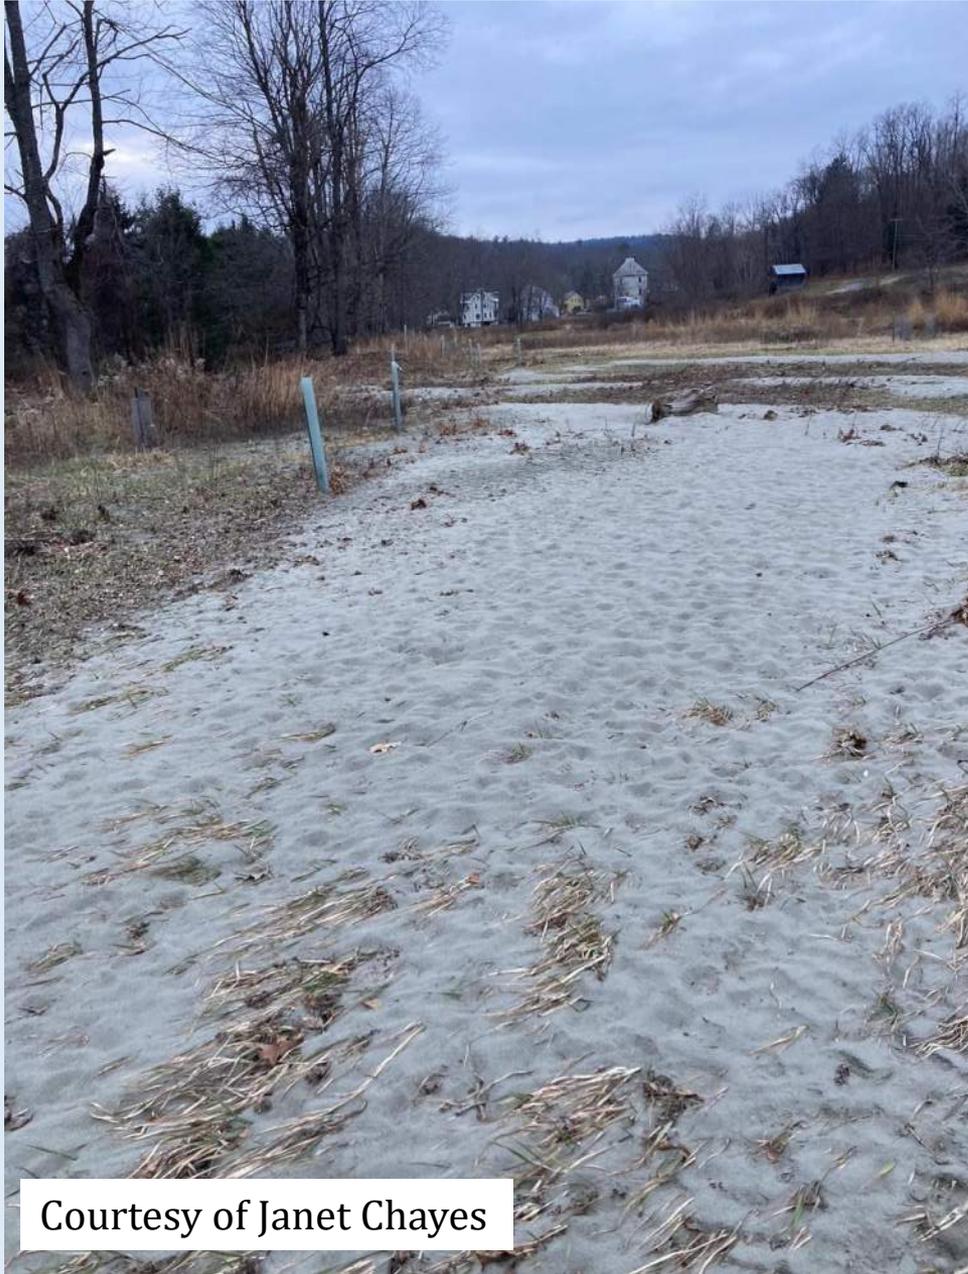
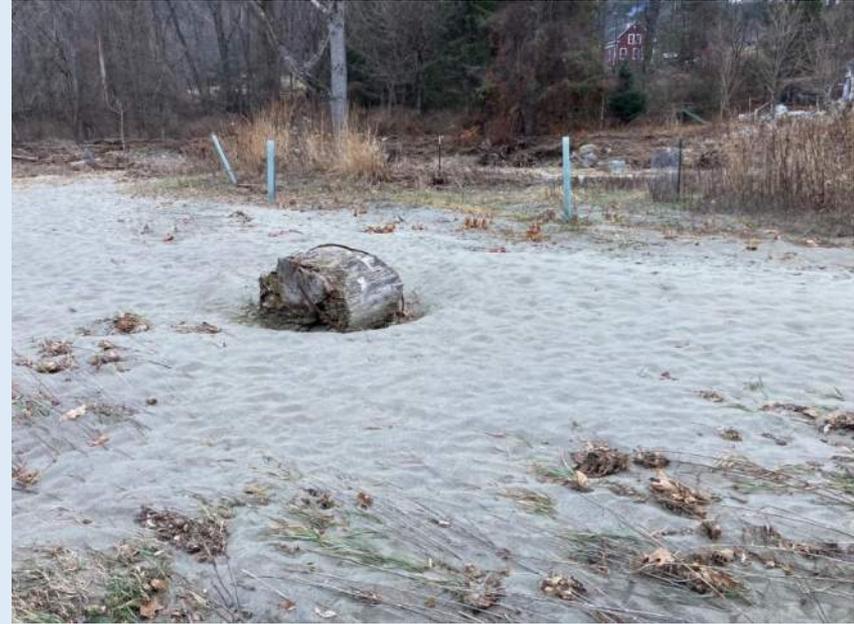
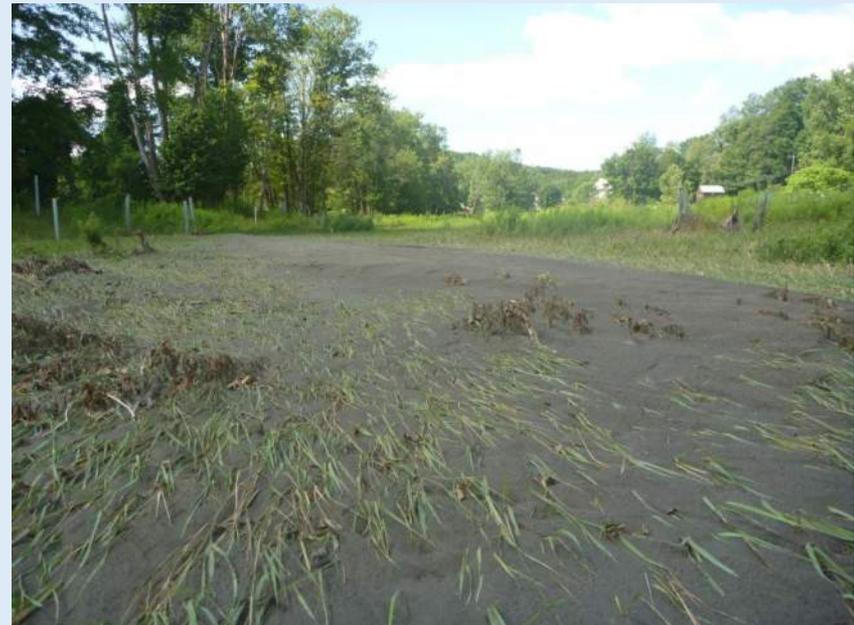
Whetstone Brook – Brattleboro, VT

2023 Restoration of 12-acre floodplain parcel

- Former Cersosimo Lumber site
- Removed 40,000 cu.yds of gravel fill
- Restored wetland
- Planted 100 ft wide riparian buffer
- New park provides recreational asset for downtown Brattleboro area
