Update on Bloody Brook and Sugarloaf Brook Watershed Analysis

Town of Deerfield

Municipal Vulnerability Preparedness (MVP)
Core Group Meeting

May 7, 2025

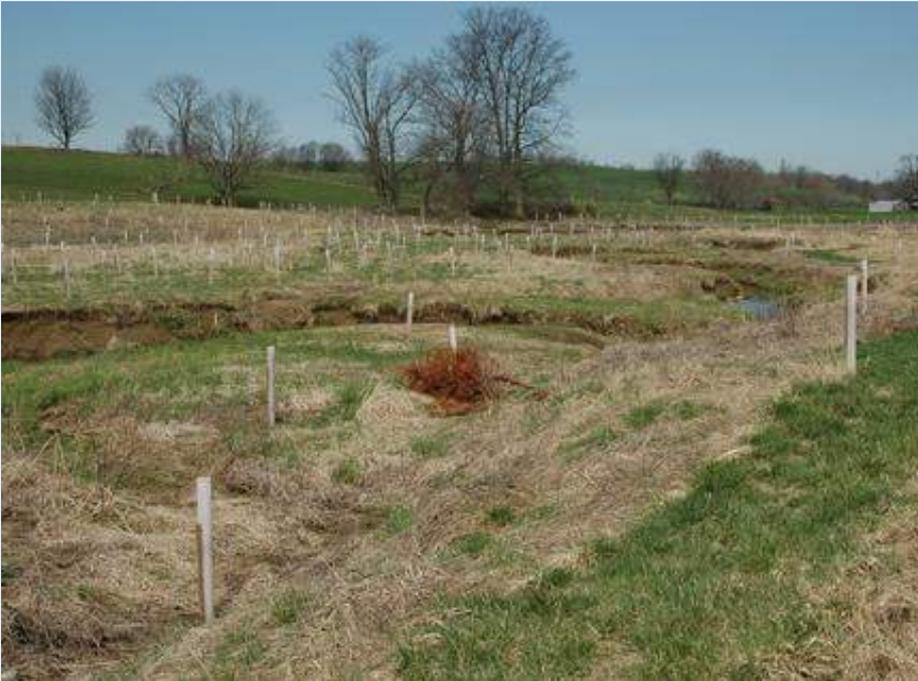
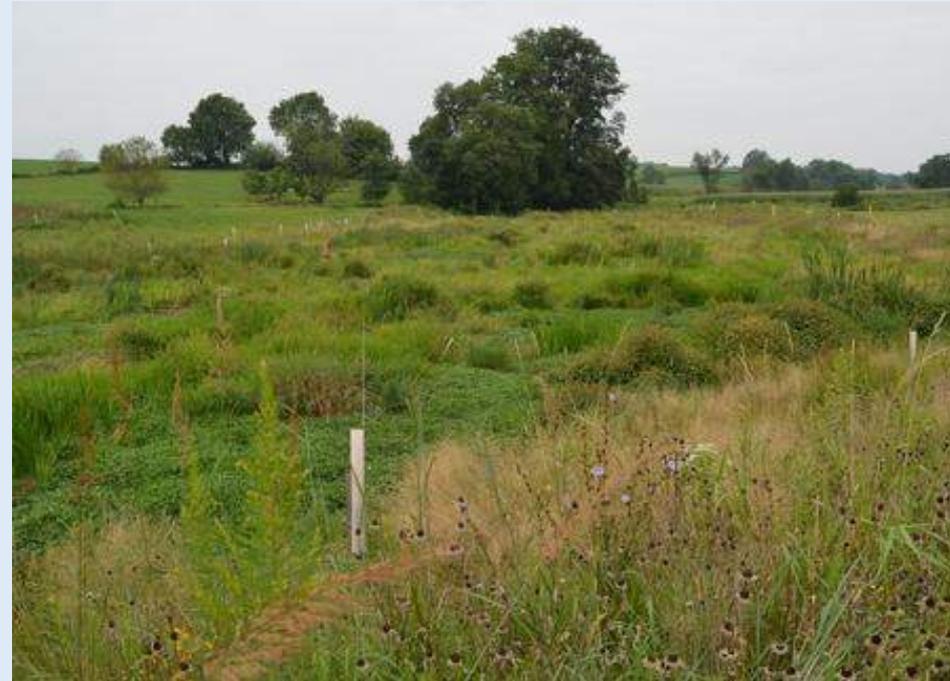
Big Spring Run – Chesapeake Watershed, PA

Sediment load reductions

- Total sediment removed = 25,955 tons
- Annual sediment reduction = 109 tons
- Total stream length restored = 3,000 ft restored
