**Geomorphic Assessment of Bloody
and Sugarloaf Brooks**
South Deerfield - Deerfield, MA

Prepared for
Town of Deerfield

Prepared by
Nicolas Miller
Field Geology Services
Charlemont, MA

June 2025

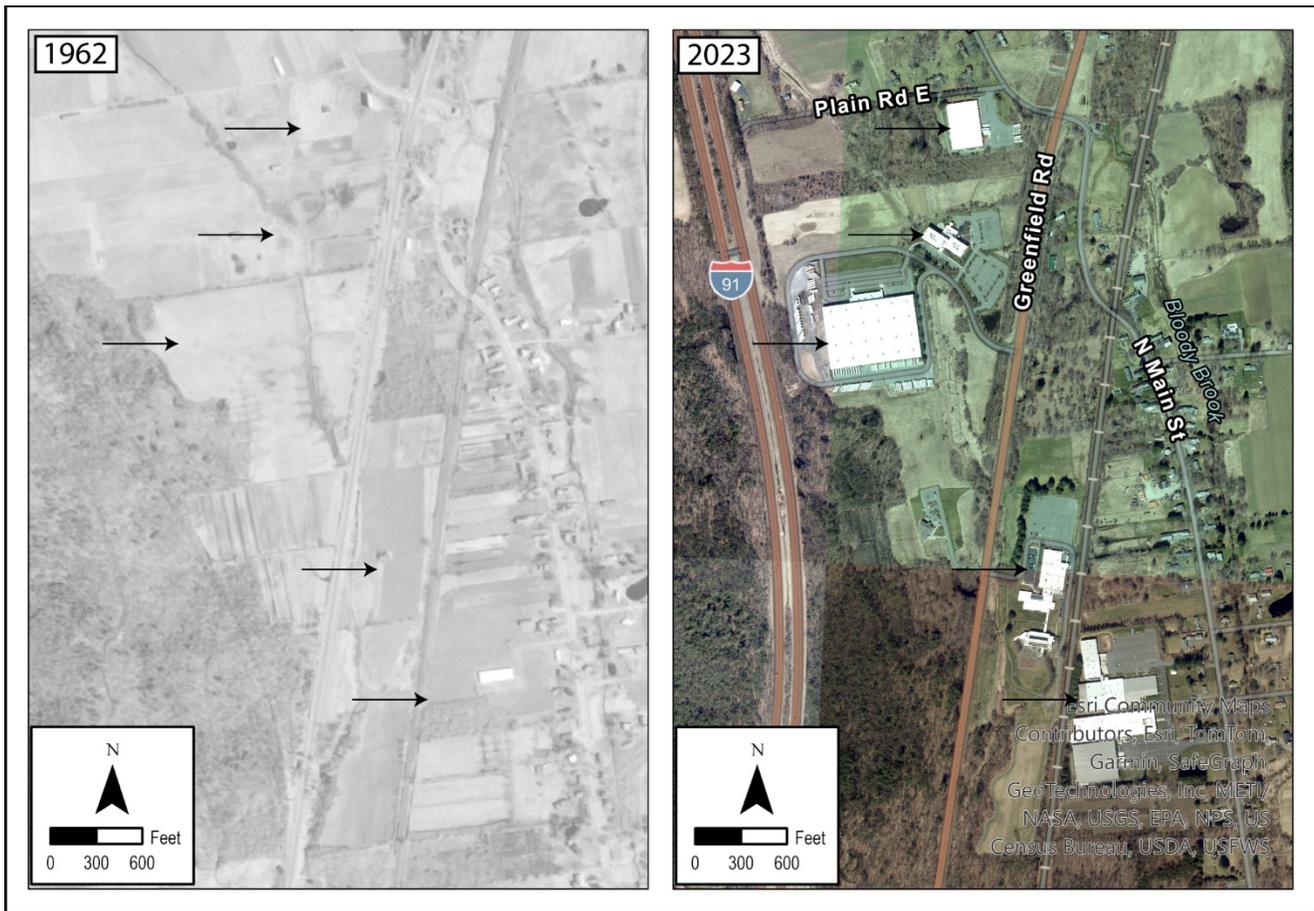
Figure 3. Geo-rectified historic aerial photo from 1962 (left) shows a portion of the Bloody Brook watershed prior to the building of I-91 when land use was largely agricultural. Black arrows point to the same locations in both photos and highlight the increase in commercial and industrial buildings and impervious surface.

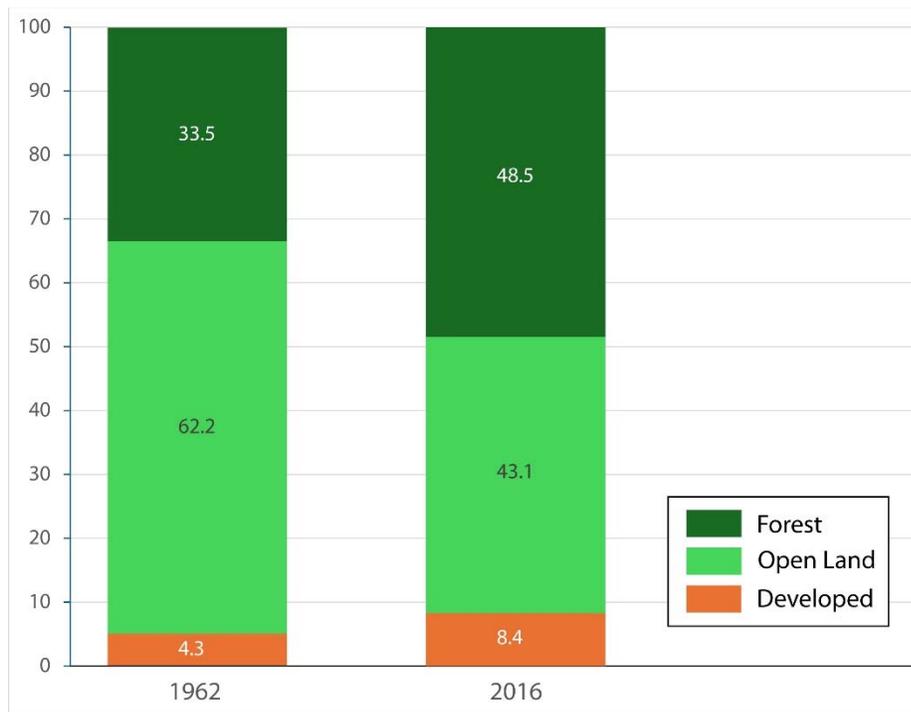
Our analysis shows a 30.8 percent reduction in open land use during this time period while developed land has increased by 97.4 percent (Table 1 and Figure 4). Impervious surface covers nine percent of the Bloody Brook watershed, based on a 2005 MassGIS analysis (FRCOG, 2024b).

Figure 4 – Changes in land cover from 1962 to 2016.

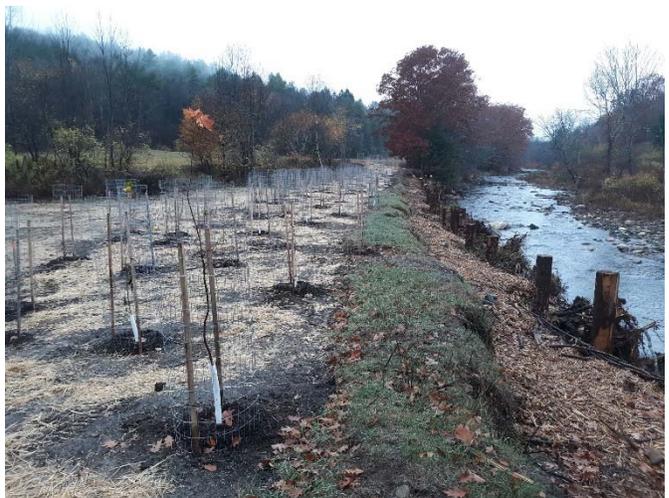
Forested buffer planted along North River in Colrain MA

Limiting runoff and sediment and nutrient inputs to Bloody and Sugarloaf brooks can be improved by establishing and enhancing riparian buffers. Grass and herbaceous filter strips have been shown to reduce sediment loading from agricultural fields by 60 to 90 percent (Daniels and Gilliam, 1996). Forested buffers effectively reduce sediment and nutrient loading (Klapproth and Johnson, 2009), while also providing a myriad of habitat and ecosystem services such as forage and cover for a wide range of birds, amphibians, reptiles, and mammals. FRCOG found that riparian buffers in the Bloody Brook watershed were limited and absent in many stream reaches (FRCOG, 2024a). Buffer enhancement can include planting native trees and shrubs, wetland, and pollinator plants, and mitigating invasive species such as Japanese knotweed.
