**TOWN OF DEERFIELD**  
FACILITIES CONDITION ASSESSMENT  
OF  
TOWN BUILDINGS

**Congregational  
Church**

Gorman Richardson Lewis Architects

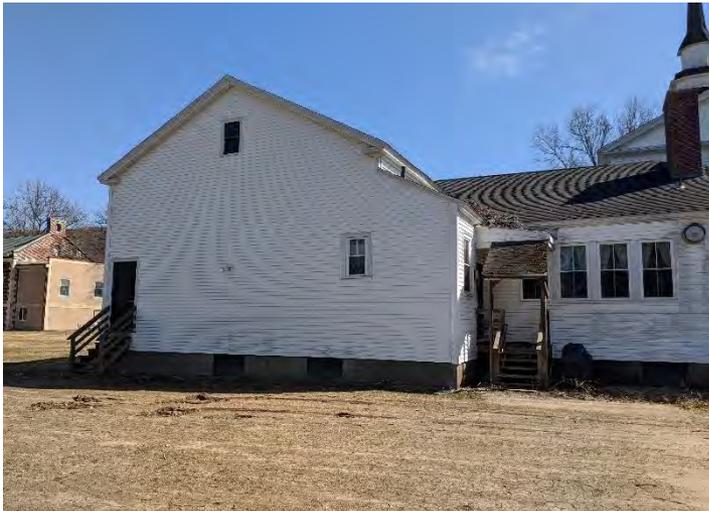
Issue #	Room Name / Elev.	System/ Component	Existing Description	Photo #	Commentary/ Proposed Work	Quantity	Unit	Repair/ Replace Priority by			
								0-11 mths Costs	1-5 yrs Costs	5-10 yrs Costs	11-20 yrs Costs
25	site east front	Site	Concrete walkways leading up to 3 entrances are in serviceable condition but nearing end of their service life		Replace concrete walks with new concrete walks	900	Allow			\$ 10,000	
26	site south side	Site	Paved parking area in good condition; striping for parking needed		Install striping for parkings	1	LS		\$ 10,000		
27	site west rear	Site	Landing at ramp at rear of church needs to be replaced as it is a tripping hazard		5'x5' concrete pad. Coordinate site parking so that pavement connects with ramp landing	1	EA		\$ 2,500		
28	site west rear	Site	2 rear entrance doors do not have paved sidewalk that connects them to parking area	B19	Install new sidewalk to both rear entrances	564	SF		\$ 8,000
