TOWN OF DEERFIELD
DEERFIELD COMMUNITY PRESERVATION COMMITTEE
CPA Funding Application

Title of proposal: 1821 Meeting House – Clock Tower Restoration and Re-use Engineering Report

Facilities Condition Assessment

Congregational Church

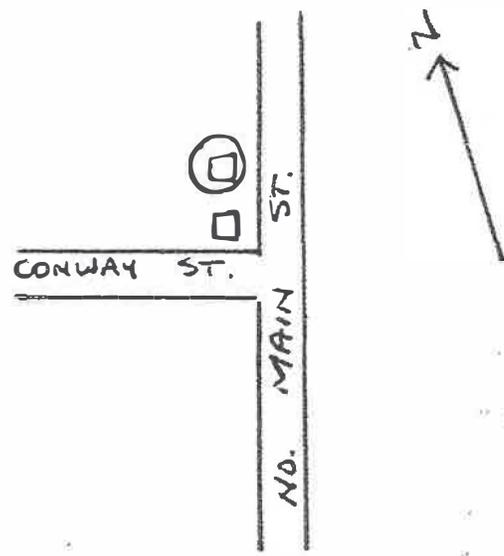
in relation to nearest cross streets and other buildings. Indicate north.

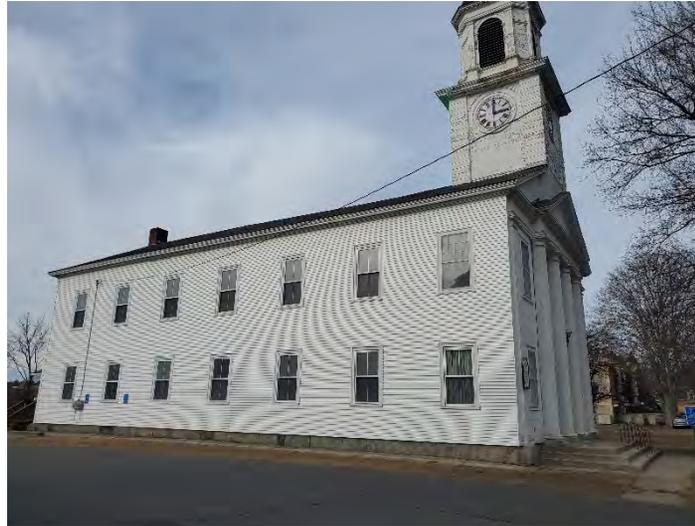
OVERVIEW PHOTOGRAPH

In this section of the Facilities Condition Assessment Report, RRC Engineering presents a summary of observations regarding the condition of Deerfield Congregational Church building, including summary description of structural systems and recommendations for action to be taken.

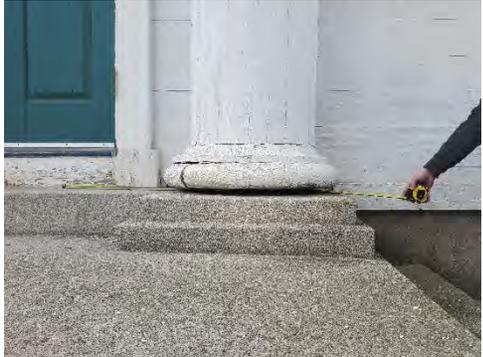
| Component | Deficiency | Description | Photograph |
|---|---|---|---|
| Foundation/Floor Slab | <input checked="" type="checkbox"/> Deterioration <input type="checkbox"/> Weakness <input checked="" type="checkbox"/> Settlement Other | <ul style="list-style-type: none"> • Accessible portions of basement appear relatively dry considering there is not poured concrete slab or vapor retarder throughout. • Dirt is mounded on either side of the center aisle of the main hall and is within 1'-6" of the underside of timber framing. Timbers appeared sound with no signs of rot observed. • Several brick piers supporting the main hall floor are deteriorated with disintegrating mortar and spalling brick. • Front exterior stairs supporting pediment columns appears to be settling leaving a gap of about 1" below the northern column. | <p style="text-align: center;">S1</p> <p style="text-align: center;">S2</p> |

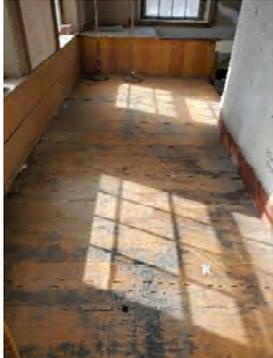
| <p>Upper Floors</p> | <p><input type="checkbox"/> Deterioration <input type="checkbox"/> Weakness <input checked="" type="checkbox"/> Settlement <input type="checkbox"/> Other</p> | <ul style="list-style-type: none"> • There is a noticeable settlement of 2"-4" towards the center aisle of the main hall. • The balcony floor is very uneven with many boards heavily worn. | <p>S3</p> |

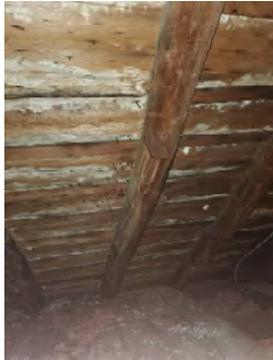
| <p>Roof</p> | <p><input type="checkbox"/> Deterioration <input type="checkbox"/> Weakness <input type="checkbox"/> Settlement <input checked="" type="checkbox"/> Other</p> | <ul style="list-style-type: none"> • Due to the limited access and lighting within the main hall roof structure, it was difficult to observe the majority of the framing. In areas that could be accessed, there are signs of slight moisture staining on framing, minor settlement, checking of timbers, etc. typical of wood framed structures of this era. • The attic of the rear addition was not accessed during this visit. | <p>S4</p> |

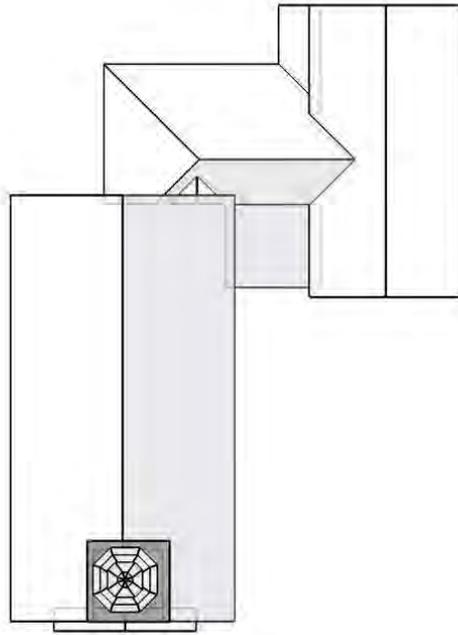
In this 3D model, facets appear as semi-transparent to reveal overhangs.

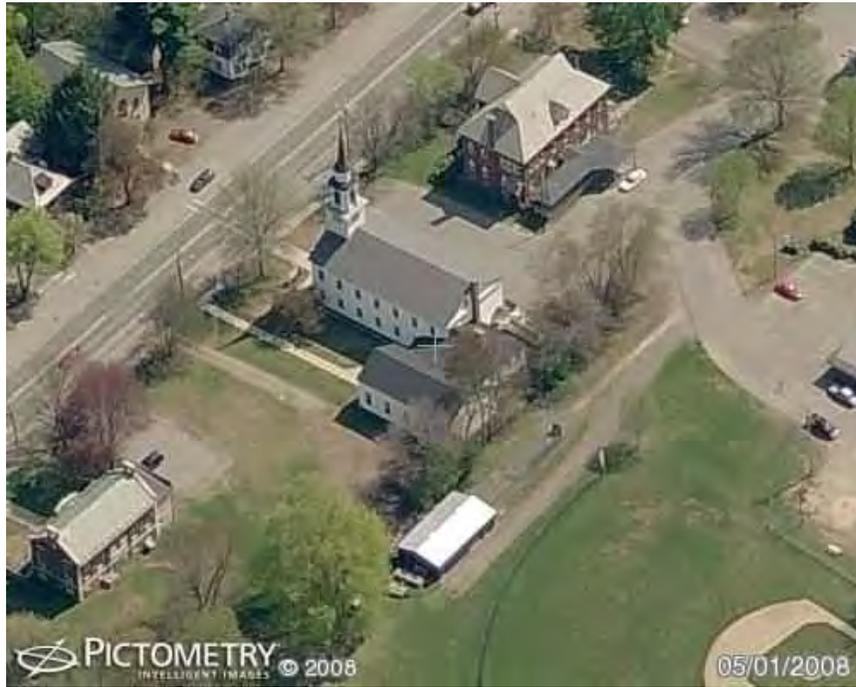
North Side

The following aerial images show different angles of this structure for your reference.

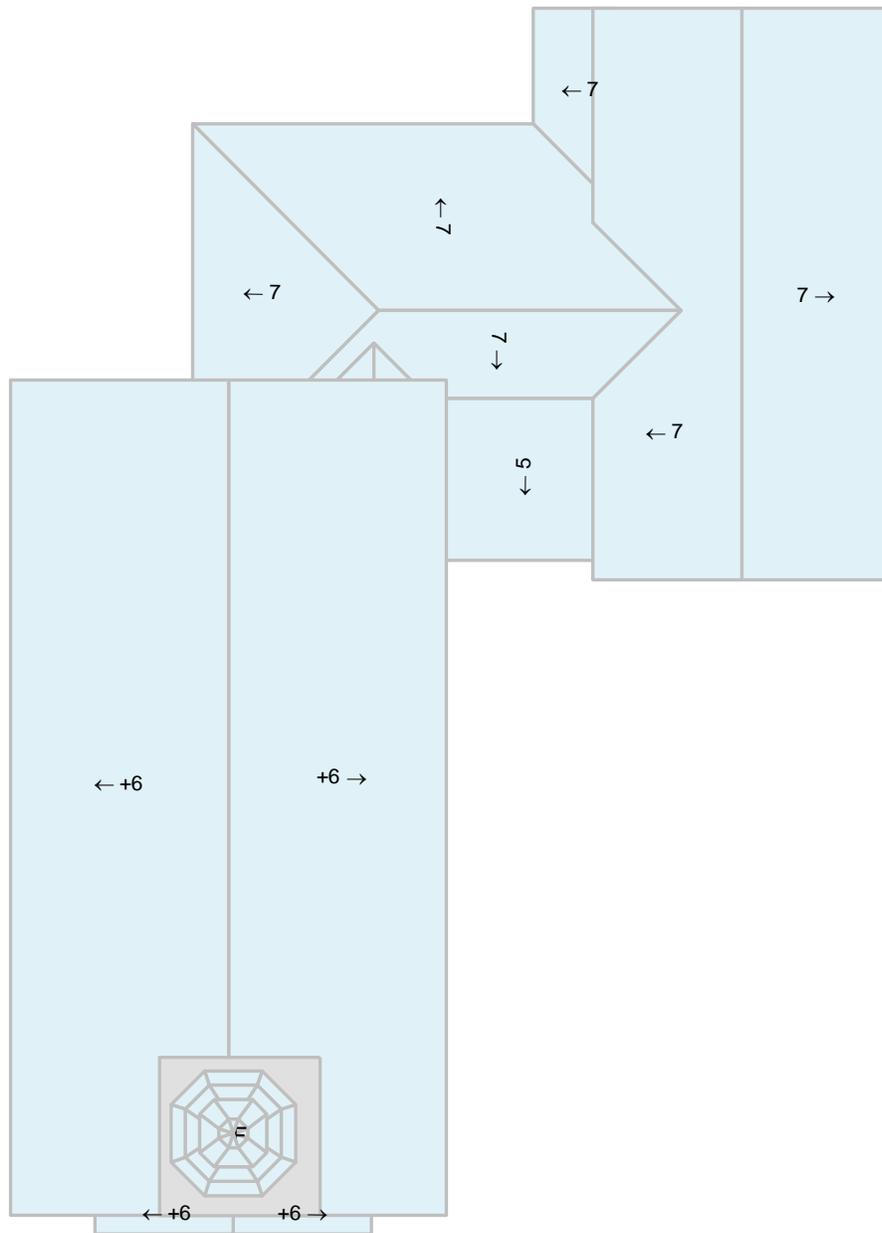
Pitch Diagram

Pitch values are shown in inches per foot, and arrows indicate slope direction. The predominant pitch on this roof is 6/12.

Note: This diagram contains labeled pitches for facet areas larger than 20 square feet. In some cases, pitch labels have been removed for readability. Plus signs preface some numbers to avoid confusion when rotated (e.g. +6 and +9). Blue shading indicates a pitch of 3/12 and greater. Gray shading indicates flat, 1/12 or 2/12 pitches. If present, a value of "F" indicates a flat facet (no pitch).

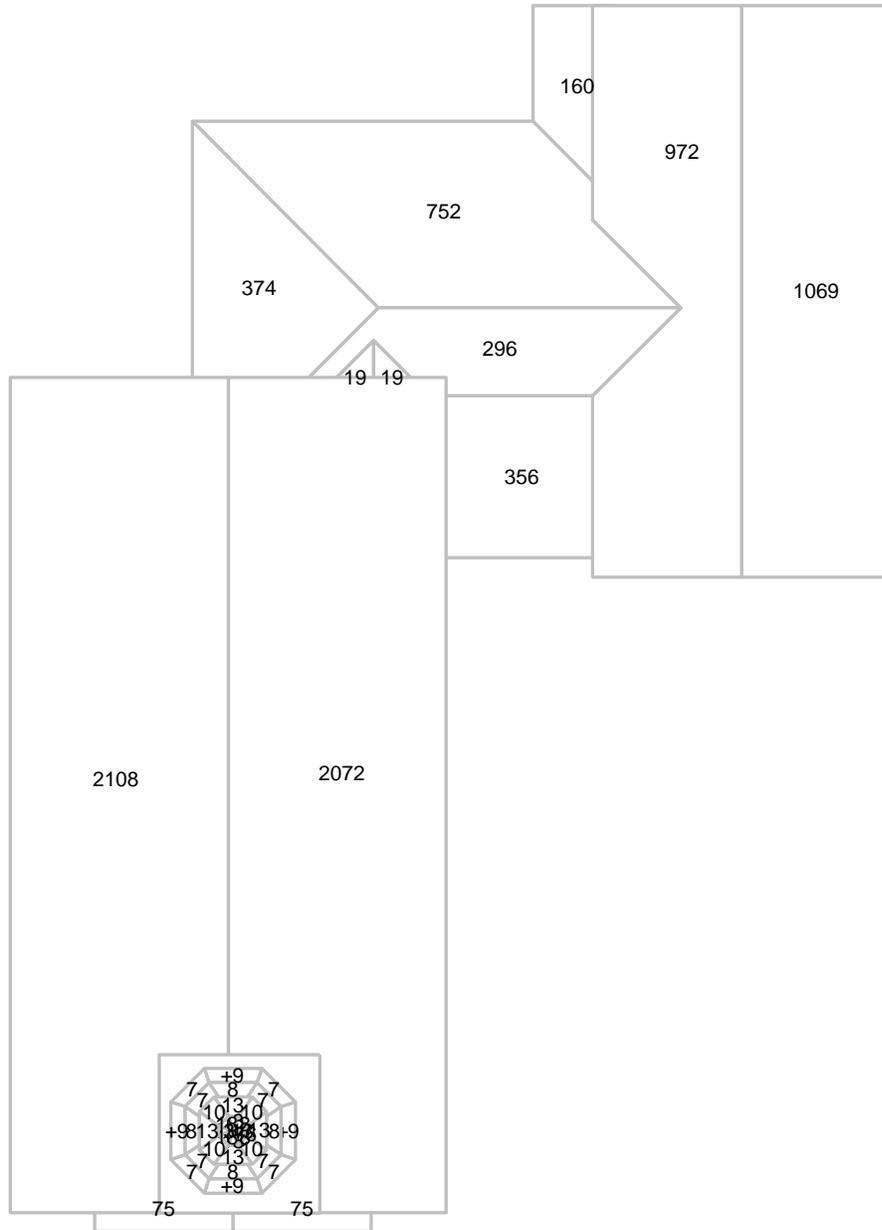
Area Diagram

Total Area = 8,961 sq ft, with 46 facets.

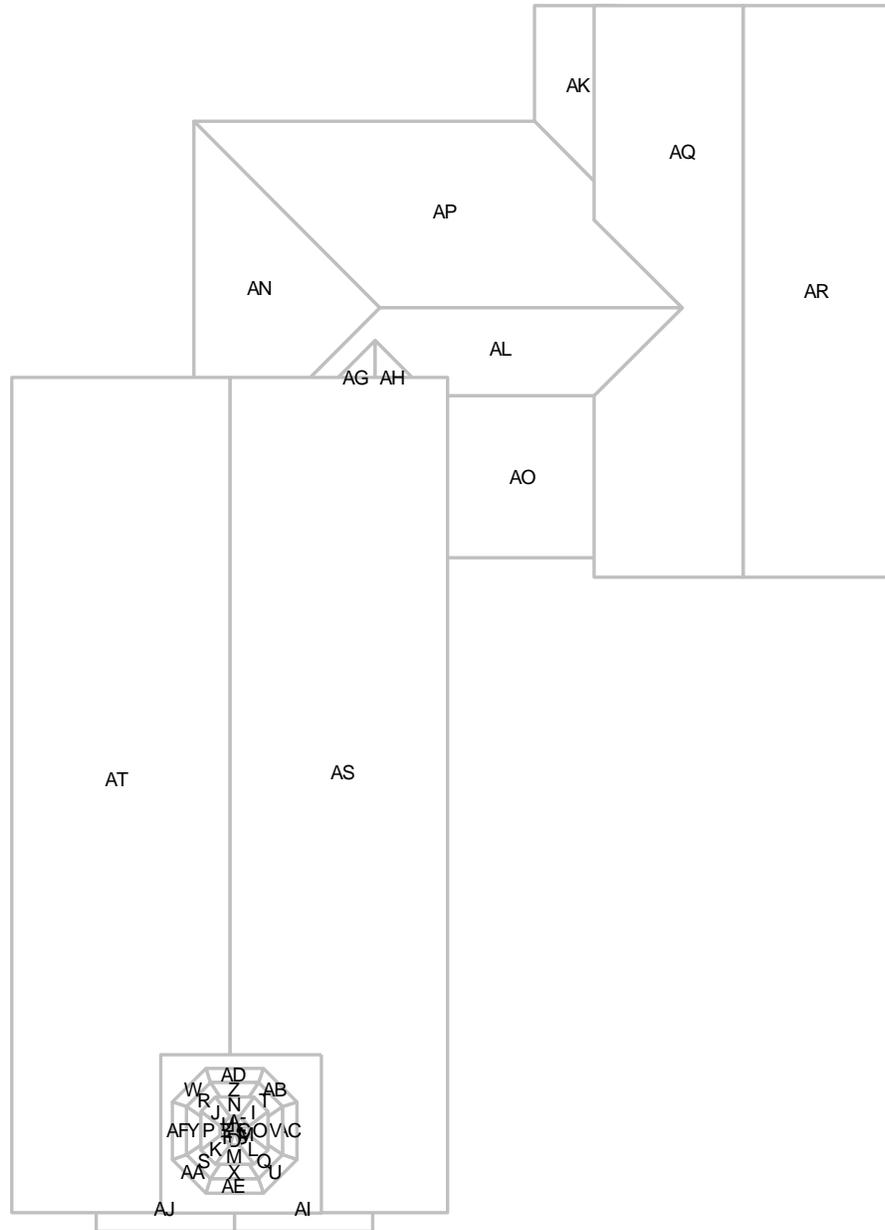
Notes Diagram

Roof facets are labeled from smallest to largest (A to Z) for easy reference.

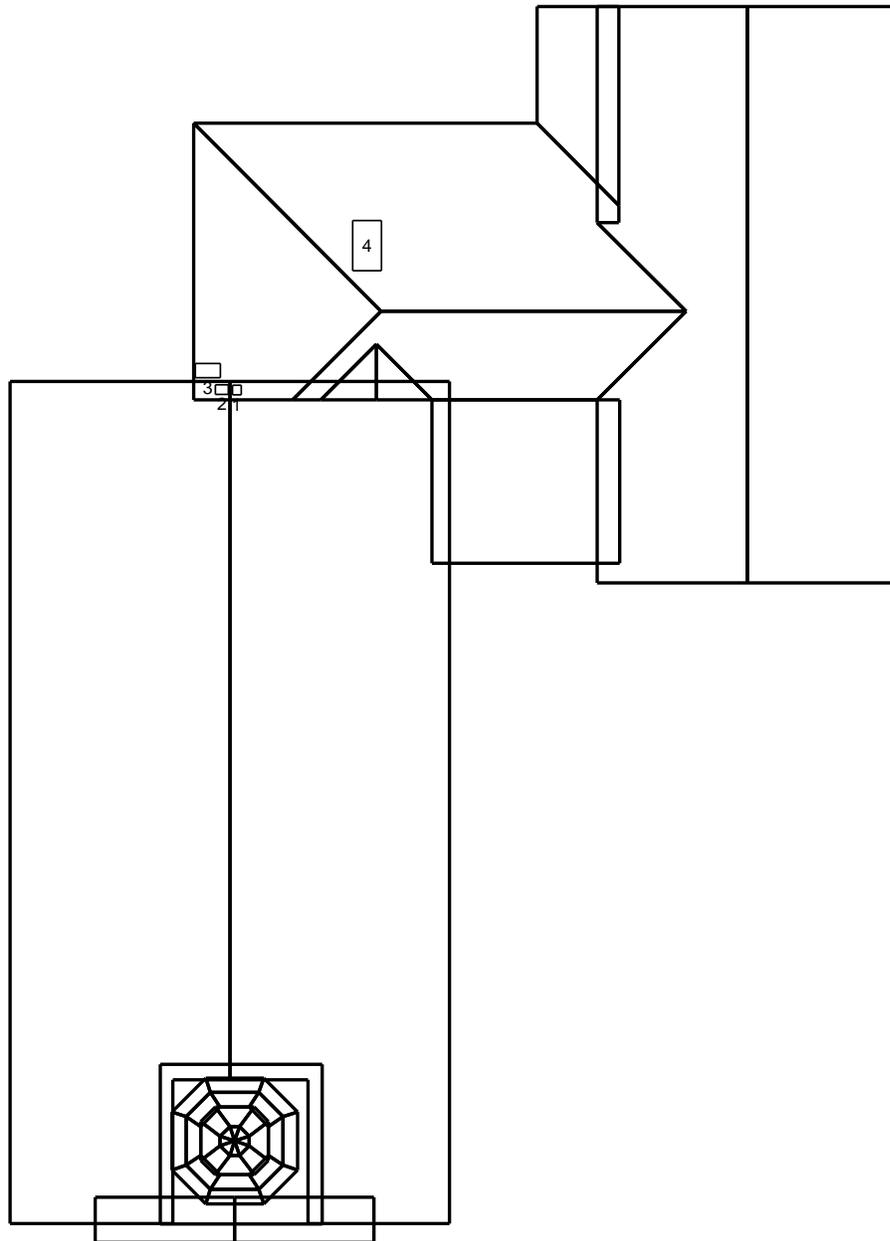
Total Penetrations Perimeter = 36 ft

Total Roof Area Less Penetrations = 8,936 sq ft
