TOWN OF DEERFIELD
FACILITIES CONDITION ASSESSMENT
OF
TOWN BUILDINGS

**Department of
Public Works**

Gorman Richardson Lewis Architects

Executive Summary

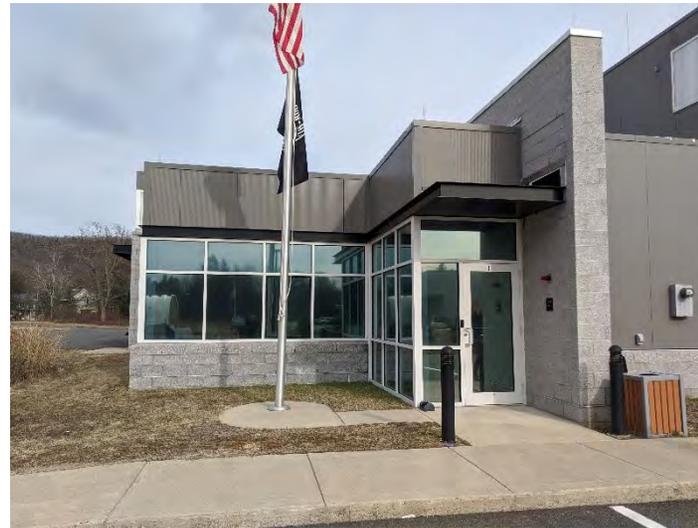
OVERVIEW PHOTOGRAPH

In this section of the Facilities Condition Assessment Report, RRC Engineering presents a summary of observations regarding the condition of the DPW building, including summary description of structural systems and recommendations for action to be taken.

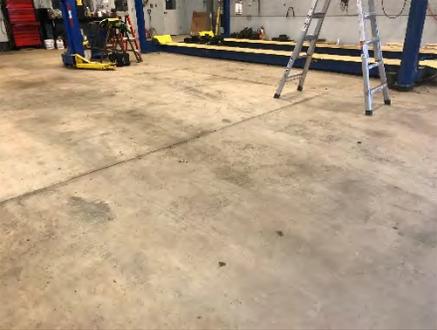
| Component | Deficiency | Description | Photograph |
|---|--|--|---|
| Foundation/Floor Slab | <input type="checkbox"/> Deterioration <input type="checkbox"/> Weakness <input type="checkbox"/> Settlement <input type="checkbox"/> Other | <ul style="list-style-type: none"> No deficiencies noted. | |

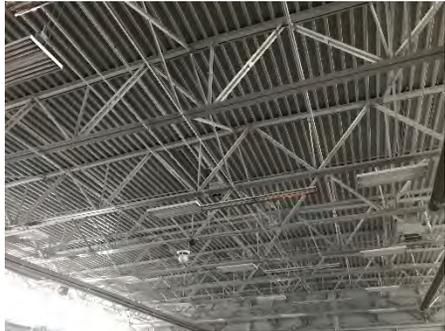
| Roof | <input type="checkbox"/> Deterioration <input type="checkbox"/> Weakness <input type="checkbox"/> Settlement <input type="checkbox"/> Other | <ul style="list-style-type: none">• No deficiencies noted. | |

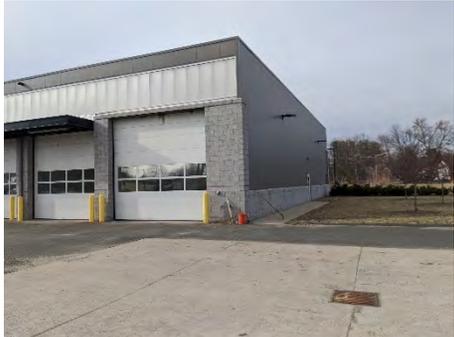
| Exterior Walls | <input type="checkbox"/> Deterioration <input type="checkbox"/> Weakness <input type="checkbox"/> Settlement <input type="checkbox"/> Other | <ul style="list-style-type: none">• No deficiencies noted. | |

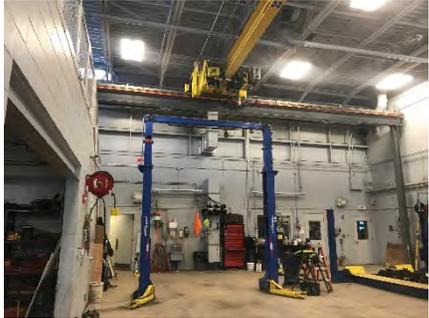
| Other | <input type="checkbox"/> Deterioration <input type="checkbox"/> Weakness <input type="checkbox"/> Settlement <input type="checkbox"/> Other | <ul style="list-style-type: none">• No deficiencies noted. | |

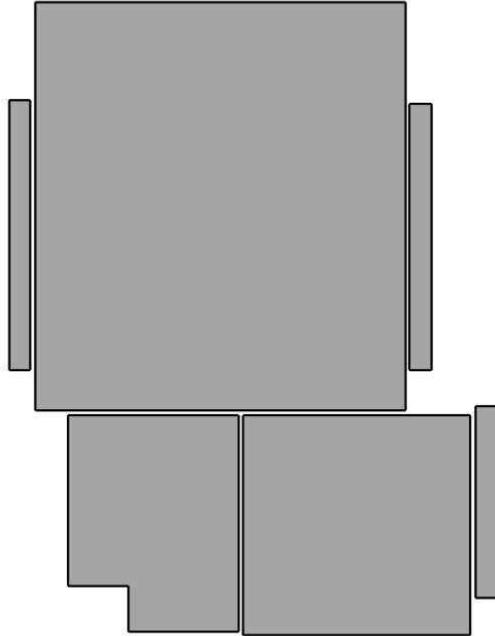
In this 3D model, facets appear as semi-transparent to reveal overhangs.

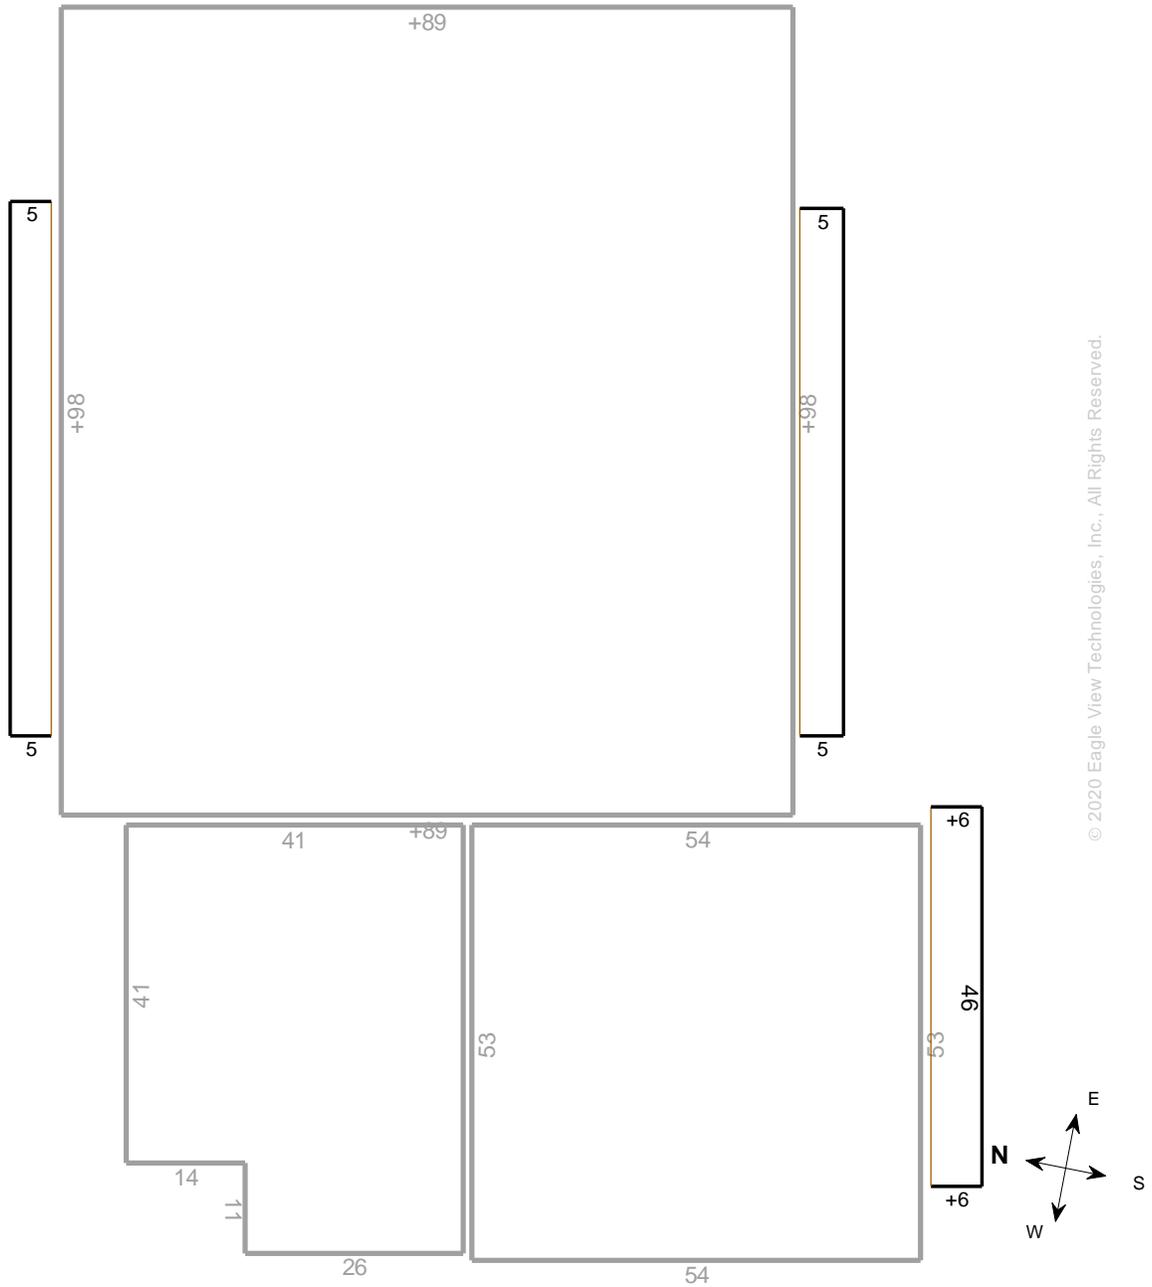
Length Diagram

Total Line Lengths:
 Ridges = 0 ft
 Hips = 0 ft

Valleys = 0 ft
 Rakes = 0 ft
 Eaves = 208 ft

Flashing = 175 ft
 Step flashing = 0 ft
 Parapets = 773 ft

Note: This diagram contains segment lengths (rounded to the nearest whole number) over 5 feet. In some cases, segment labels have been removed for readability. Plus signs preface some numbers to avoid confusion when rotated (e.g. +6 and +9).

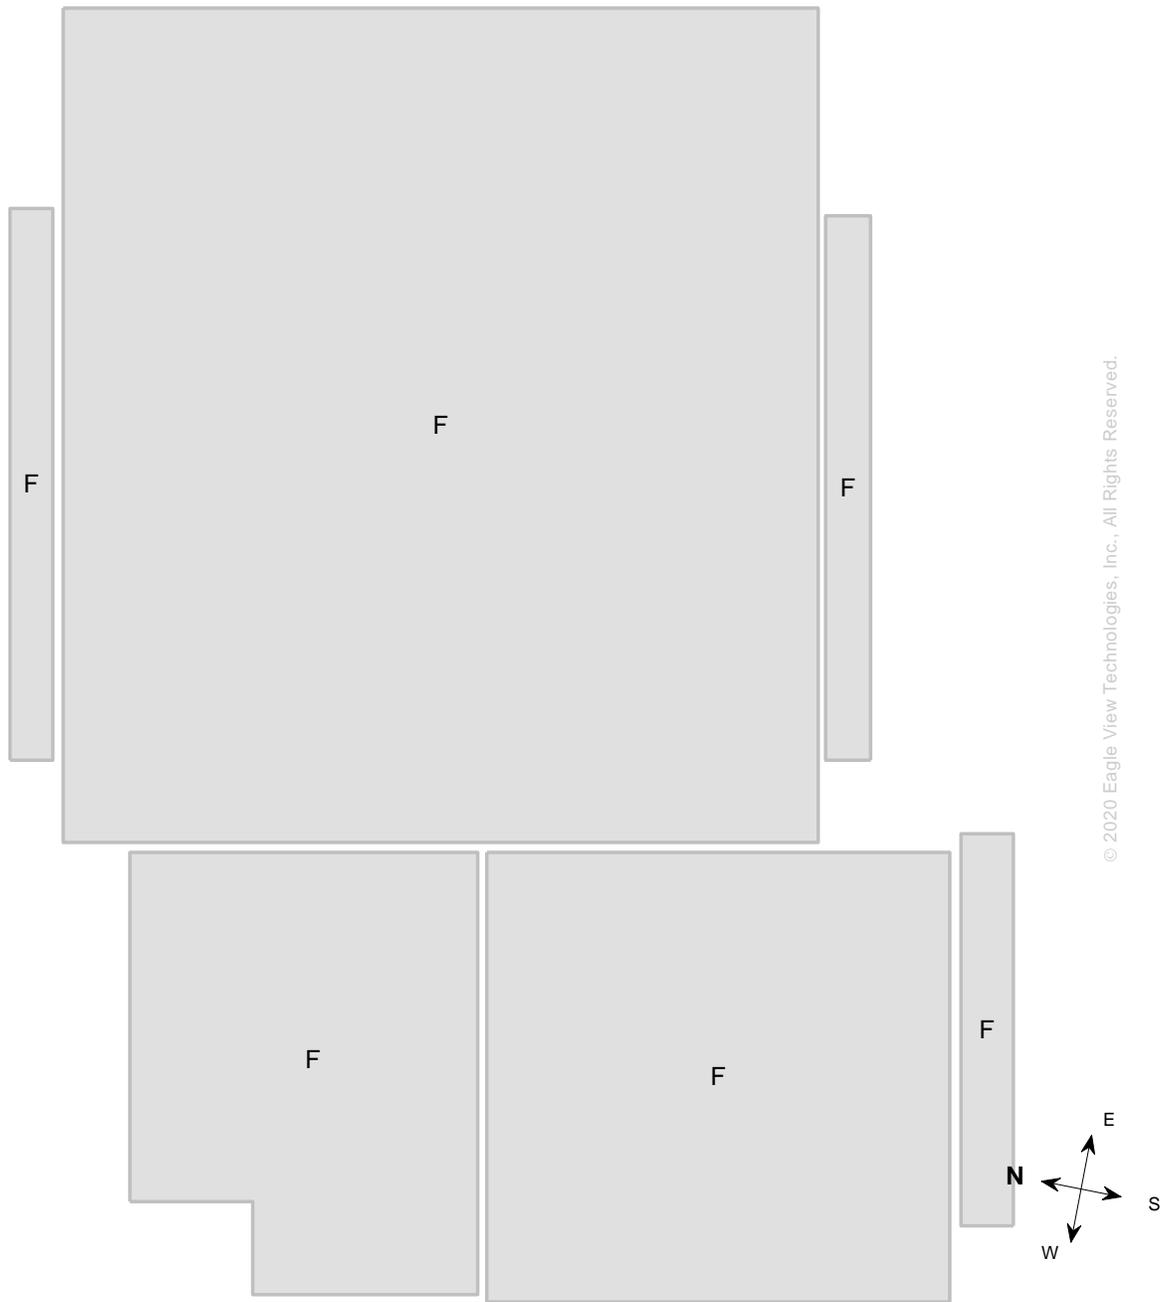
Pitch Diagram

Pitch values are shown in inches per foot, and arrows indicate slope direction. The predominant pitch on this roof is 0/12.

Note: This diagram contains labeled pitches for facet areas larger than 20 square feet. In some cases, pitch labels have been removed for readability. Plus signs preface some numbers to avoid confusion when rotated (e.g. +6 and +9). Gray shading indicates flat, 1/12 or 2/12 pitches. If present, a value of "F" indicates a flat facet (no pitch).

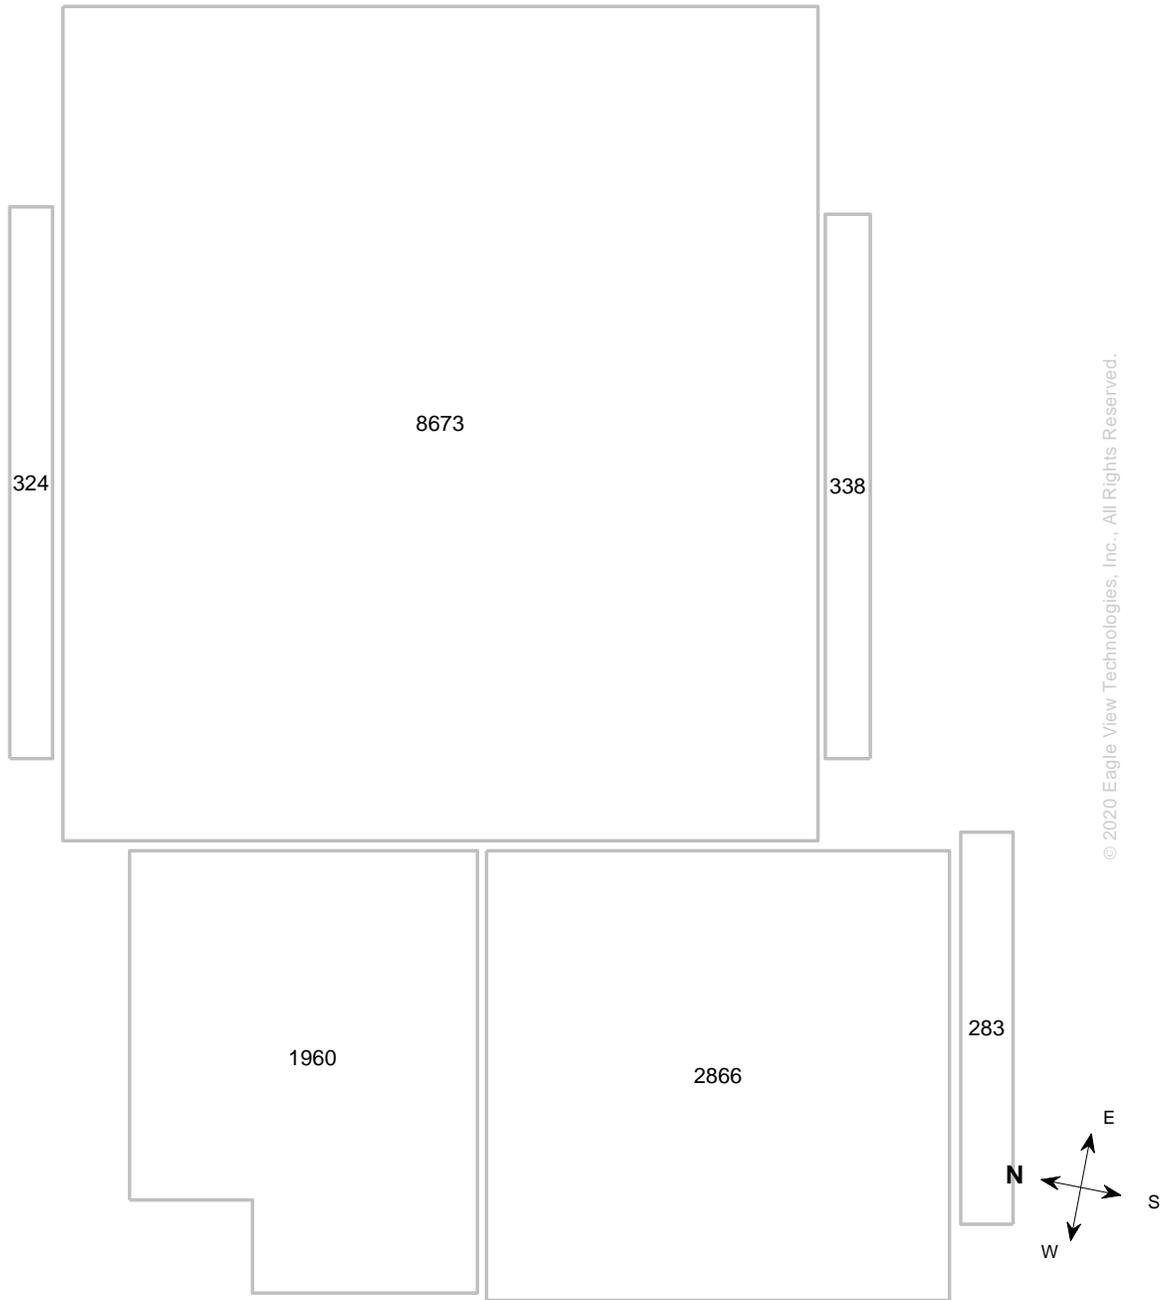
Area Diagram

Total Area = 14,445 sq ft, with 6 facets.

Note: This diagram shows the square feet of each roof facet (rounded to the nearest foot). The total area in square feet, at the top of this page, is based on the non-rounded values of each roof facet (rounded to the nearest square foot after being totaled).

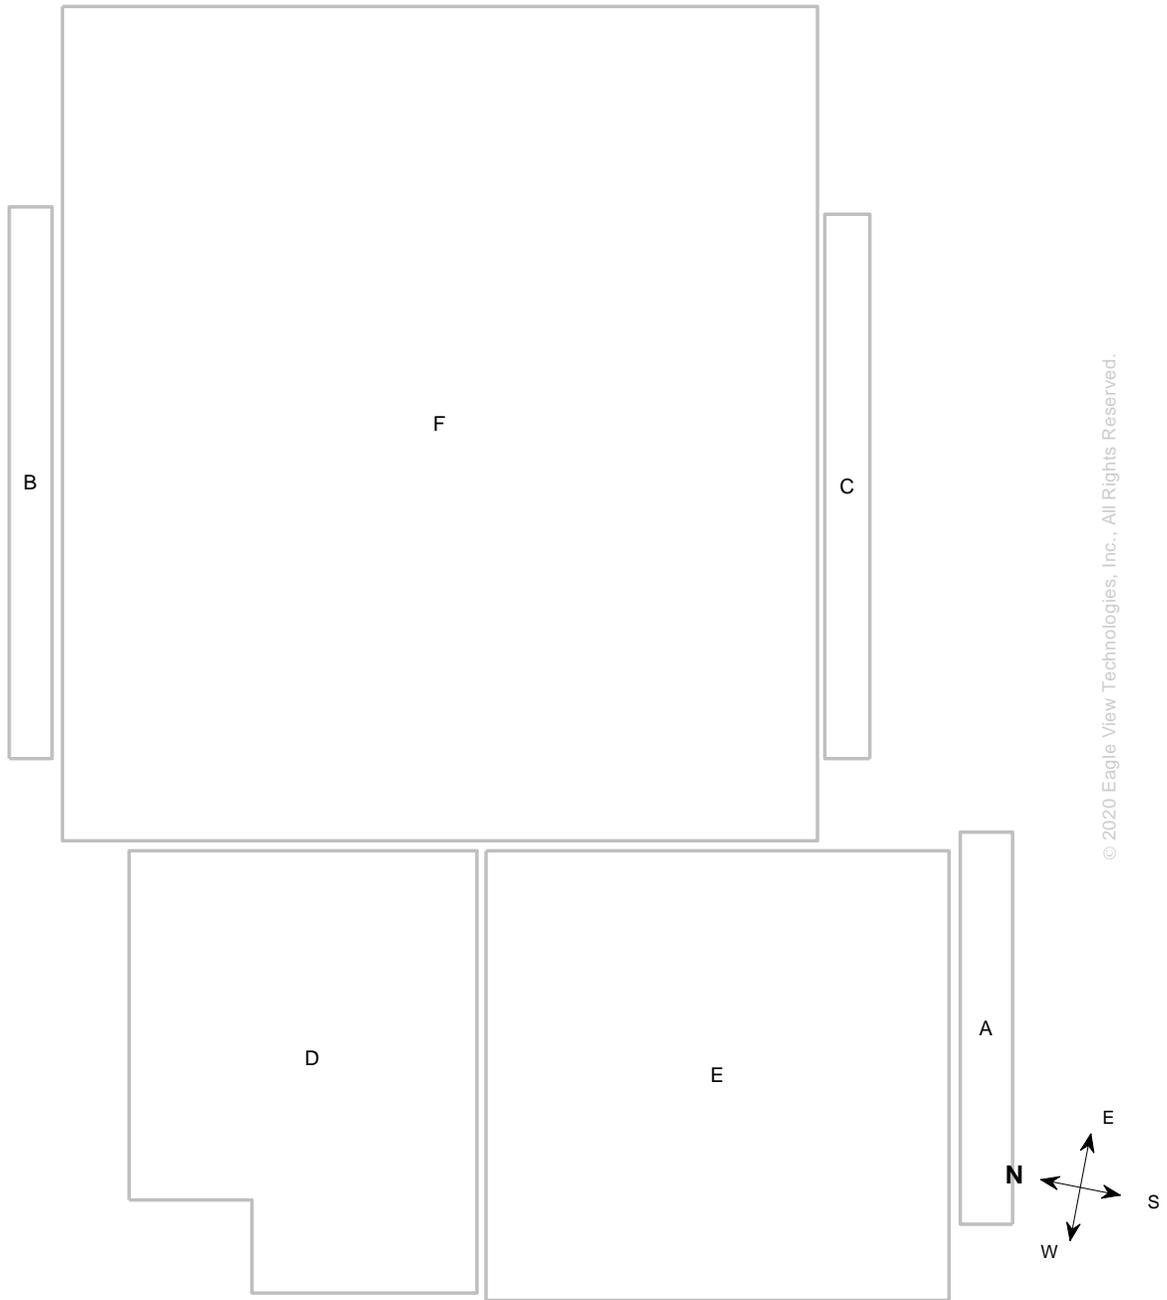
Notes Diagram

Roof facets are labeled from smallest to largest (A to Z) for easy reference.

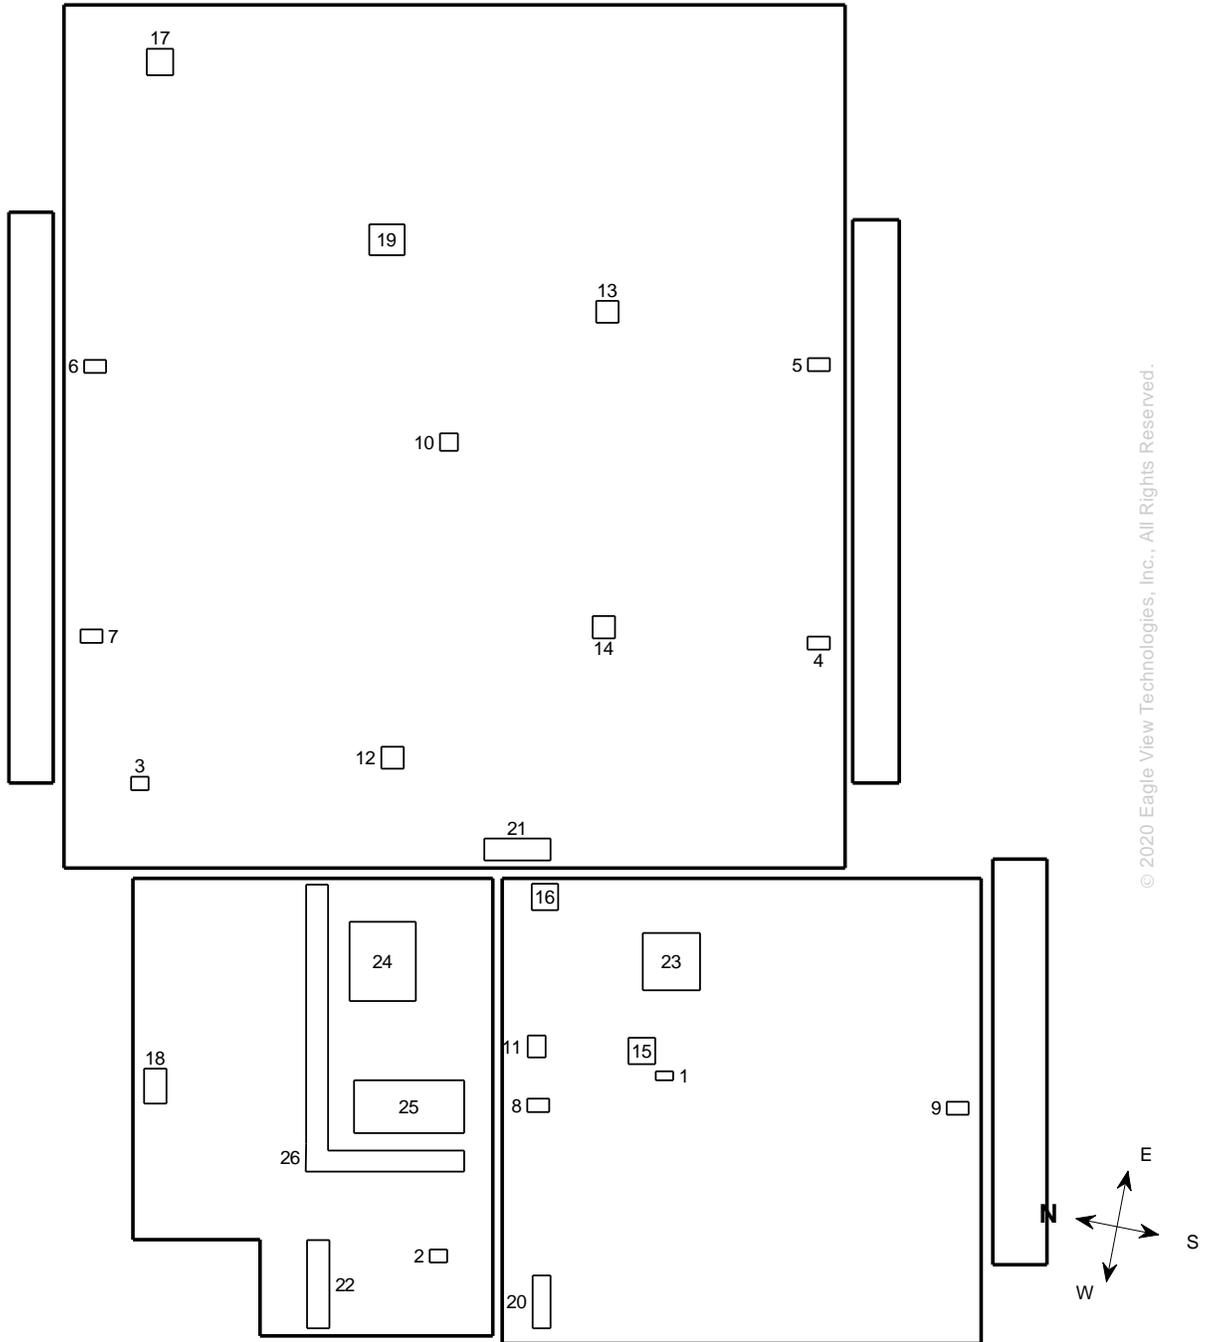
Total Penetrations Perimeter = 437 ft

Total Roof Area Less Penetrations = 13,976 sq ft
