TOWN OF DEERFIELD
FACILITIES CONDITION ASSESSMENT
OF
TOWN BUILDINGS

**Police
Department**

Executive Summary

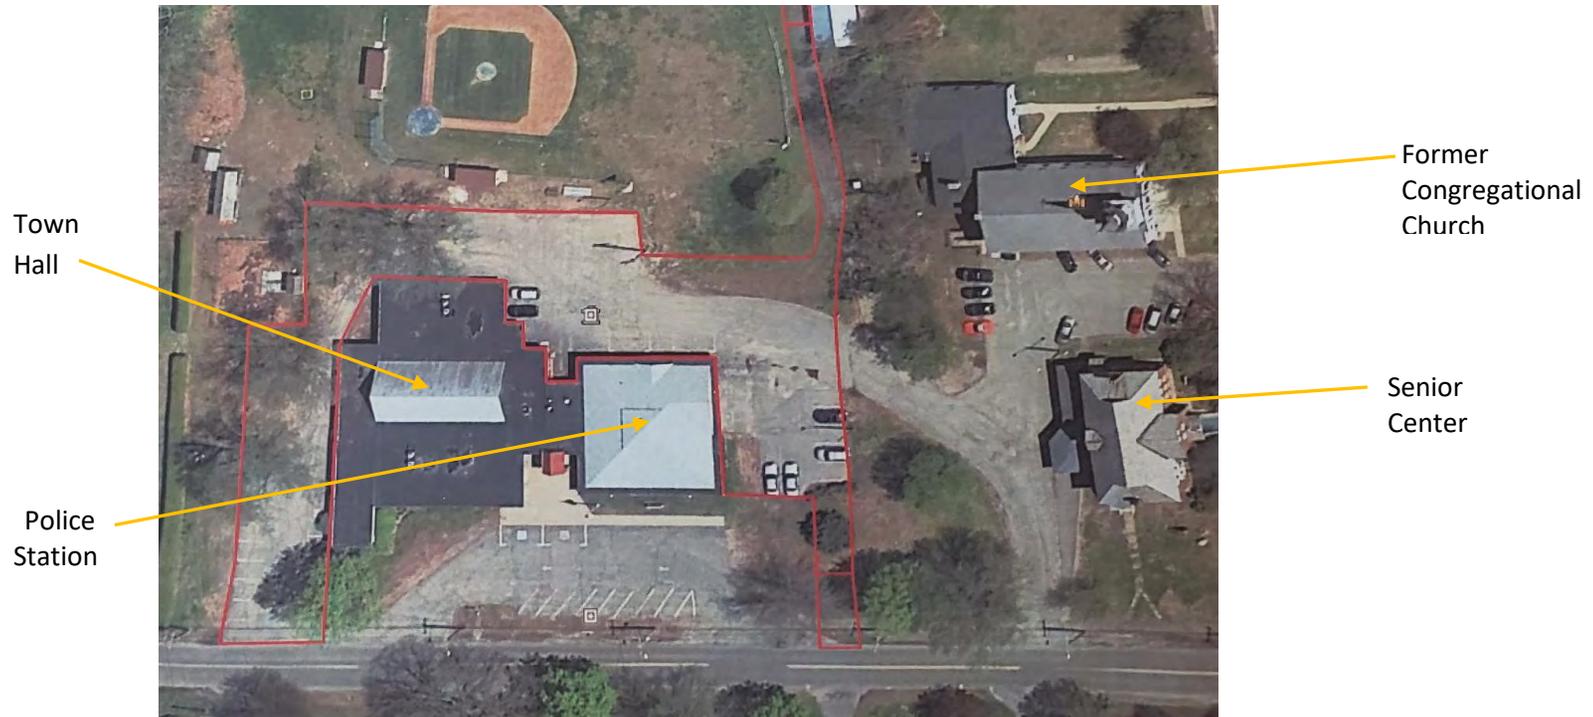
- Lawn areas are worn in areas and overgrown in others. Drainage is very poor with flooding during wet seasons especially along the north portion of the site. The edge of the lawn areas is poorly defined leading to an unsightly encroachment of the planted area into the driveway edge.

Aerial view of municipal complex site

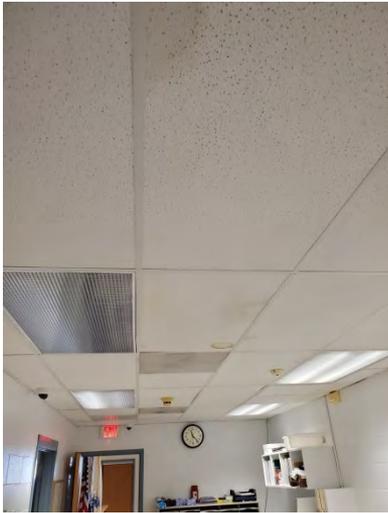
A25 Booking Area Ceiling

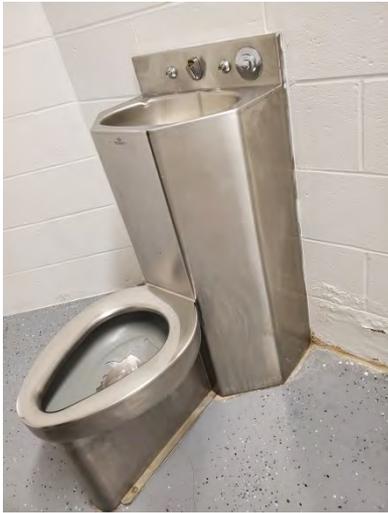
A29 Combination Cell Plumbing Fixture

- Interior floor, wall and ceiling finishes, though currently in serviceable condition will require replacement within 10 years.
- Existing combo plumbing fixtures in the 3 holding cells are deteriorating and should be replaced within 1 to 5 years.

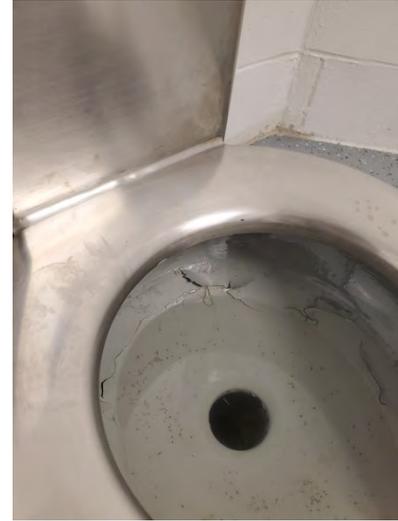
A30 Combination Cell Plumbing Fixture

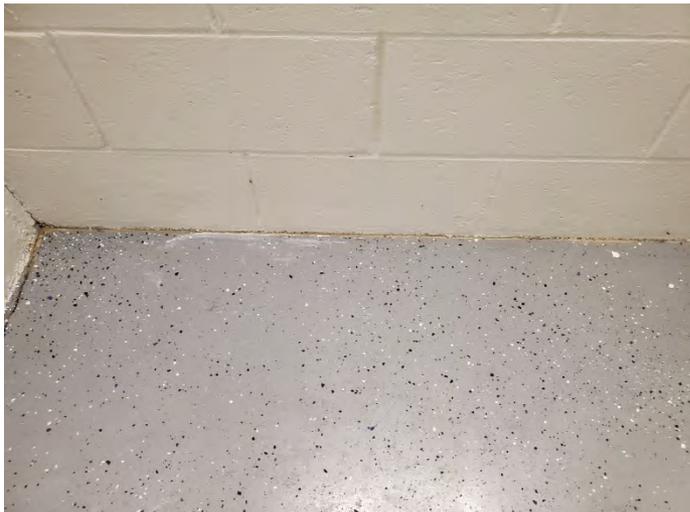
A31 Typical Cell floor & wall finish

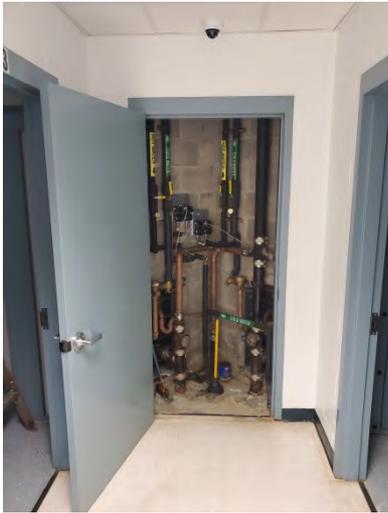
A33 Plumbing Closet to cell water shutoffs

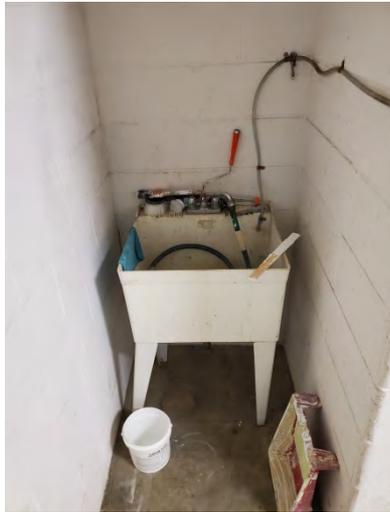
A37 Janitor's sink in Sallyport 117

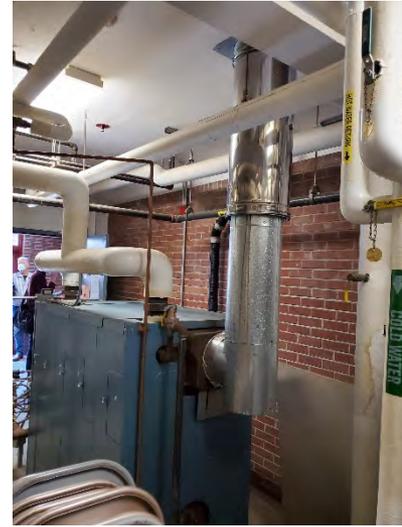
Plumbing	The domestic hot water heater is close to the end of useful life.	100036 100026	Replace domestic water heater with new high efficiency gas-fired water heater.	1	EA			\$ 8,500		
8		HVAC	Heating Boiler, Non Condensing	MEP 10	Remove existing cast iron sectional boiler and abandoned oil tanks in the boiler room and replace with two (2) high efficiency gas fired condensing boilers.	2	EA			\$ 45,000		
9		HVAC	The primary hot water heating pumps are Taco Inline pumps with replacement motors. The fair condition.	MEP 11	Replace existing expansion tank and heating (2) hot water pumps with new energy efficient ECM pumps.	1	LS			\$ 10,000		
10		HVAC	Piping, Insulation	MEP 12	Reuse where possible	5,363	SF					
11		HVAC	Unit heaters	MEP 13	Replace the existing aged baseboard radiators, convectors and cabinet heaters throughout the building.	5,363	SF			\$ 53,000		
12		HVAC	General Exhaust	MEP 14	Upgrade the exhaust fans with new high efficiency, ECM direct drive motor type.	5,363	SF			\$ 21,000

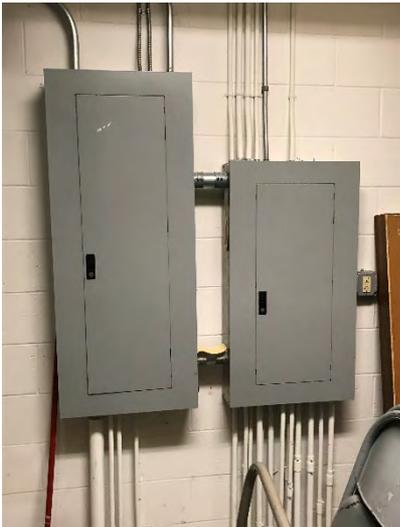
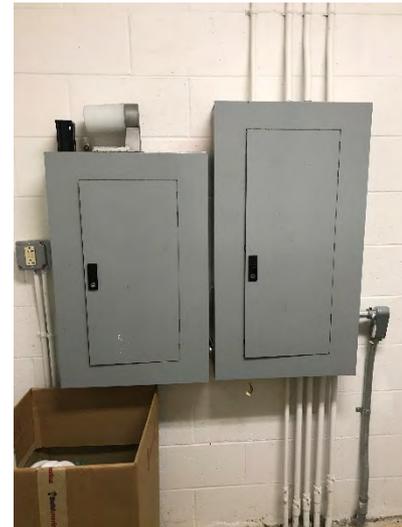
16		Electrical	The existing panels do not have many spare circuit breakers or spaces available for the addition of new lighting and power circuits. There is no surge protection device (SPD) installed in these panels.	MEP 19 & 20	Replace sub panels to provide expansion room for additional circuits; include surge protection at each panel.	4	EA		TBD			
17		Equipment	Branch Circuits - Existing offices have approximately one receptacle per wall. Extension cords are being used in IDF Closet and on top of some desks.	MEP 21 & 22	Additional receptacles shall be installed in areas where extension cords are being used.	8	EA		TBD			
18		Electrical/ Lighting Fixtures	Interior Lighting - Existing lighting generally consists of 2'x4' recessed mounted fluorescent fixtures. The light fixtures have T8 fluorescent lamps with electronic ballasts.	MEP 23 - 28	All existing fluorescent lighting should be replaced with new energy saving LED type fixtures. Occupancy sensors should be installed to conserve energy when space is unoccupied.	5,363	SF			\$ 25,000
