**TOWN OF DEERFIELD**  
**FACILITIES CONDITION ASSESSMENT**  
**OF**  
**TOWN BUILDINGS**

**Senior**  
**Center**

**Gorman Richardson Lewis Architects**

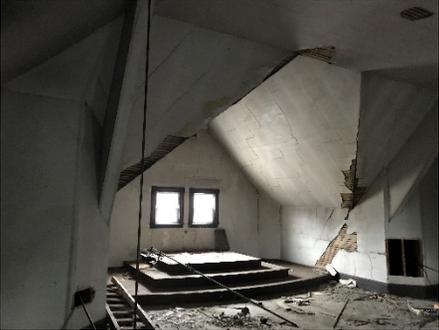
<ul style="list-style-type: none"> <li>The second and third floor appears to be settling and is quite uneven throughout.</li> </ul>	
Roof	<input checked="" type="checkbox"/> Deterioration <input type="checkbox"/> Weakness <input type="checkbox"/> Settlement <input type="checkbox"/> Other	<ul style="list-style-type: none"> <li>Plaster ceiling in attic space is severely damaged by previous or ongoing roof leaks, with large areas spalled and cracks throughout. Exposed areas of timber framing show evidence of moisture stains.</li> </ul>

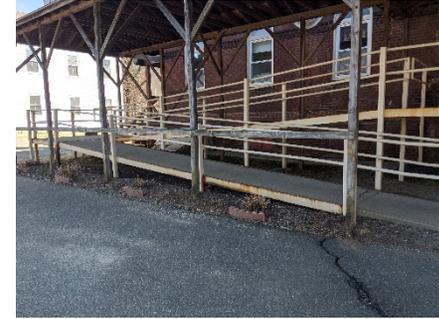
- Wood framed canopy structure over concrete ramp structure at rear of building appears very “lightly” framed with tall 4x4 posts with limited lateral bracing. The wood appears weathered from exterior exposure and lack of maintenance.
- Several steel pipe posts supporting the concrete ramps are corroding and should be repaired/repainted to prolong their useful life.

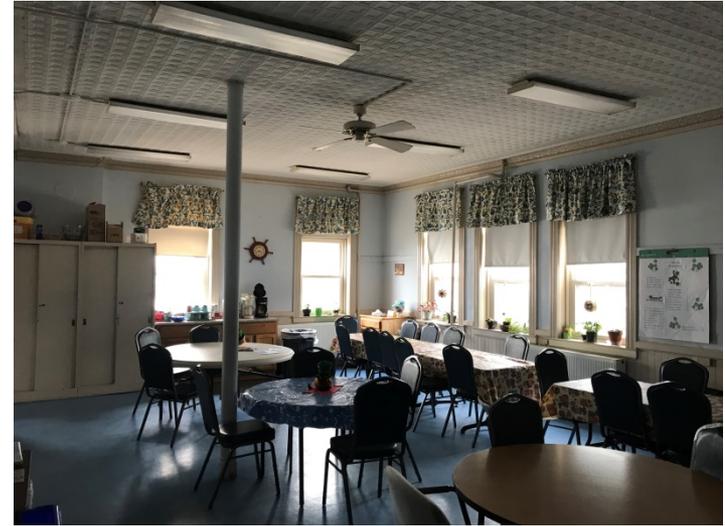
1-12 Dining Room 106

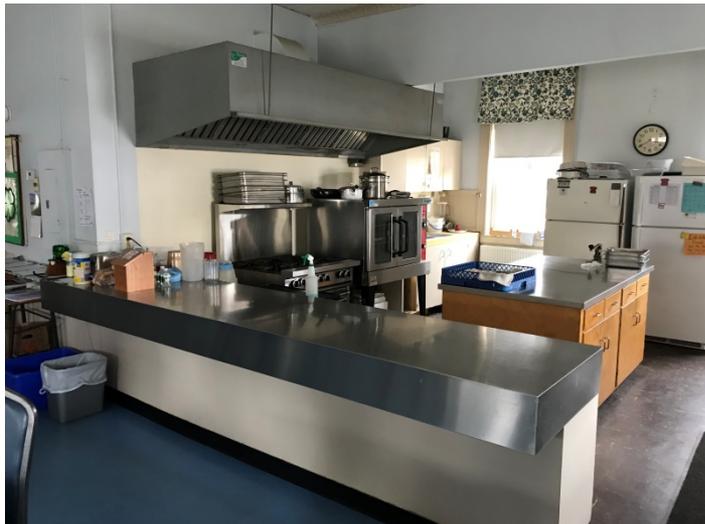
1-13 Dining with serving counter

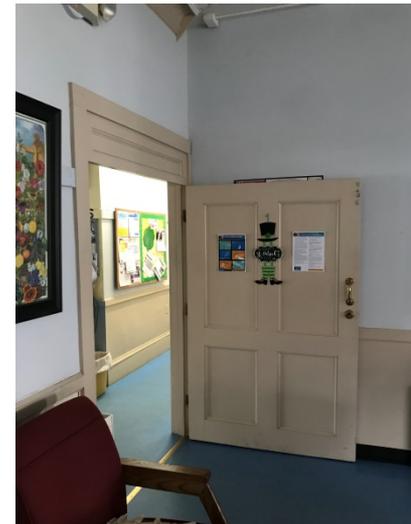
1-14 Door from Dining Room to Corridor 100

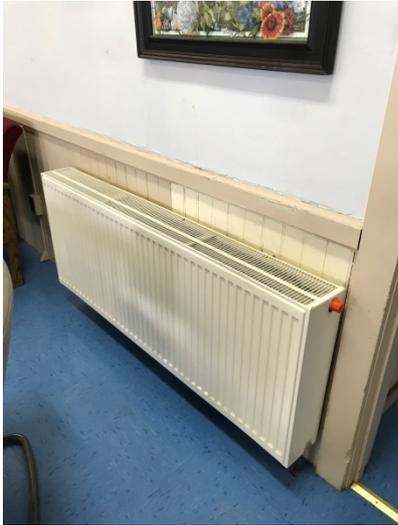
1-15 Dining Room 106 typical radiator

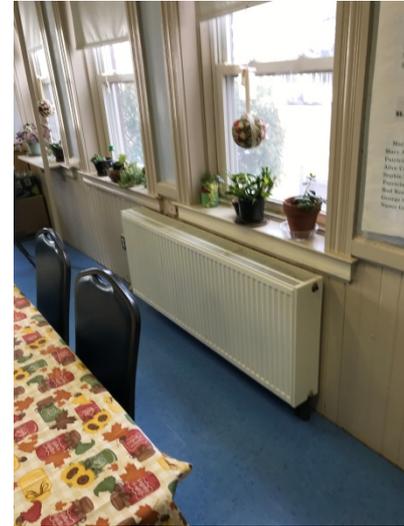
1-16 Dining Room 106 typical radiator

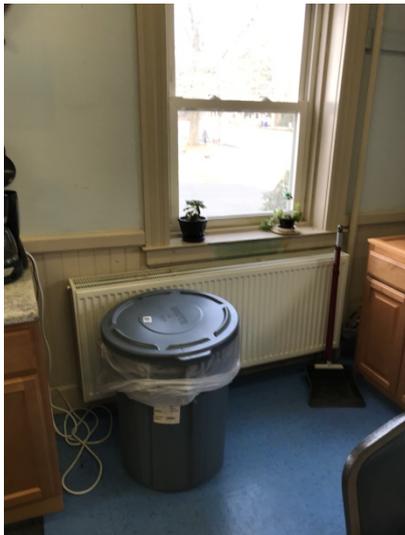
1-17 Dining Room 106 typical radiator

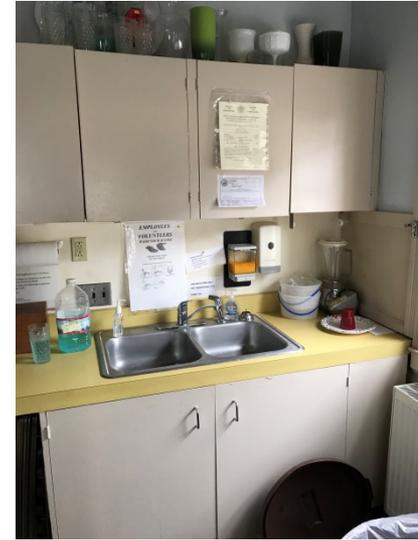
1-20 Kitchen 107 toward dishwashing area

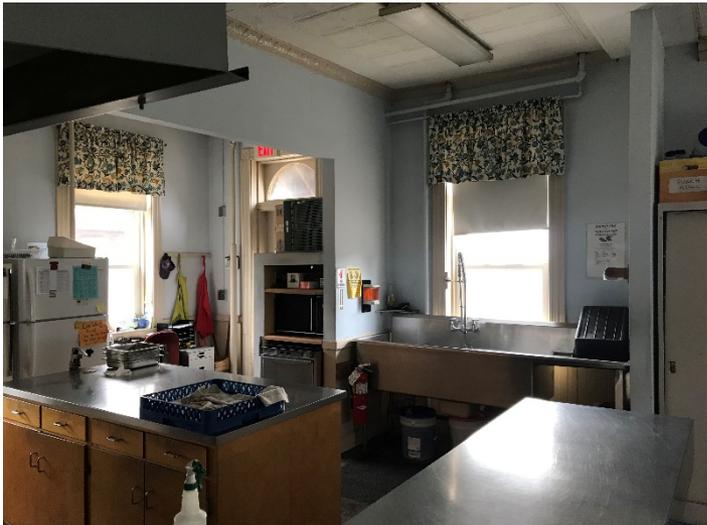
1-21 Kitchen 107 toward pot sink

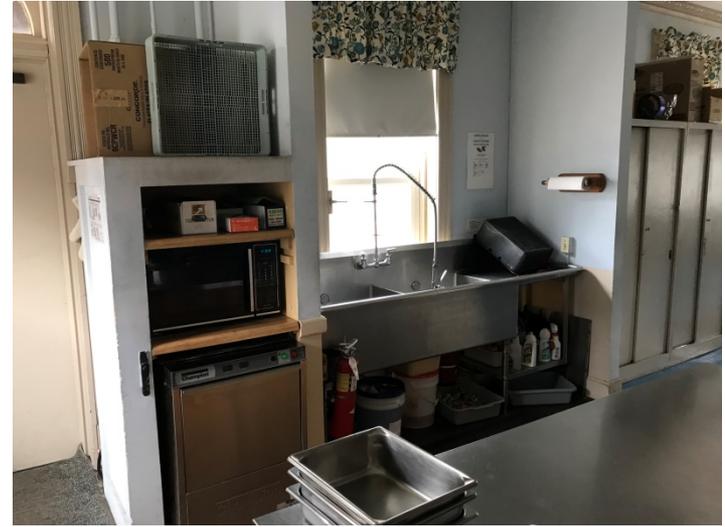
1-24 Kitchen 107 dishwasher & pots sink

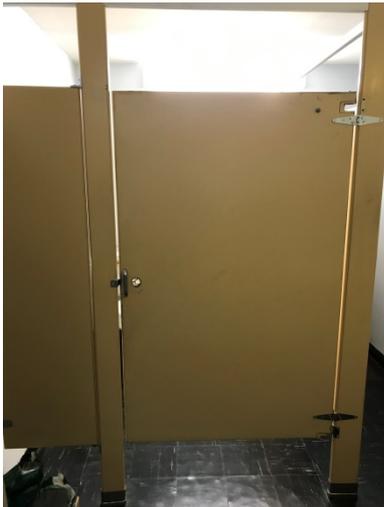
1-25 Men's Room 105 metal toilet partitions

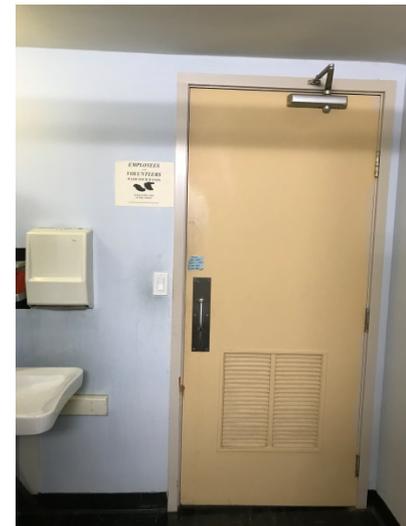
1-26 Men's Room 105 entry door

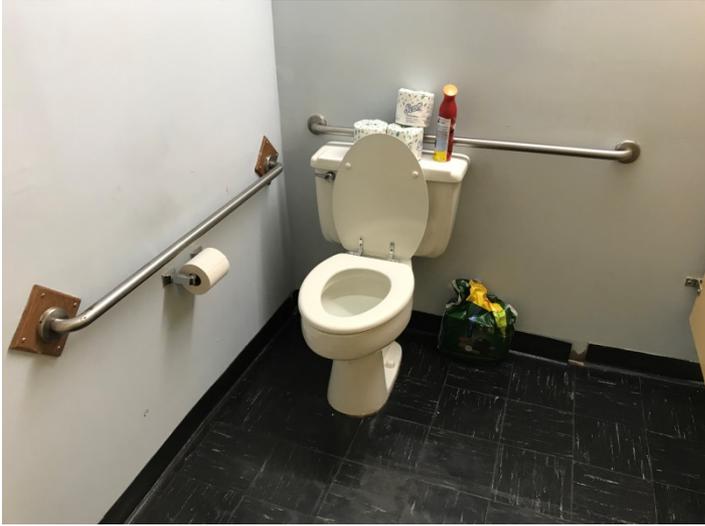
1-27 Men's Room 105 water closet

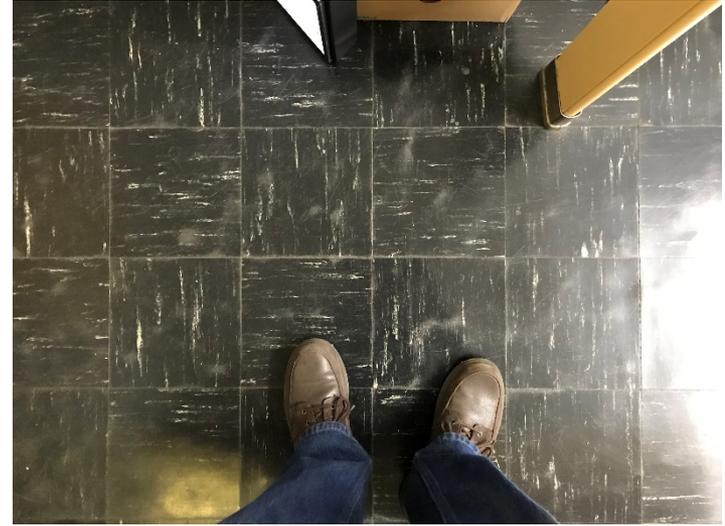
1-28 Men's Room 105 floor

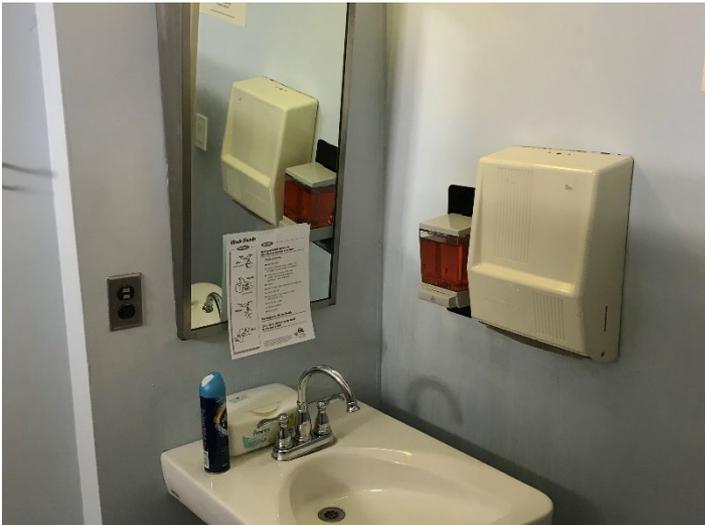
1-29 Men's Room 105 Lav

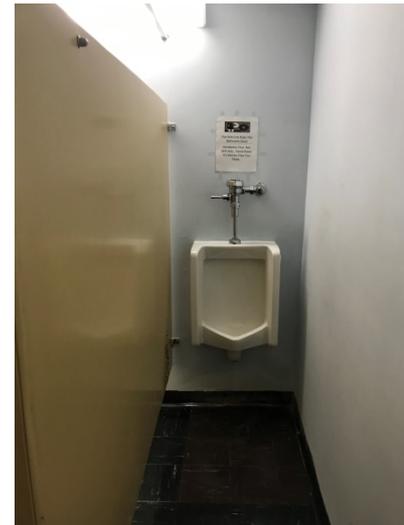
1-30 Men's Room 105 urinal

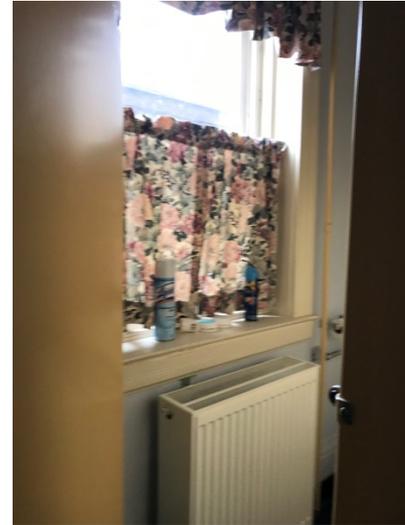
1-32 Women's Room 104 radiator

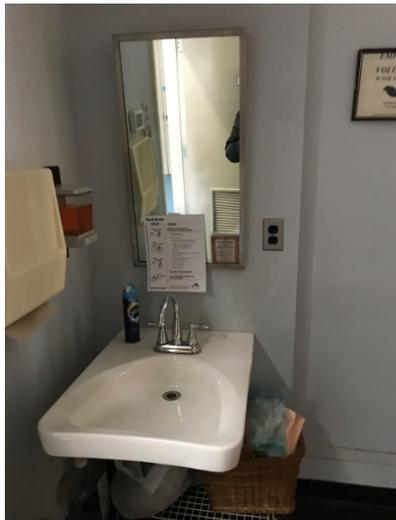
1-33 Women's Room 104 Lav

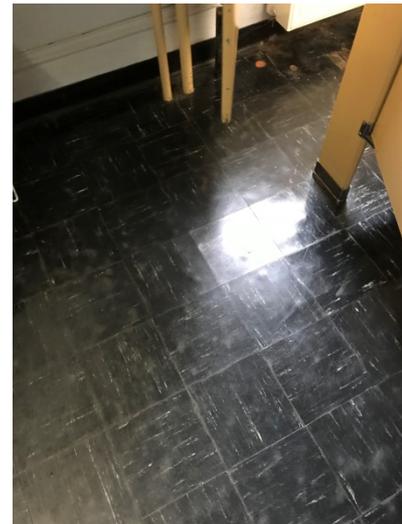
1-34 Women's Room 104 floor

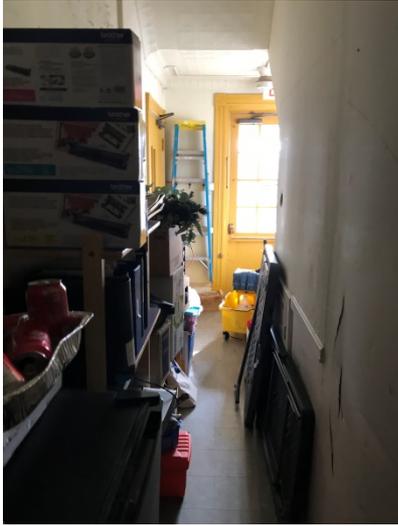
1-35 Egress Hallway 102 toward egress door

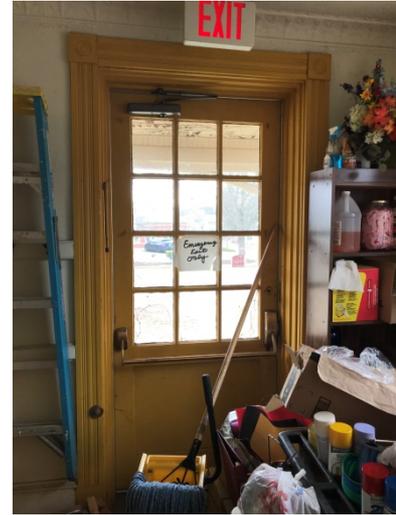
1-36 Egress Hallway 102 Egress Door

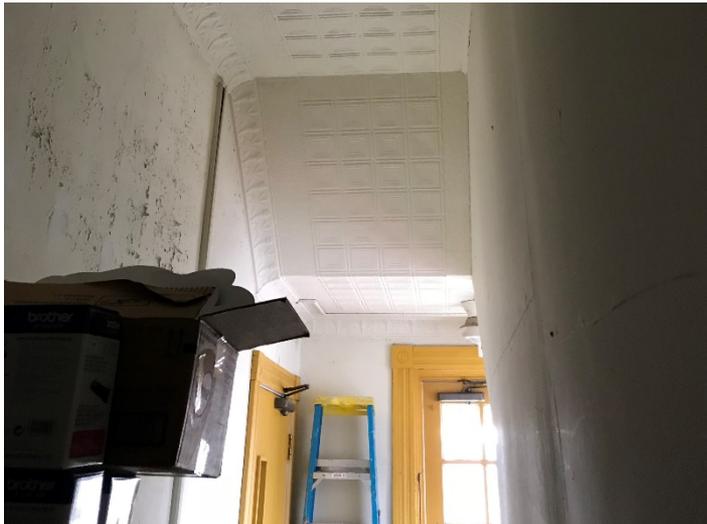
1-37 Egress Hallway 102 ceiling

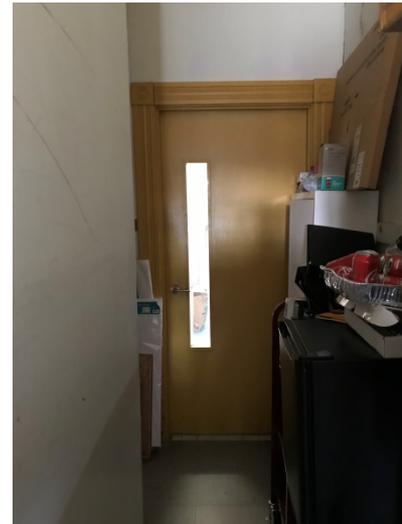
1-38 Egress hallway 102 Door to Office 103

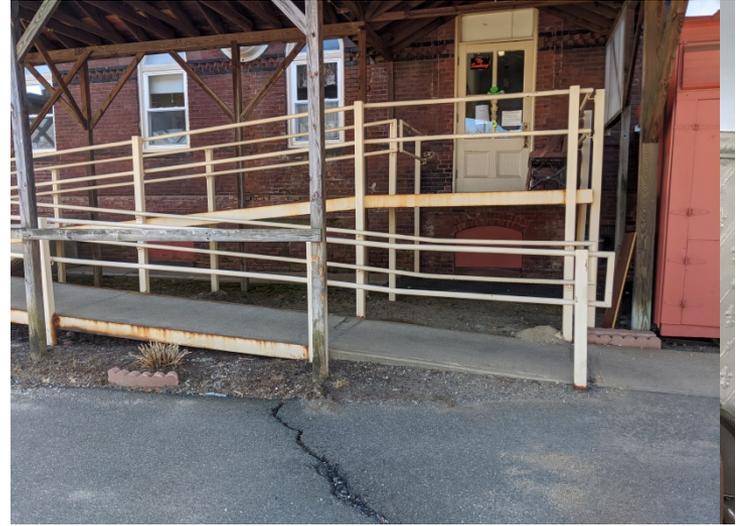
10	Rear (West Building Façade)	Roof Assembly	Wood framed canopy structure over concrete ramp structure at rear of building appears very "lightly" framed with tall 4x4 posts with limited lateral bracing. The wood appears weathered from exterior exposure and lack of maintenance.		Canopy roof assembly to be removed as part of a full-building renovation	See Architecture Interior Report for more information.					
11	Rear Entry	Ramp structure	Several steel pipe posts supporting the concrete ramps are corroding and should be repaired/repainted to prolong their useful life.		Scrape and repaint rusted components of ramp; Ramp to be removed as part of a full-building renovation.. See Architectural Report for more information.	See Architecture Interior Report for more information.					
<b>STRUCTURAL SCOPE TOTALS</b>							\$ -	\$ 17,500	\$ -	\$ -	
							0-11 mths Costs	1-5 yrs Costs	5-10 yrs Costs	11-20 yrs Costs

1-44 Rear Entry ramp and door

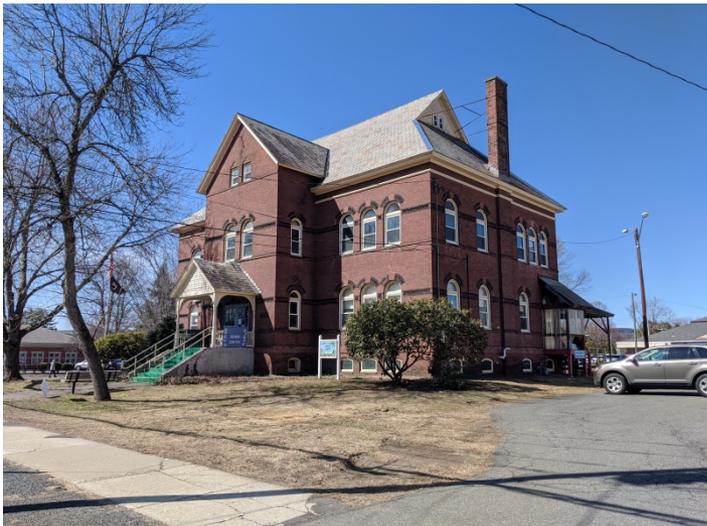
1-45 Front facade

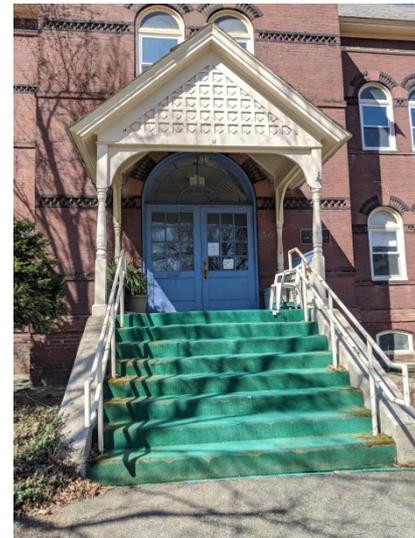
1-46 Front Entry Porch

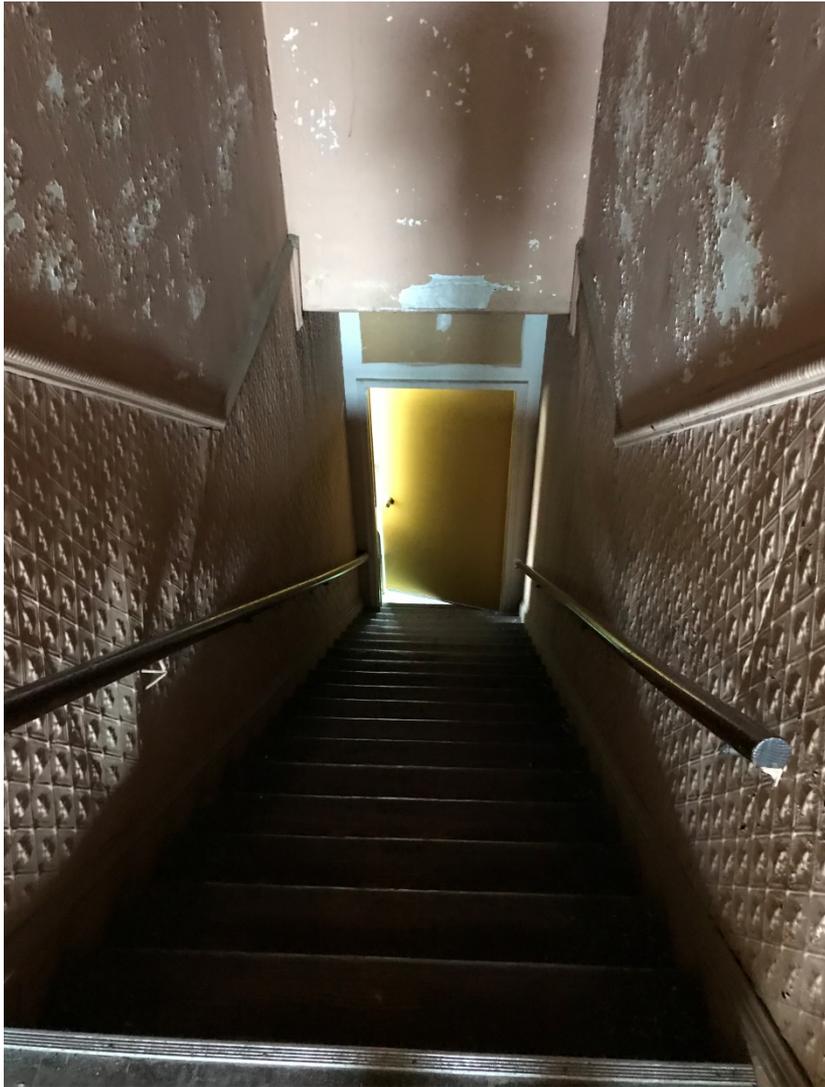
2-1 Stair 1 at Corridor 200

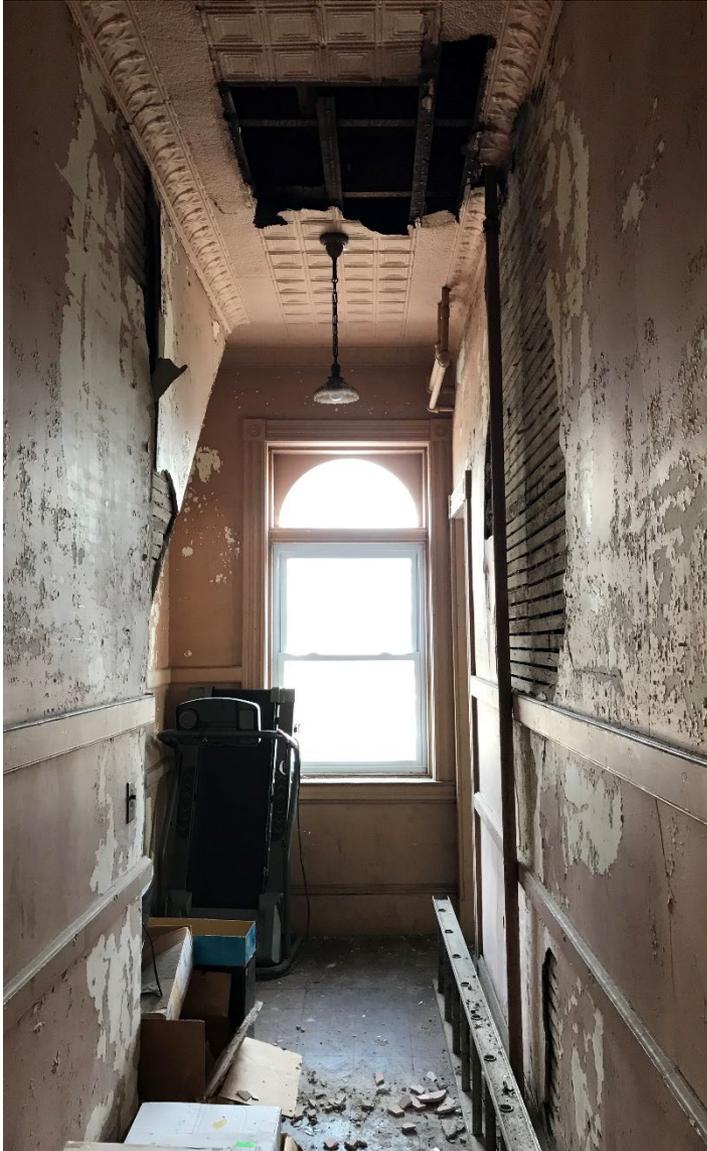
2-3 Corridor 200

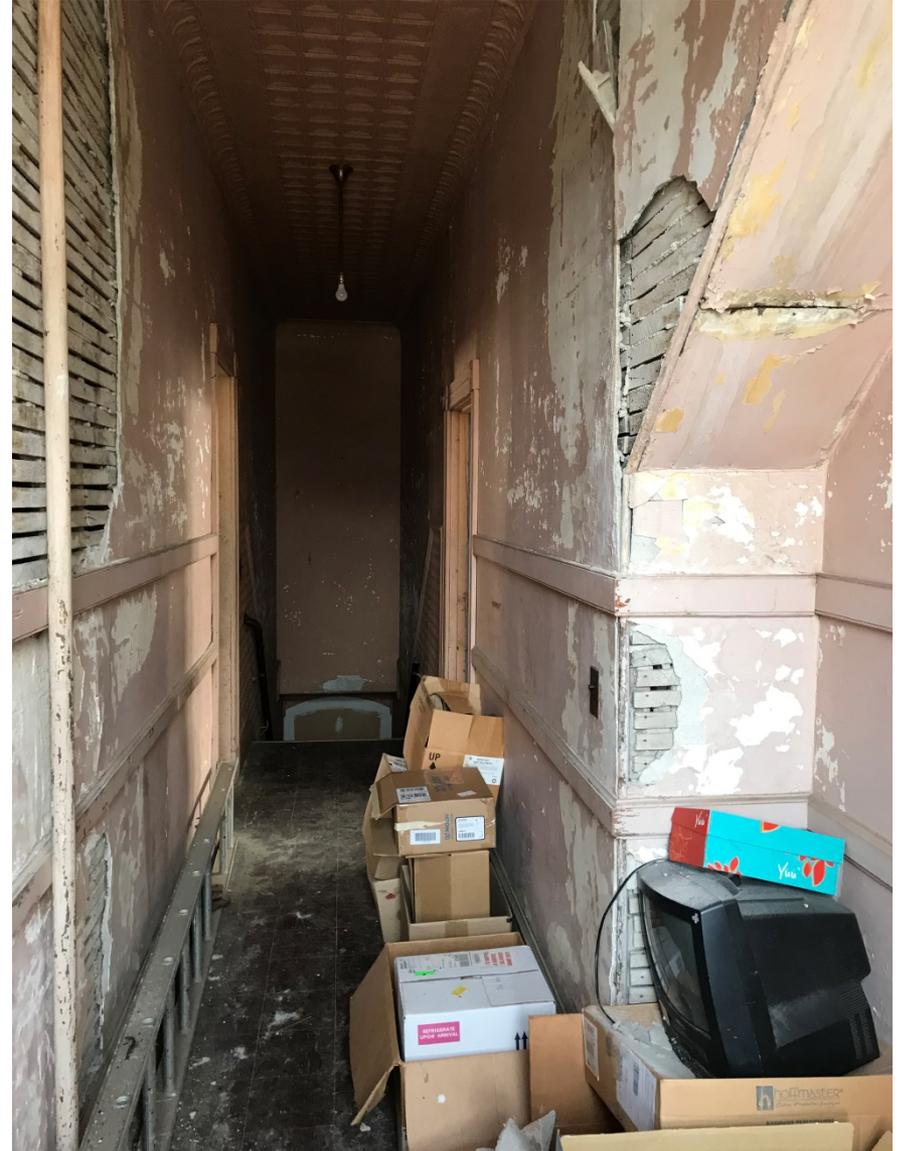
2-4 Corridor 200

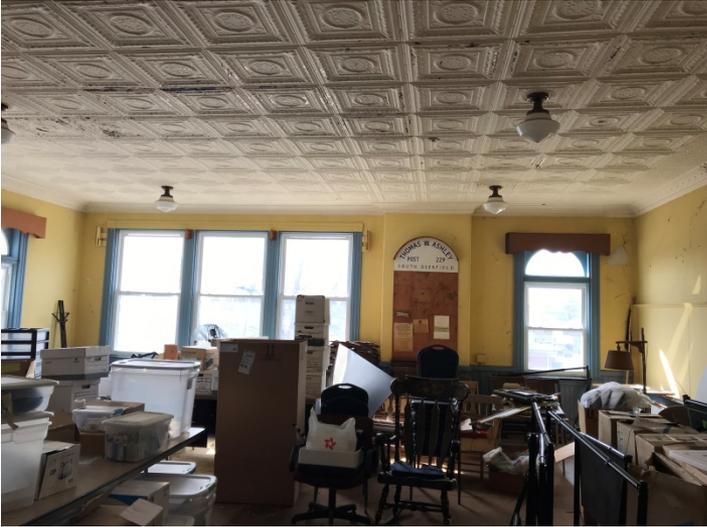
2-5 Room 201-looking south

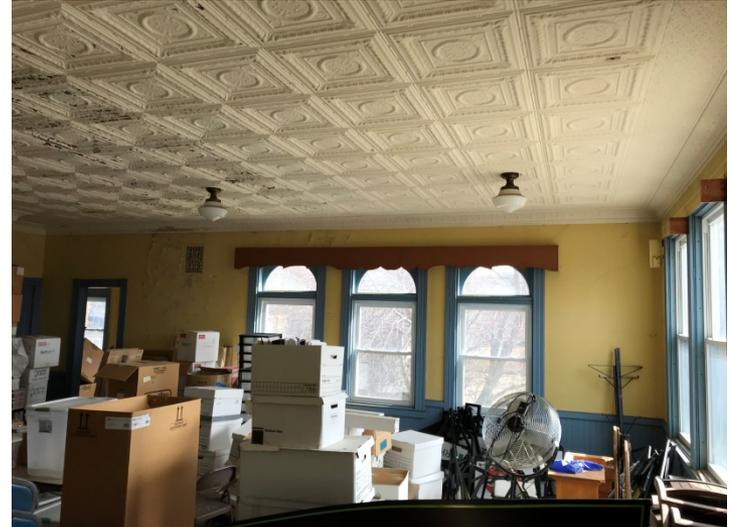
2-6 Room 201 – looking east

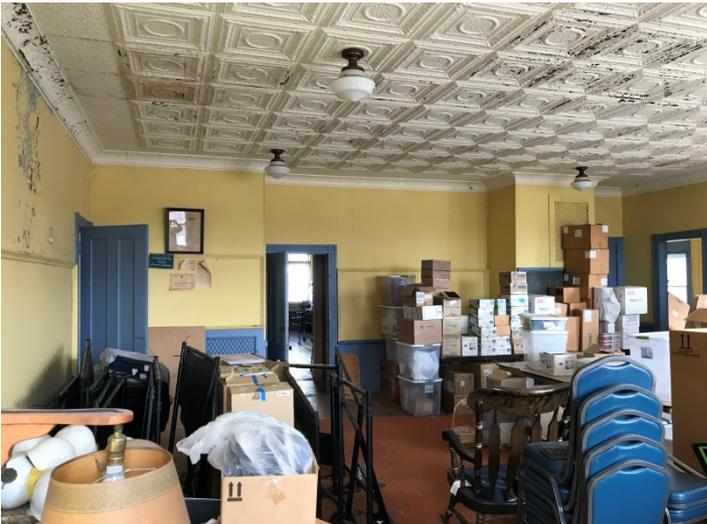
2-7 Room 201- looking north (toward Corridor 200)

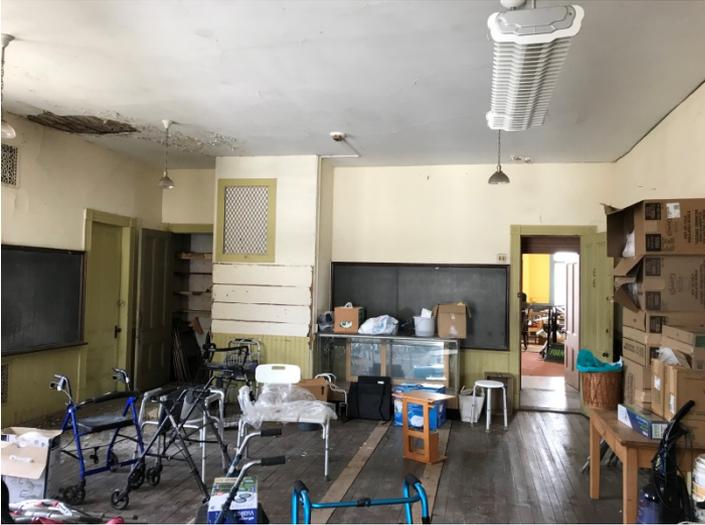
2-9 204 looking south toward Corridor 200

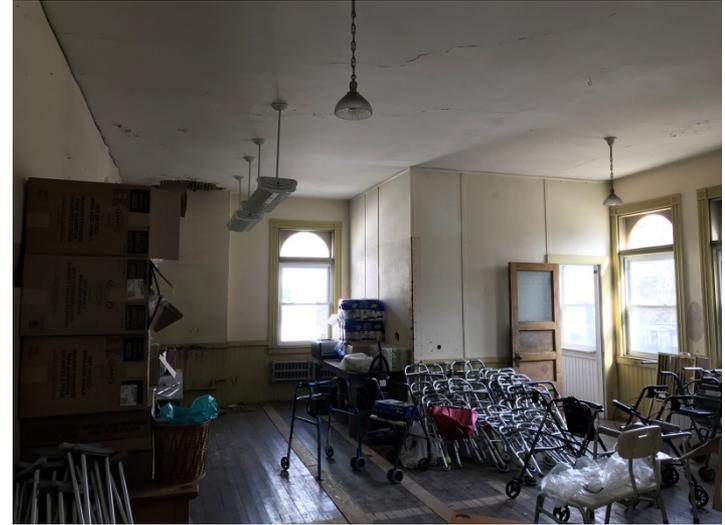
2-10 Room 204 looking north

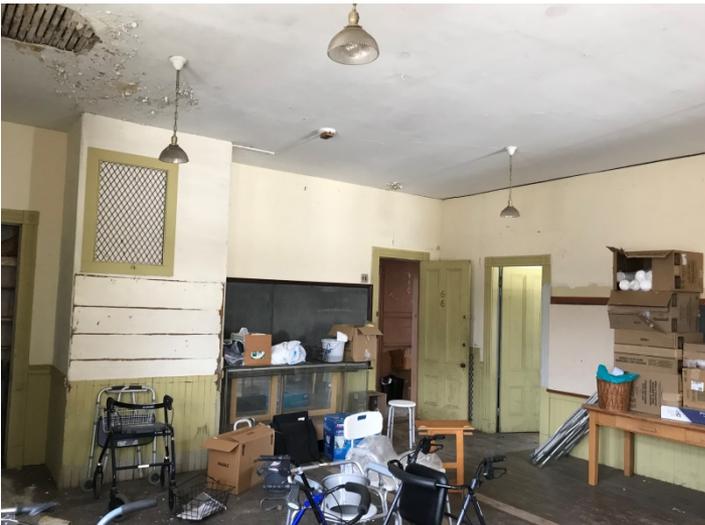
2-11 Rom 204 looking southwest

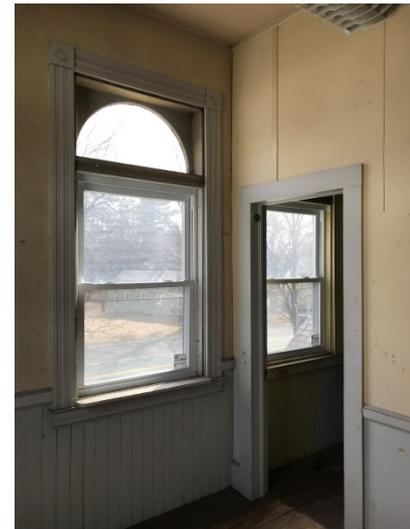
2-12 Room 205 toward door to 204

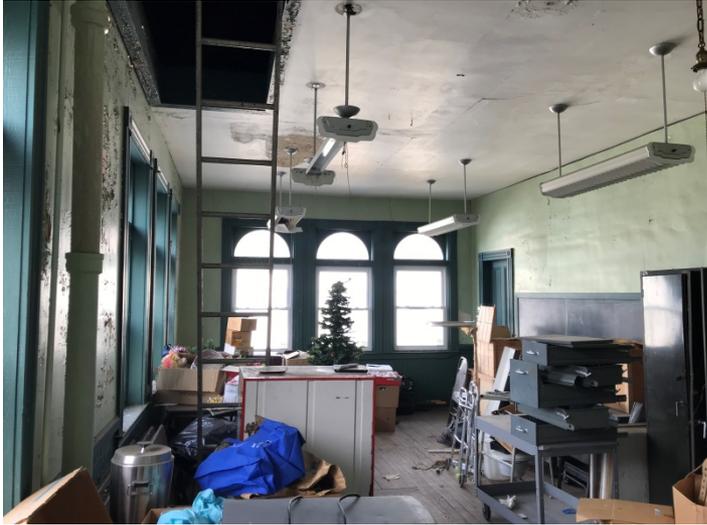
2-13 Room 203 looking north

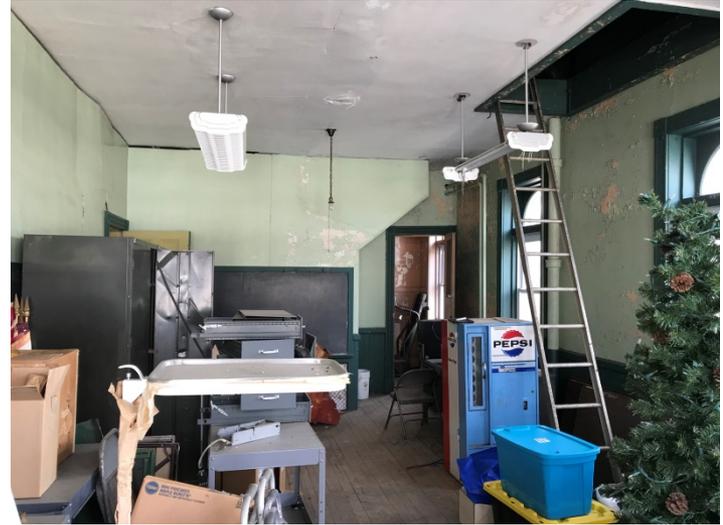
2-14 Room 203 looking south toward Corridor 200

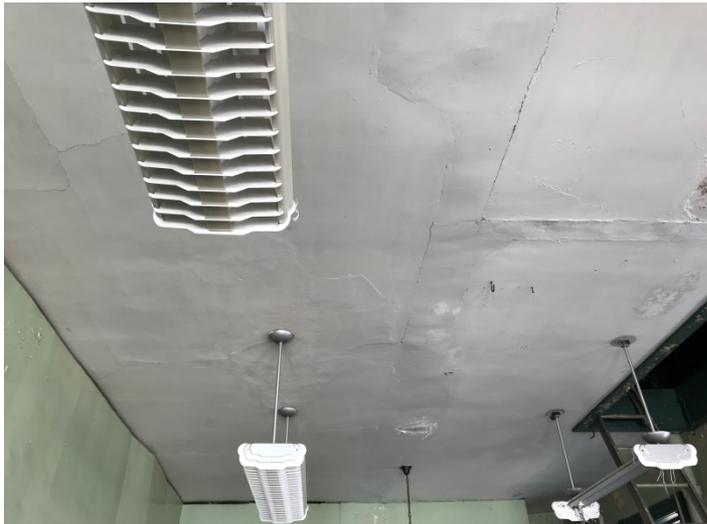
2-15 Room 203 ceiling

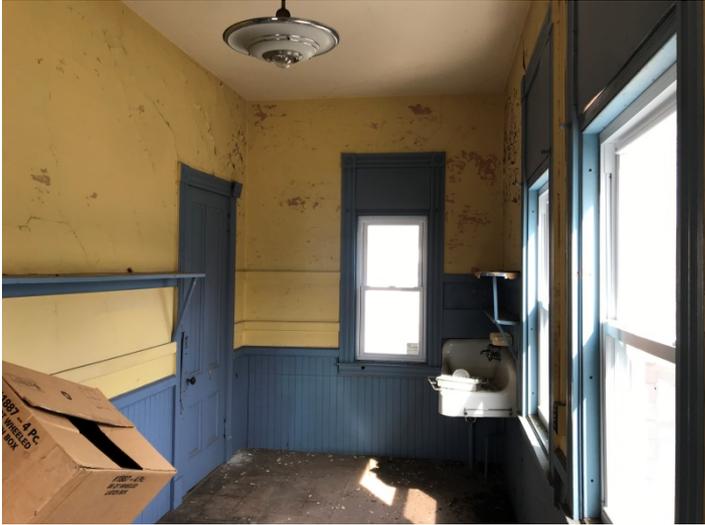
2-17 Room206 looking north

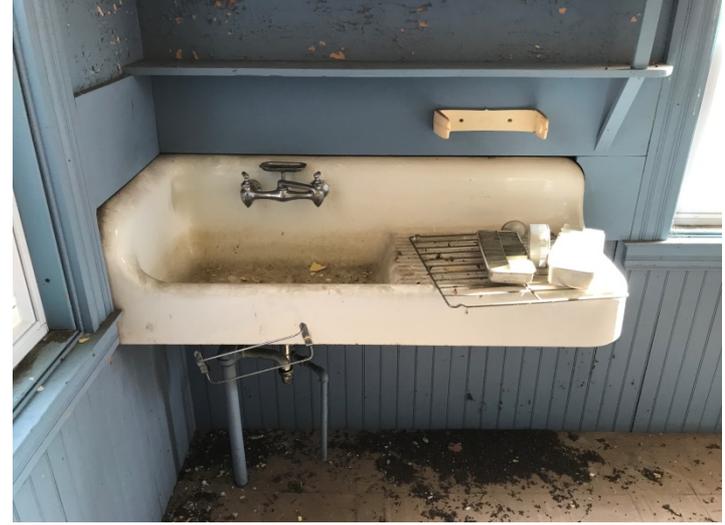
2-18 Room 206 sink

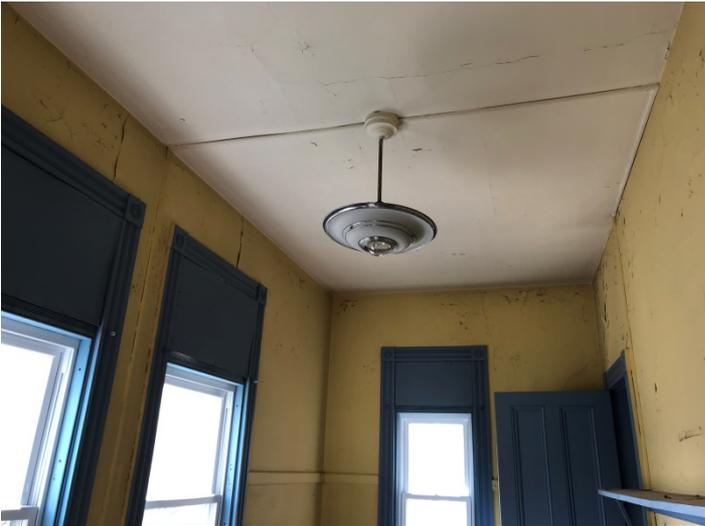
2-19 Room 206 ceiling

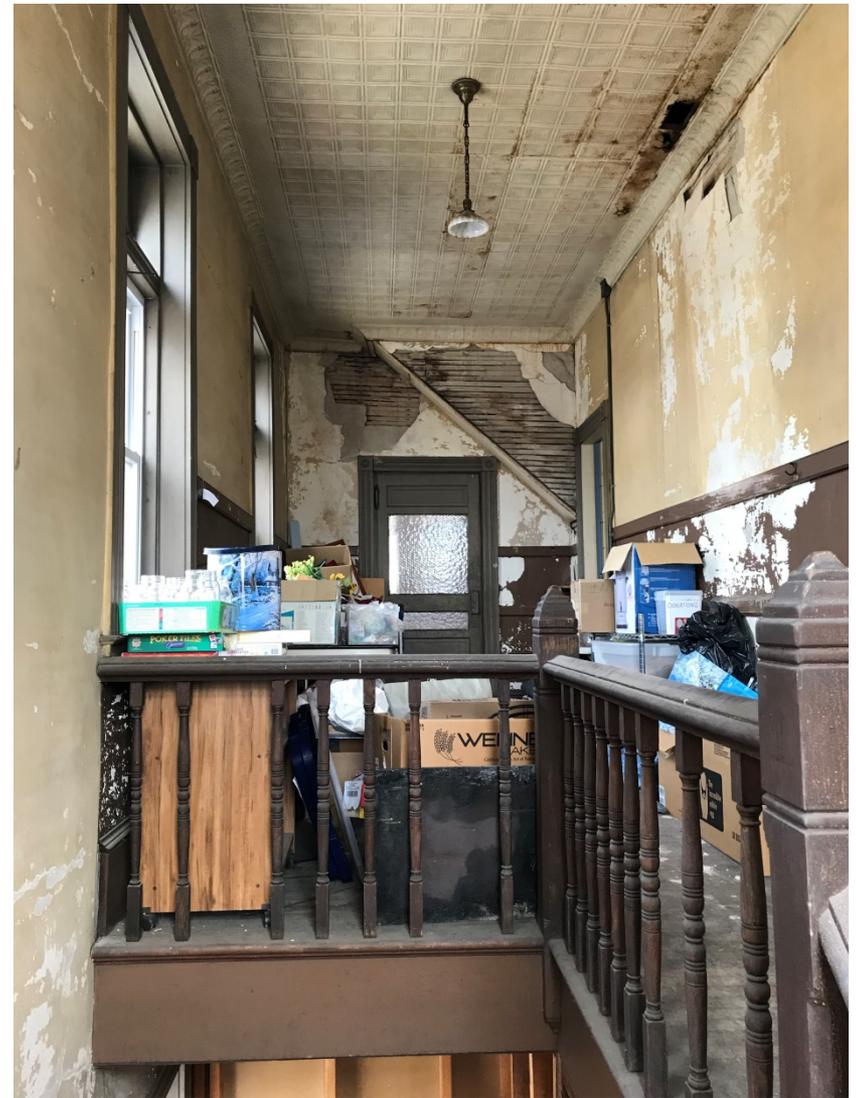
2-22 Corridor 202 looking north

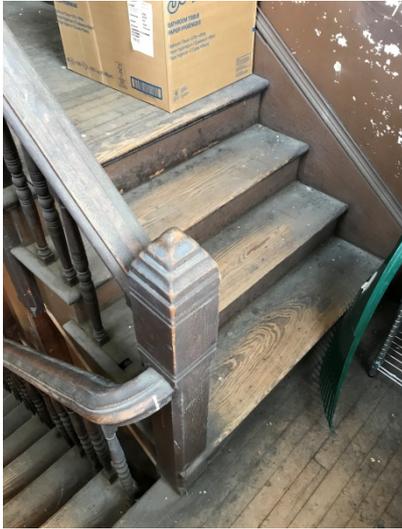
2-23 Corridor 202 stair detail

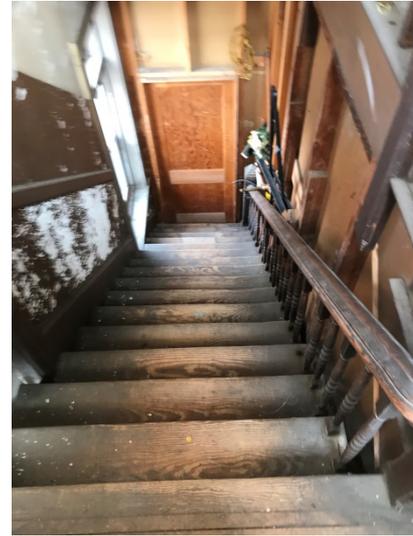
2-24 Corridor 202 stair

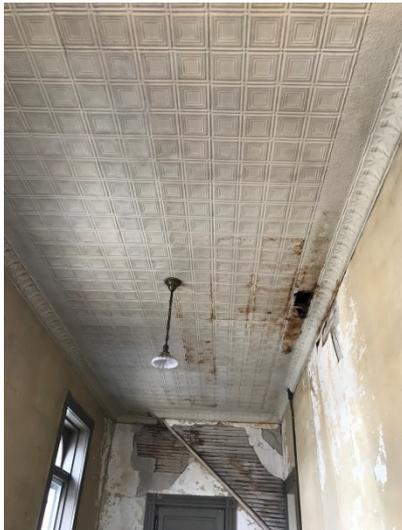
2-25 Corridor 202 ceiling

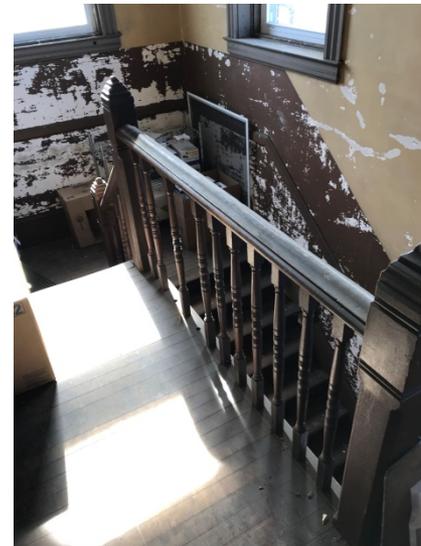
2-26 Corridor 202 stair railing

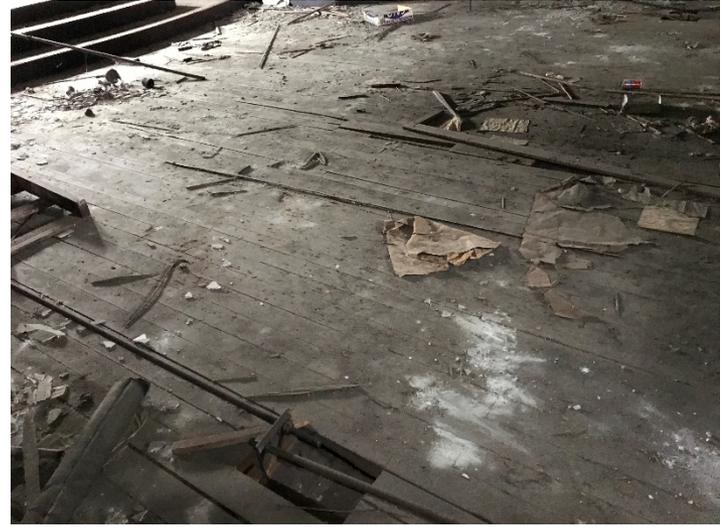
3-2 Debris on floor of finished area

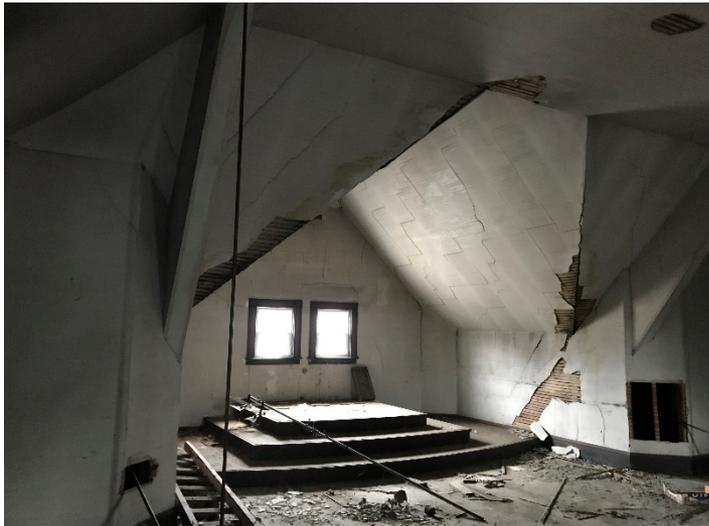
3-3 Raised platforms at east (street) side dormer

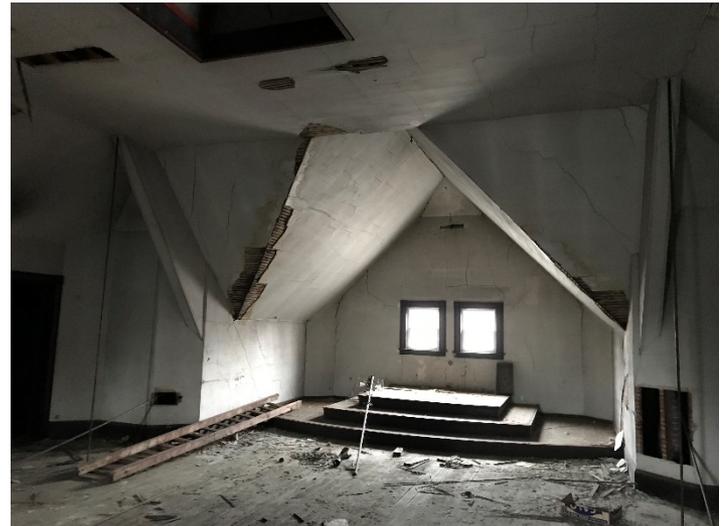
3-4 Raised platforms at east (street) side dormer

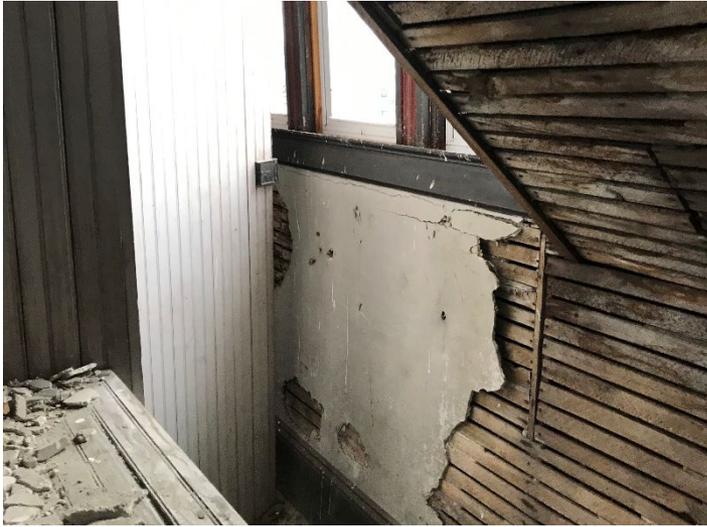
3-5 Wall finish at west dormer wall

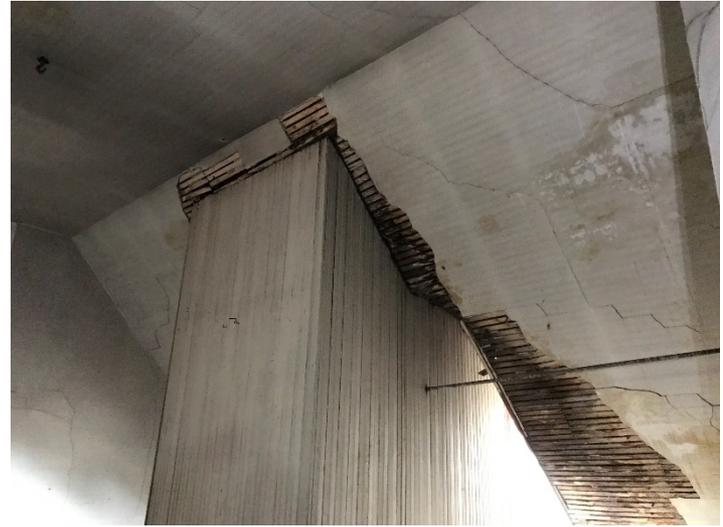
3-6 Vent shaft at west dormer

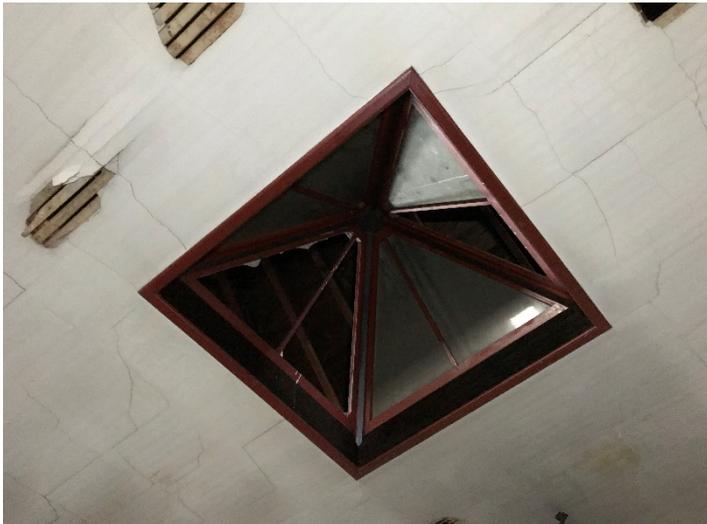
3-7 Interior "skylight" at ceiling of finished area

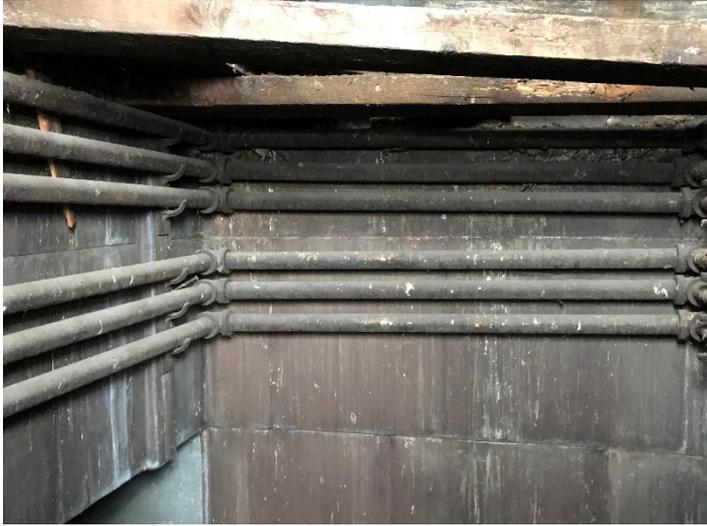
3-9 Interior of vent shaft

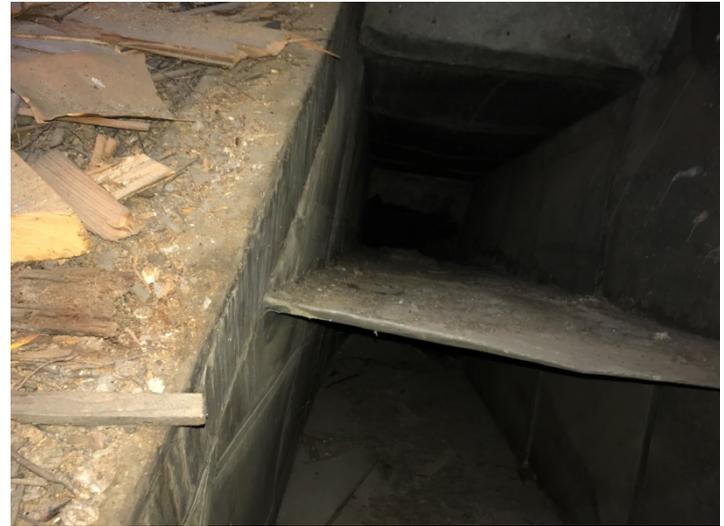
3-10 Vent shaft

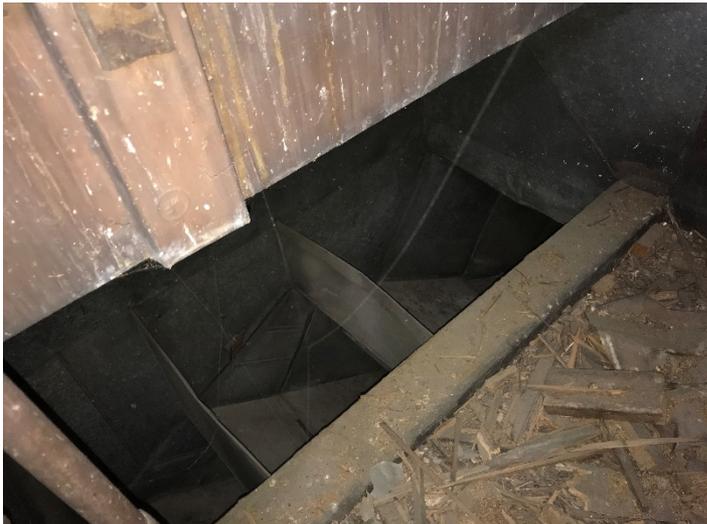
3-11 Vent shaft

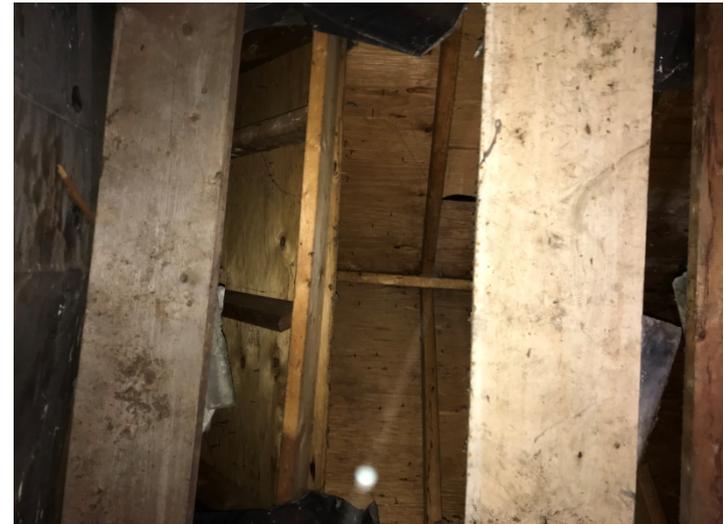
3-12 Roof ridge from inside vent shaft enclosure

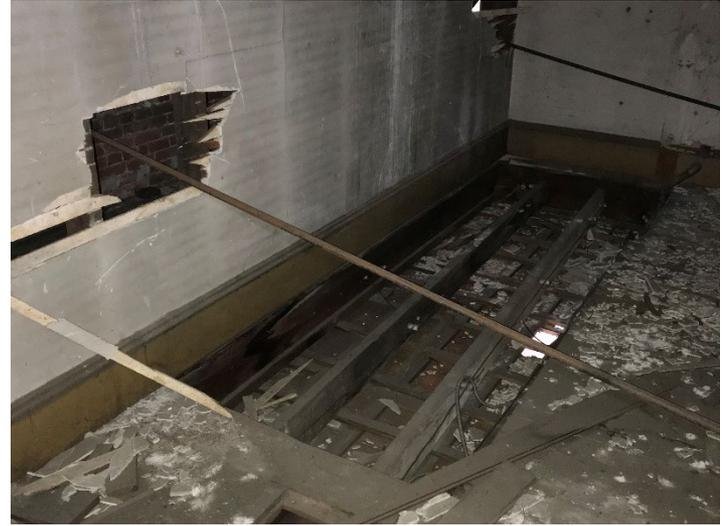
3-14 Exposed floor structure within Room 304

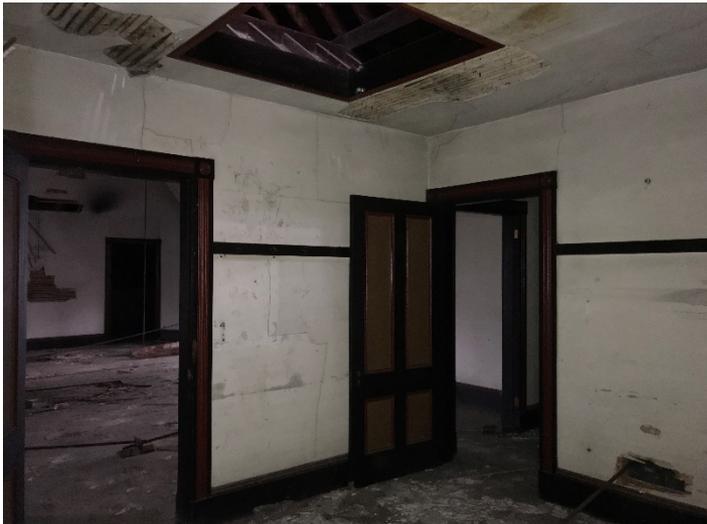
3-15 Room 303

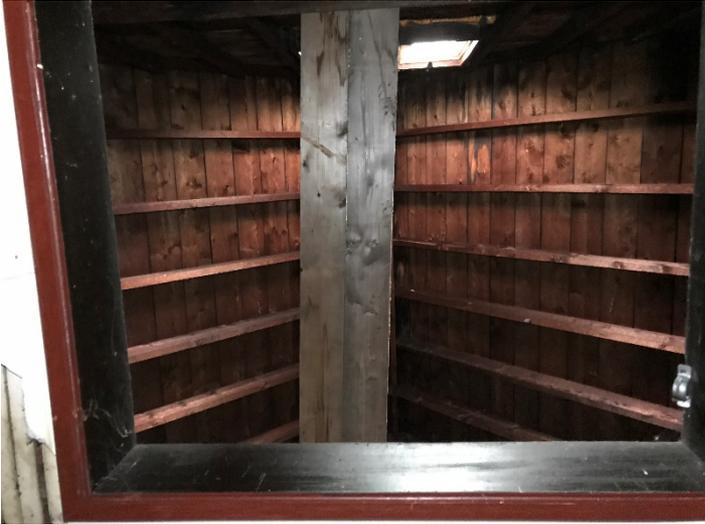
3-17 Roof structure above finished area

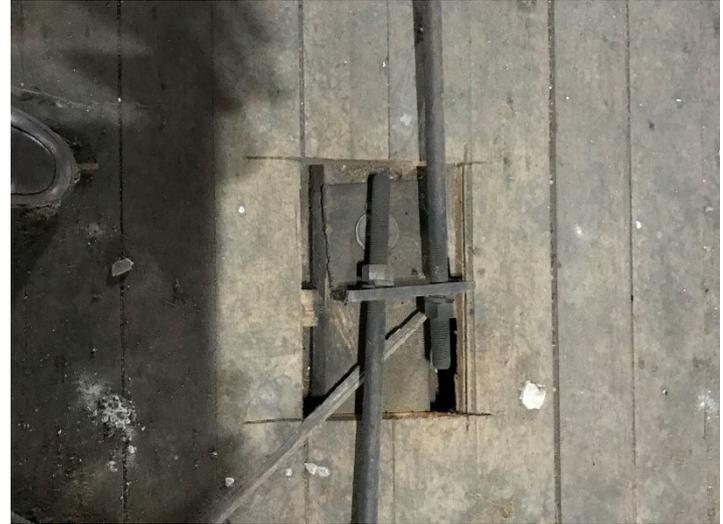
3-18 Steel bar strong-back tie at floor structure

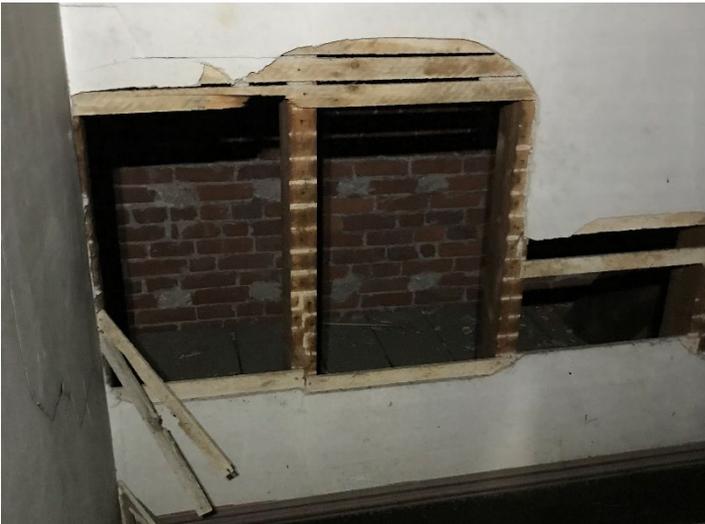
3-19 Brick wall behind finished wall
