**TOWN OF DEERFIELD**  
**FACILITIES CONDITION ASSESSMENT**  
**OF**  
**TOWN BUILDINGS**

**Senior**  
**Center**

**Gorman Richardson Lewis Architects**

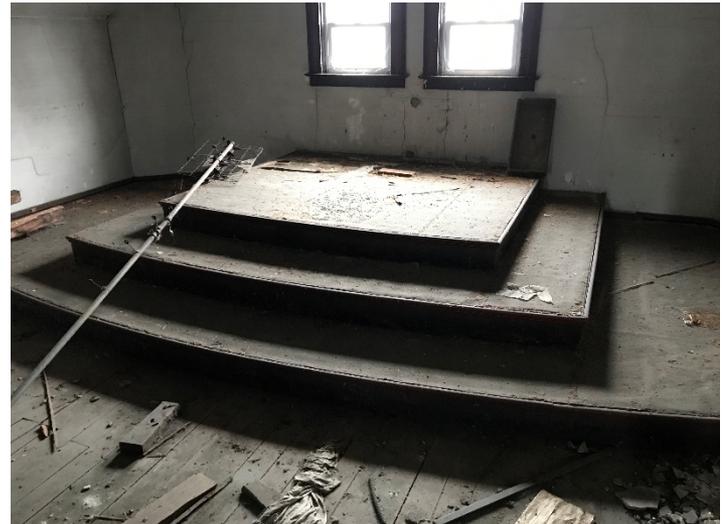
3-20 Platforms at east dormer

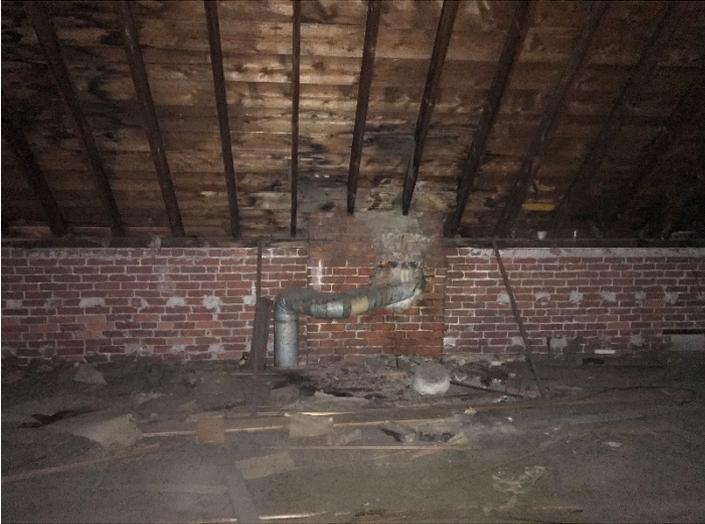
3-21 Flue duct at north chimney

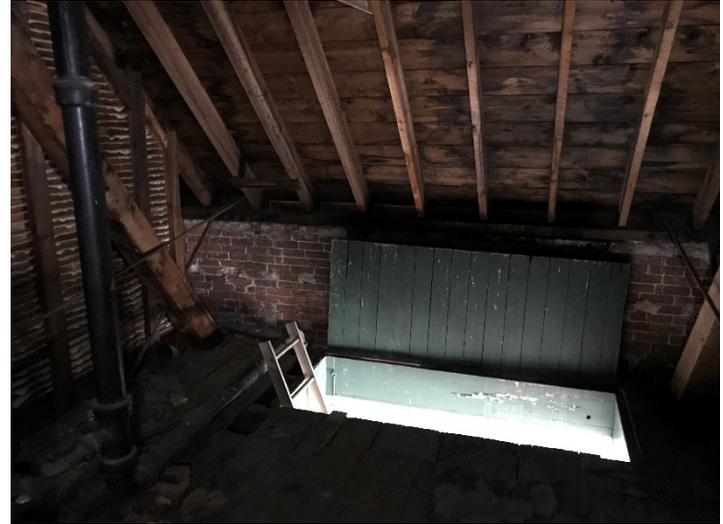
3-22 Access hatch from Room 203 below

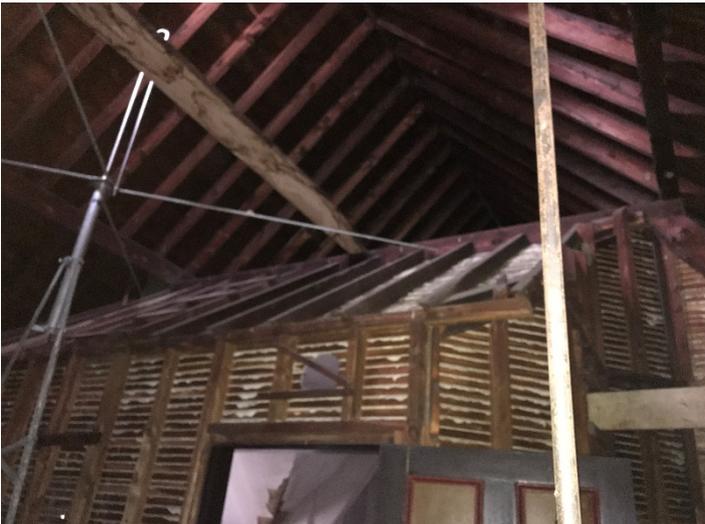
3-23 Wall & ceiling framing of finished area
