TOWN OF DEERFIELD
FACILITIES CONDITION ASSESSMENT
OF
TOWN BUILDINGS

Town Hall
Municipal Offices

Executive Summary

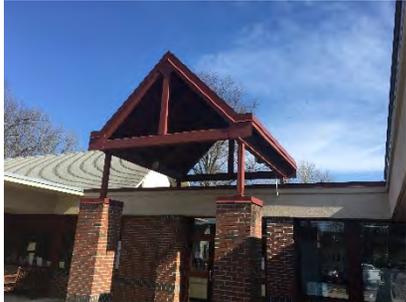
Component	Deficiency	Description	Photograph
Foundation/Floor Slab	<input type="checkbox"/> Deterioration <input type="checkbox"/> Weakness <input type="checkbox"/> Settlement <input type="checkbox"/> Other	<ul style="list-style-type: none"> No deficiencies noted 	
Upper Floors	<input type="checkbox"/> Deterioration <input type="checkbox"/> Weakness <input type="checkbox"/> Settlement <input type="checkbox"/> Other	<ul style="list-style-type: none"> Not applicable. 	
Roof	<input type="checkbox"/> Deterioration <input type="checkbox"/> Weakness <input type="checkbox"/> Settlement <input checked="" type="checkbox"/> Other	<ul style="list-style-type: none"> The entrance canopy has some rust at untreated steel that should be cleaned and repainted

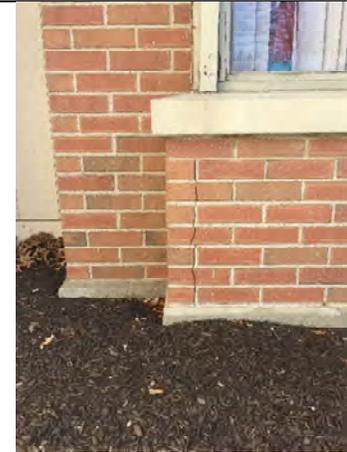
Exterior Walls

- Vertical crack near southwest corner of building through brick below window.

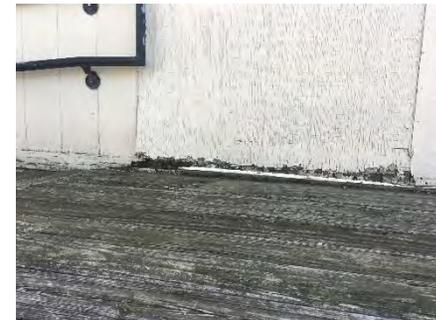
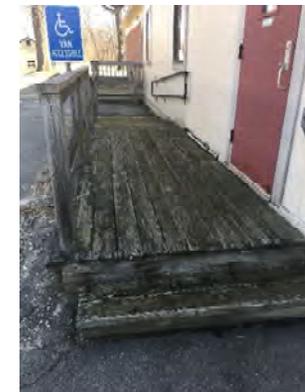
Other

- Exterior wood ramps and steps at the "Assessor's addition" are severely weathered and beginning to show signs of rotted boards. The T1-11 siding panels are also damaged due to moisture along the joint with the ramp.

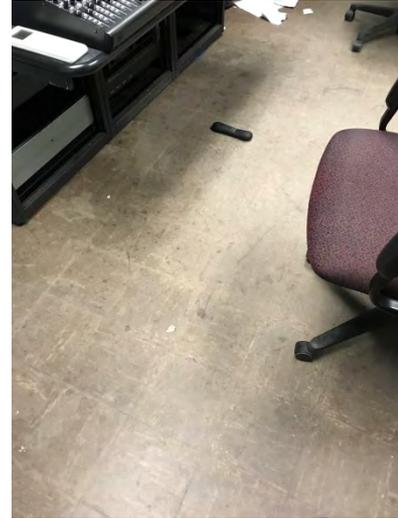
- Based upon the age of the building (1960) the glazing is likely single pane, non-insulated glass panel.
- Flooring is older 9” x 9” resilient tile (suspected ACM- Asbestos Containing Material) mostly in sound condition, except near the center of the floor where this is a raised ridge and blistering of the tile.

34. 9x9 tile (ACM) flooring at FCAT Office

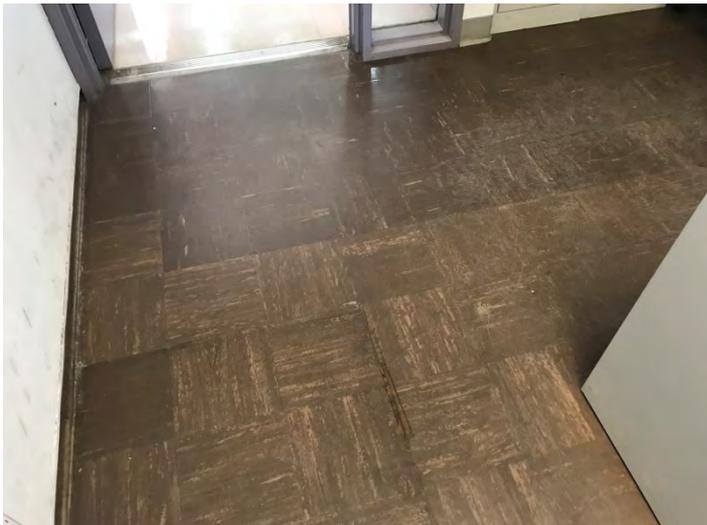
39. Building Inspection Office floor (9x9 tile (ACM))

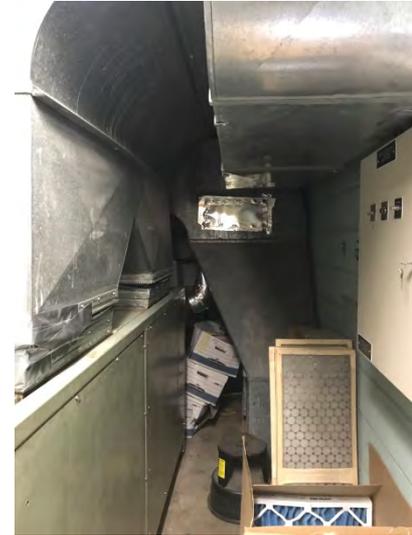
- The existing (original) mechanical room houses a very large indoor air handler with associated ductwork, taking up a significant amount of space, and appears to be beyond its service life. As part of an overall renovation to improve the functionality and efficiency of the Town Hall Building, it is recommended this unit be removed and replaced with a roof-top air handler to provide fresh air to the building along with centralized AC and supplemental heat that would allow repurposing of the existing Mechanical Room to office or support space.

50. Mechanical Room AHU

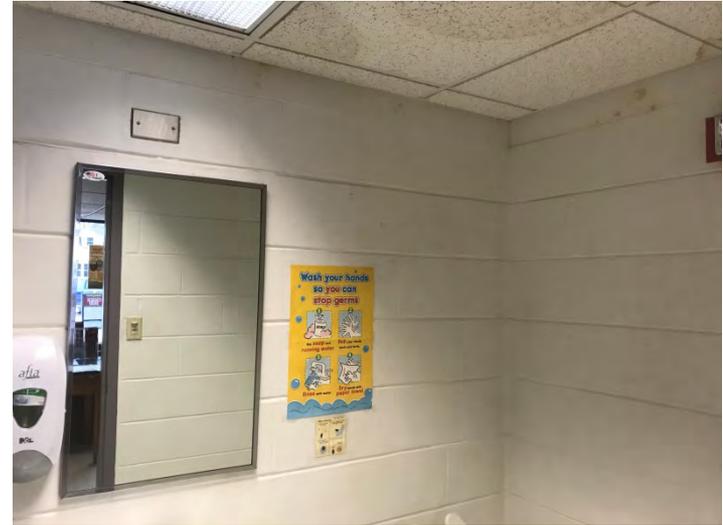
58. Small Men's Room off Hall 126

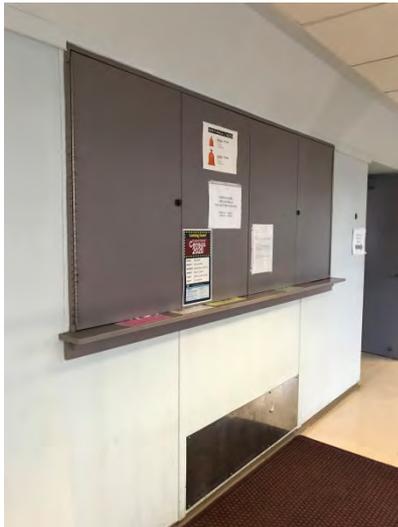
59. Town Clerk's Transaction Counter along South Corridor

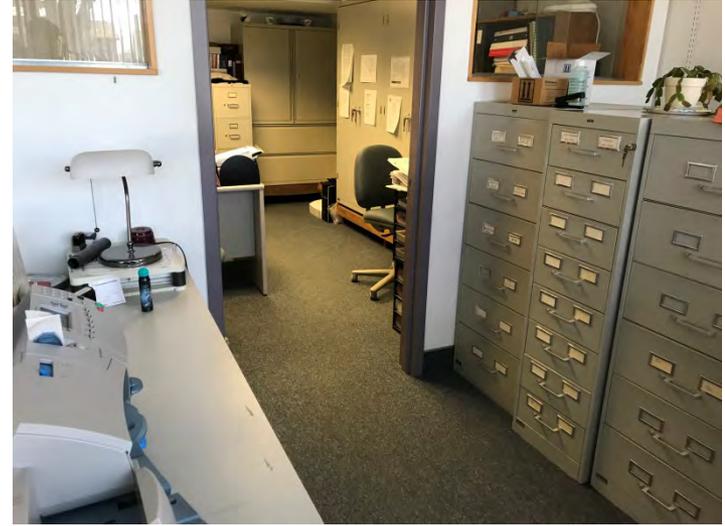
62. Door to Town Treasurer's Office

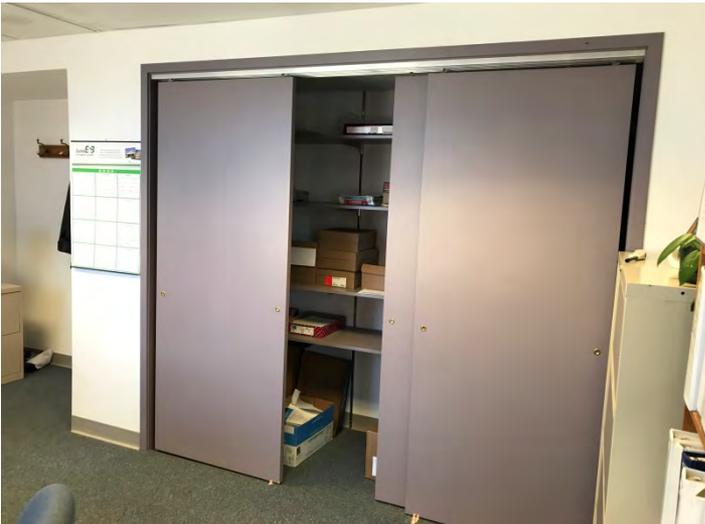
63. Town Accountant's Office

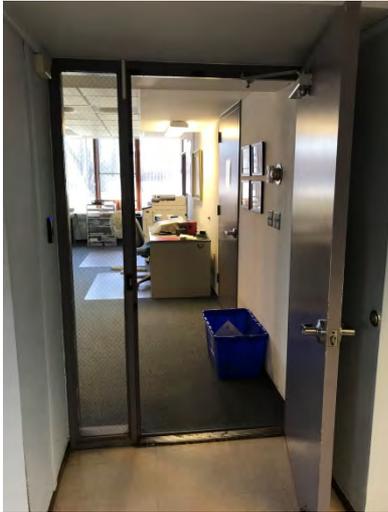
65. Entry to Town Clerk's Office off South Corridor

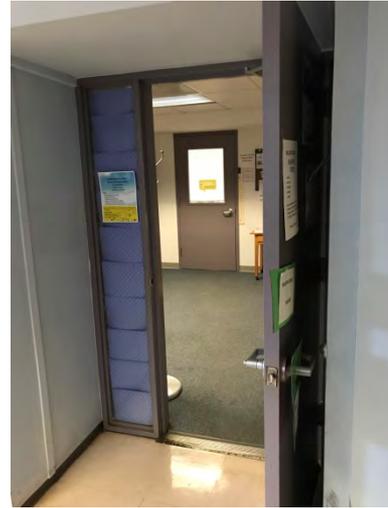
66. Entry to Nurse's Office off South Corridor

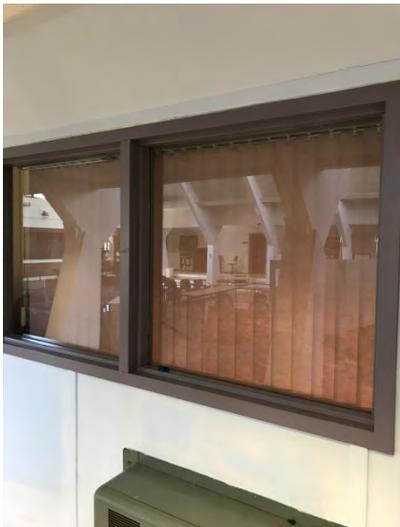
67. Interior glazed openings in Nurse's Office

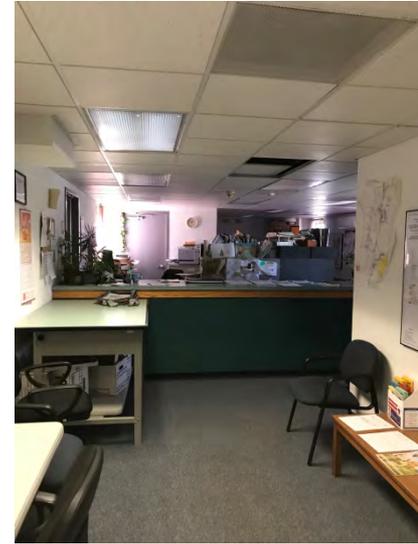
70. Assessor's Office

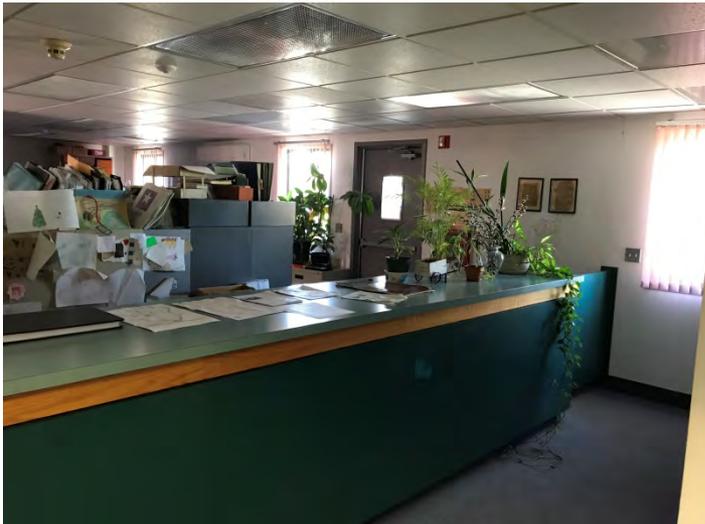
71. Transaction counter at Assessor's Office

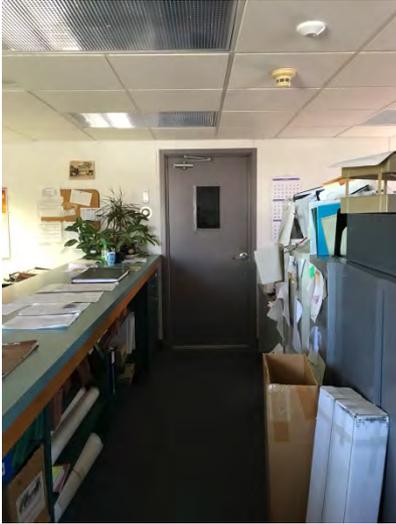
73. Door to Nurse's Office from Assessor's Office

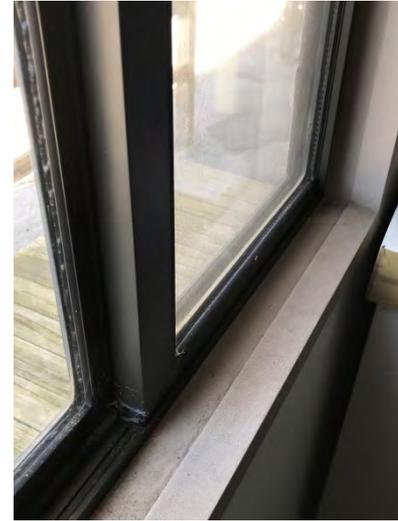
74. Typical window at Assessor's Office (Modular wing)

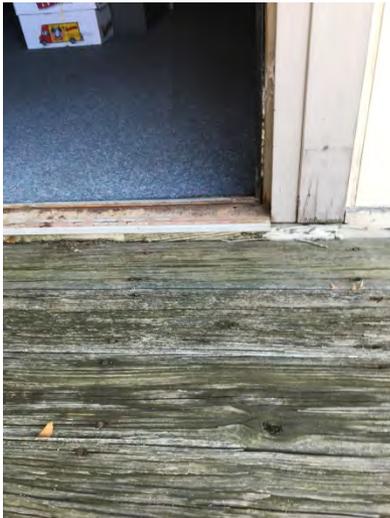
75. Threshold at exterior door to Assessor's Office

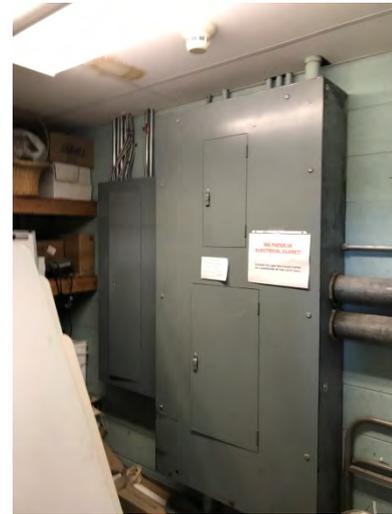
78. Electrical Room

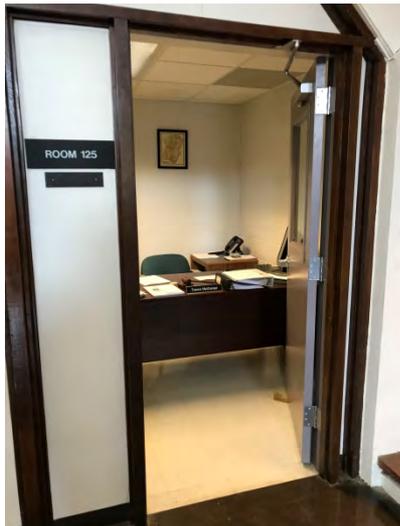
79. Entry to Room 125 at west end of Assembly Area

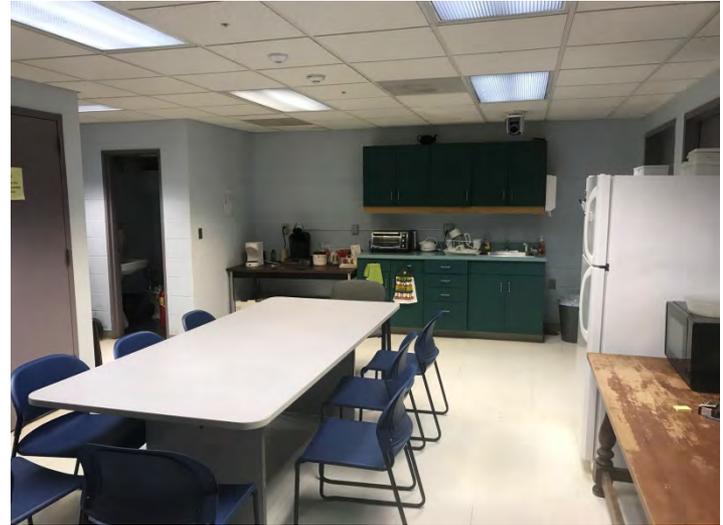
82. Kitchenette

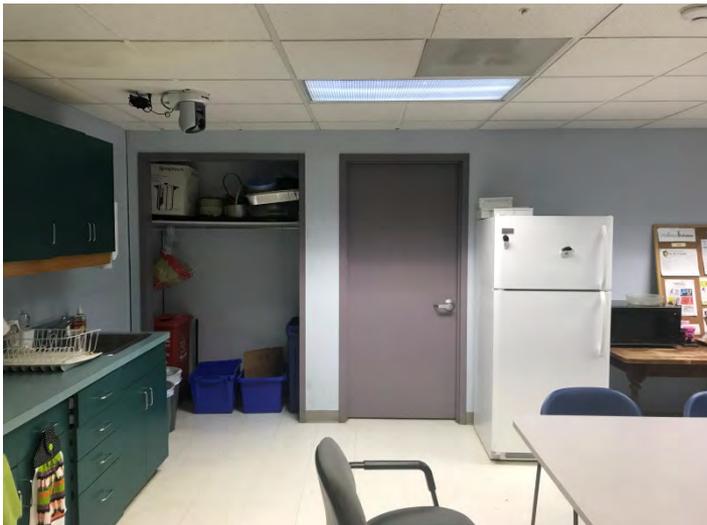
83. Kitchenette

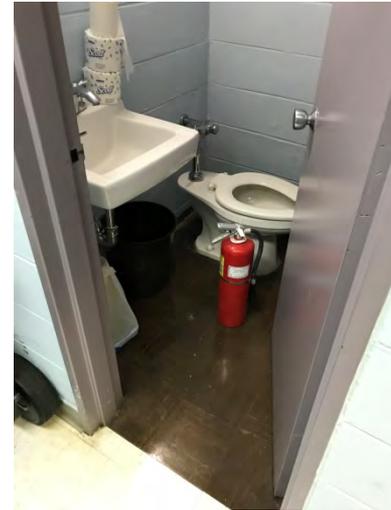
86. Lav off Kitchenette

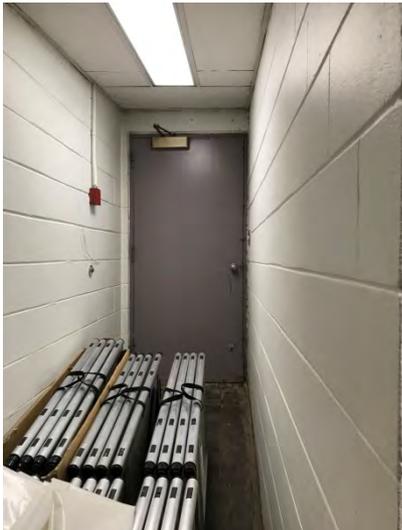
87. Ramped egress corridor off Kitchenette

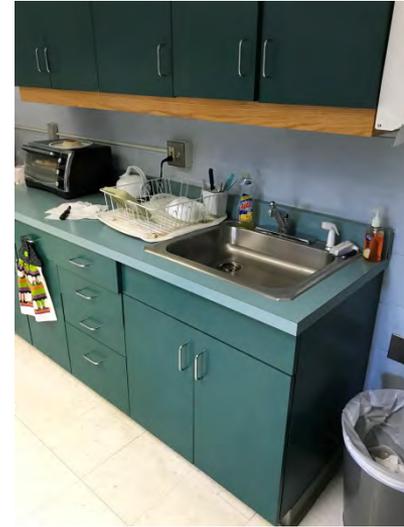
90. Sink and counter at Kitchenette

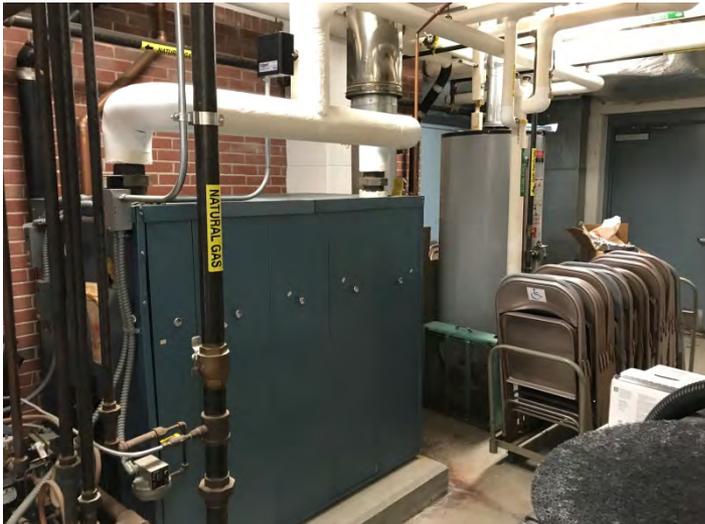
91. Boiler Room off Hall 126

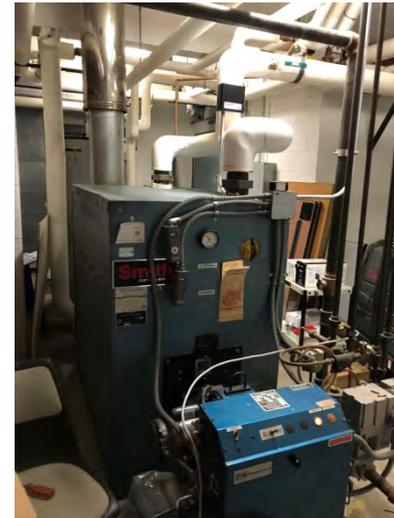
92. Boiler Room

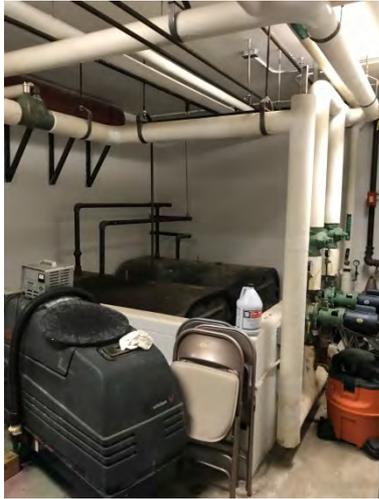
93. Oil tanks in Boiler Room within cmu enclosure

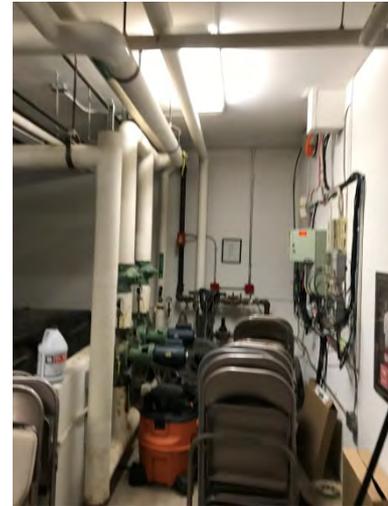
94. Pumps in Boiler Room

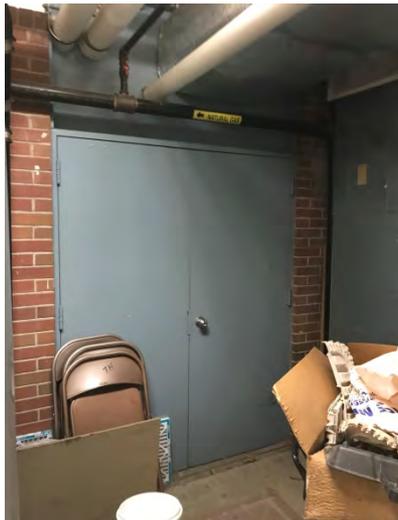
95. Door to Mechanical Room from Boiler Room

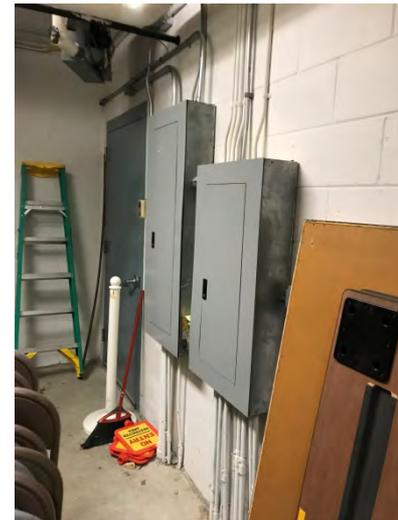
96. Electrical Panels in Boiler Room

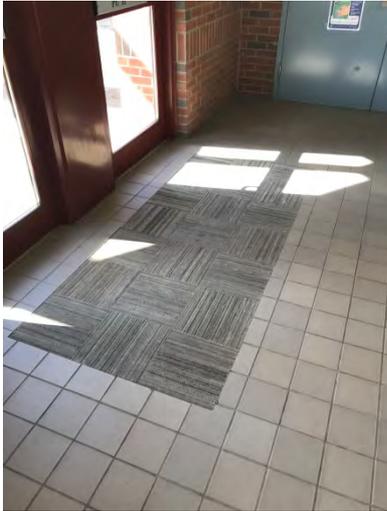
97. Recessed walk-off mat at Main Entry Vestibule

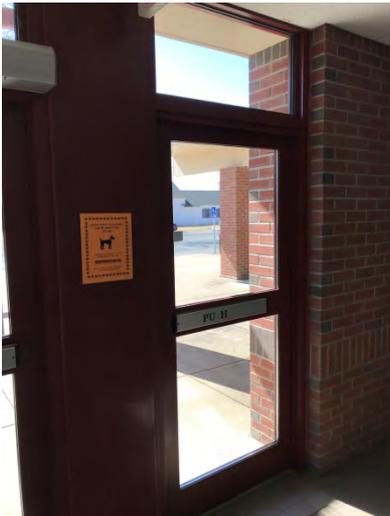
99. Main Entry Doors
